Dundon Consulting Pty Limited

4 October 2012

Re: Calga Sand Quarry – Re-testing of Bore CP3

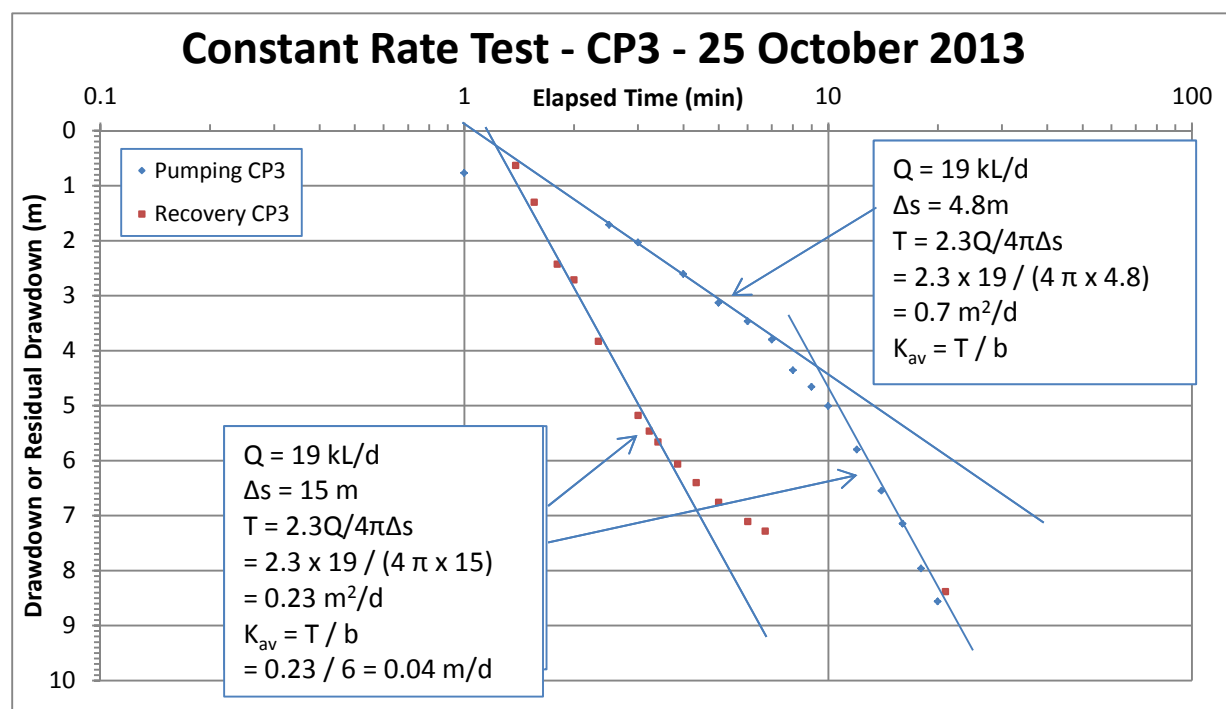
Figure 2: Constant Rate Pumping Test – CP3 – 25 October 2013

The test was terminated after 20 minutes, by which time the water level had declined to around 18m, and the pump had started showing signs that it was about to run out of water.

The plot of drawdown and recovery data from the test is shown on **Figure 2**.

The test data were analysed using the Cooper-Jacob method (Cooper and Jacob, 1946) and determined an aquifer transmissivity¹ of 0.7 m²/d.

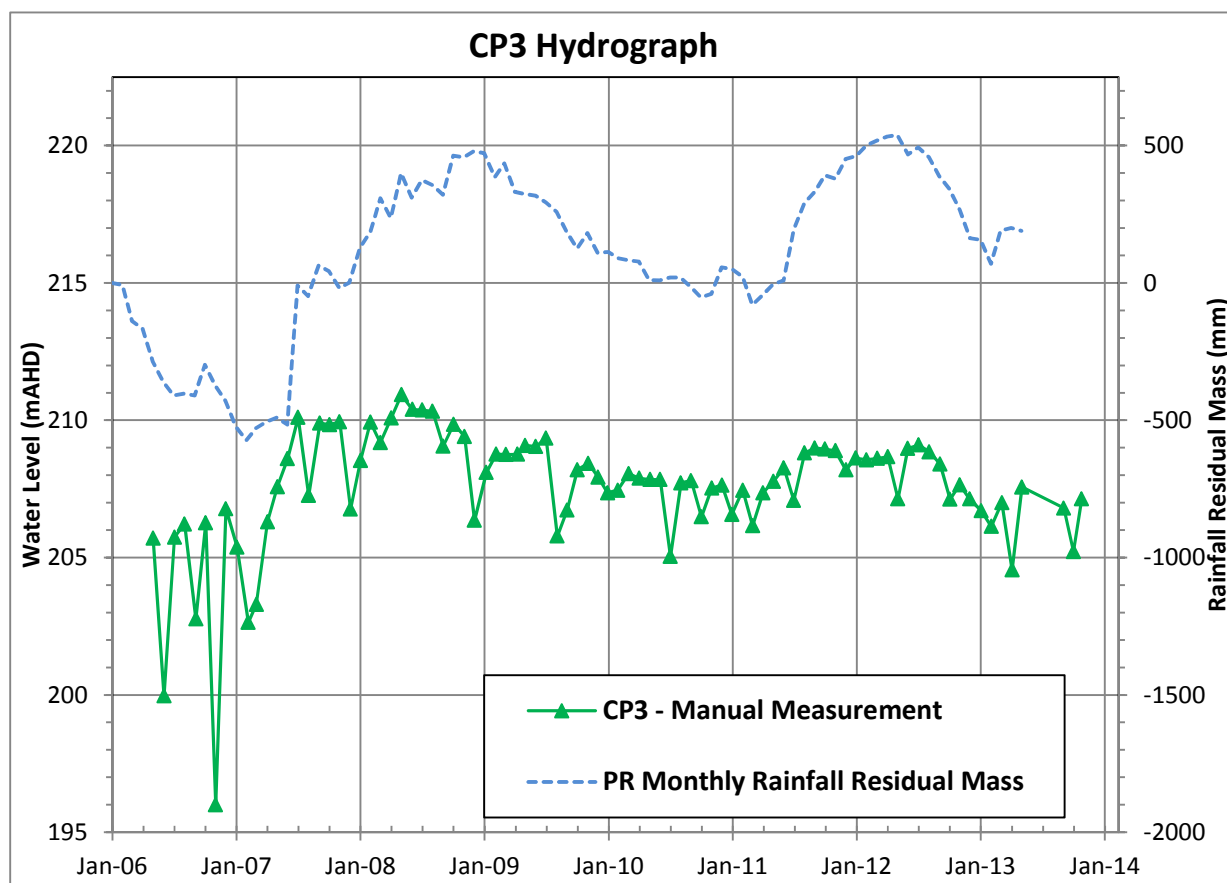
Figure 2: Constant Rate Pumping Test – CP3 – 25 October 2013

The monitoring data shows that the water level in CP3 is not low by historical levels, and is actually higher now than during 2006, when the pre-extraction bore testing was undertaken. The water level in the bore immediately prior to the test was 8.97m below ground level which is well within the long-term range of water level fluctuation, and therefore no reduction in performance (ie yield potential) would have been expected to have occurred. This can be seen on **Figure 3**, which shows the CP3 water level hydrograph through the monitoring period from 2006 to 2013.

The interpreted drawdown impact on CP3 was only detectable as a divergence between the CP3 water level and the rainfall residual mass curve, and specifically a divergence between the water levels at CP3 and CP7. CP7 is located further from the quarry than CP3, and has shown no sign of impact from the quarrying operation. Prior to the onset of impact on CP3 coinciding with the period of extraction from cell 3/6 between April and October 2011, CP3 and CP7 generally fluctuated together in response to the seasonal recharge pattern which is related to larger rainfall events.
