## ASBESTOS FIBRE AIR MONITORING REPORT

Our Ref:	C107605:J111804.094-20130620					
Client:	Hanson Construction Materials Pty Lt	d				
Attention:	Martin Gear - Project Manager Aggr	egates				
Job Location:	: East Guyong Quarry, Mitchell Highway, East Guyong NSW					
Report Date:	Tuesday 25 <sup>th</sup> June 2013	Test Date:	Thursday 20 <sup>th</sup> June 2013			
Sampling Procedure: Control		Sampled By:	Pumps On: Pere Riini (Hanson) Pumps Off: Pere Riini (Hanson)

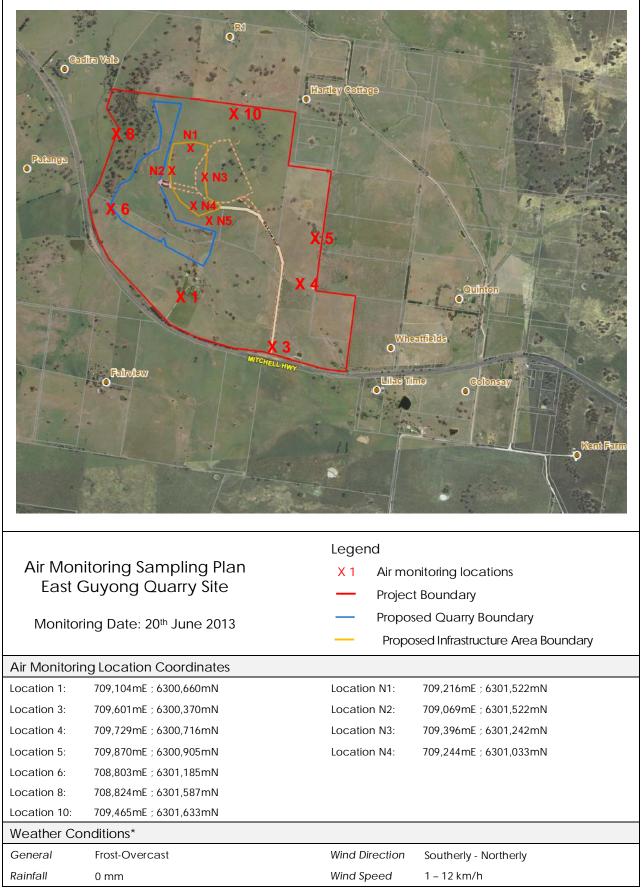
## Figure 1 – Air Monitoring Location

Filter No.	Test Type Sample Location	Sample Period Start-Finish	Average Flow Rate (L/min)	Fibres/ Fields	Result(s) Fibres/mL		
Control static monitoring during the excavation of soil in the Infrastructure Area on the East Guyong Quarry Site							
2071	Field Blank	-	-	0.0/100	-		
1245	Location 1 – Near Southern Boundary of Site, Access Road to Residence (No.3472) off Mitchell Highway, approx. 120 metres North of South Site Boundary – On barbed wire fence	0750 – 1445	1.00	0.0/100	< 0.01		
230	Location 3 – Near Southern Boundary (SE Corner) of Site, Adjacent to New Access Road Entry (No.3410) off Mitchell Highway, approx. 30 metres from South Site Boundary – On barbed wire fence	0753 – 1448	1.00	0.0/100	< 0.01		
2228	Location 4 – Near Eastern Boundary (near SE Corner) of Site, approx. 70 metres West of Shed, Access Road – On barbed wire fence	0756 – 1451	1.00	0.0/100	< 0.01		
3048	Location 5 – Near Eastern Boundary (near Centre) of Site, approx. 50 metres West of East Site Boundary – On fencing post	0759 – 1454	1.00	0.0/100	< 0.01

3036	Location 6 – Western Boundary of Proposed Quarry Pit (near Western Site Boundary) – On barbed wire fence	0805 – 1500	1.00	1.0/100	< 0.01		
2198	Location 8 – Western Boundary (near NW Corner) of Site – On barbed wire fence	0808 – 1503	1.00	0.0/100	< 0.01		
917AB	Location 10 – Near Northern Boundary of Site (near NE Corner Site) – On fencing post	0814 – 1509	1.00	0.0/100	< 0.01

Filter No.	Test Type Sample Location	Sample Period Start-Finish	Average Flow Rate (L/min)	Fibres/ Fields	Result(s) Fibres/mL		
2268	Location N1 – Northern Boundary Fence of Infrastructure Area	0817 – 1512	1.00	0.0/100	< 0.01		
2172	Location N2 - Western Boundary Fence of Infrastructure Area	0820 – 1515	1.00	0.0/100	< 0.01		
3017	Location N3 – Eastern Boundary Fence of Infrastructure Area	0827 – 1521	1.00	0.0/100	< 0.01		
1216	Location N4 – Southern Boundary Fence of Infrastructure Area	0823 – 1518	1.00	0.0/100	< 0.01		
Exposure monitoring during cutting and filling works in IA							
1011	Excavator Operator – John Willis (EODO)	0832 – 1526	1.00	0.0/100	< 0.01
