## Asbestos Fibre Air Monitoring Report

Our Ref: C107605:SO2002930.002-20161004
Client: Hanson Construction Materials Pty Ltd
Client Address: Locked Bag 5260, Parramatta NSW 2124

Job Location: East Guyong Quarry, Mitchell Highway, East Guyong NSW

Report Date: Thursday, 13 October 2016
Test Date: Tuesday, 4 October 2016

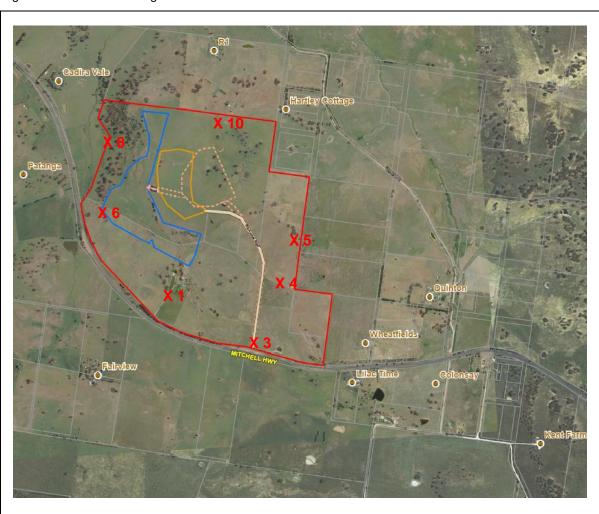
Figure 1 – Air Monitoring Location

Filter No.	Test Type Sample Location	Sample Period Start-Finish	Average Flow Rate (L/min)	Fibres/ Fields	Result(s) Fibres/mL
Asbestos background – Background asbestos air monitoring throughout various locations across the site.					
C0005 39502	Field Blank	-	-	0.0/100	-
C0005 39491	Location 1 – Near Southern Boundary of Site, Access Road to Residence (No.3472) off Mitchell Highway, approx. 120 metres North of South Site Boundary – On barbed wire fence	0714 – 1501	1.00	1.0/100	< 0.01
C0005 39429	Location 3 – Near Southern Boundary (SE Corner) of Site, Adjacent to New Access Road Entry (No.3410) off Mitchell Highway, approx. 30 metres from South Site Boundary – On barbed wire fence	0719 – 1509	1.00	0.0/100	< 0.01
C0005 39495	Location 4 – Near Eastern Boundary (near SE Corner) of Site, approx. 70 metres West of Shed, Access Road – On barbed wire fence	0724 – 1514	1.00	0.0/100	< 0.01
C0005 39471	Location 5 – Near Eastern Boundary (near Centre) of Site, approx. 50 metres West of East Site Boundary – On fencing post	0729 – 1519	1.00	1.0/100	< 0.01

C0005 39501	Location 6 – Western Boundary of Proposed Quarry Pit (near Western Site Boundary) – On barbed wire fence	0738 – 1524	1.00	0.0/100	< 0.01
C0005 39443	Location 8 – Western Boundary (near NW Corner) of Site – On barbed wire fence	0744 – 1530	1.00	0.0/100	< 0.01
C0005 39511	Location 10 – Near Northern Boundary of Site (near NE Corner Site) – On fencing post	0751 – 1537	1.00	0.0/100	< 0.01
