Dilapidation Inspection Report

Inspection Date: Thu, 20 Feb 2020

Property Address: 2, 2A, 2B Bridge Rd, Glebe NSW 2037,
Australia

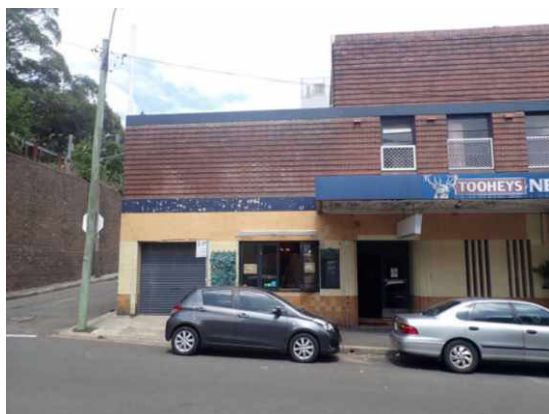
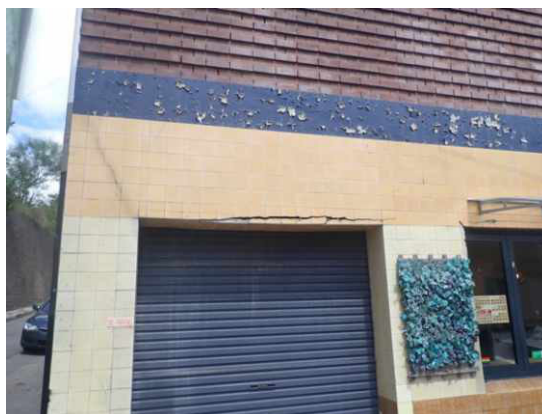
Building: Main Building
 Location: NE 1
 Finding: Photographic Documentation
 Information: Condition of the area at the time of the inspection.

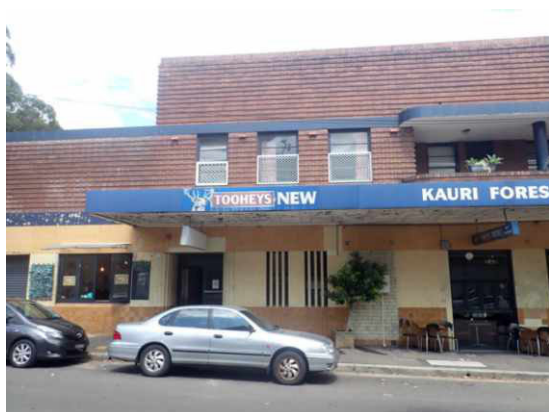
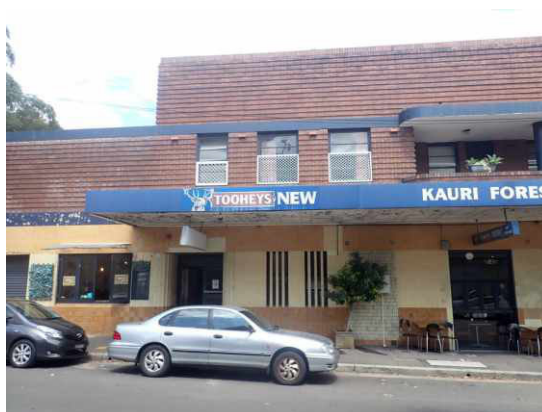
Building: Main Building
 Location: NE 2
 Finding: Photographic Documentation
 Information: Condition of the area at the time of the inspection.

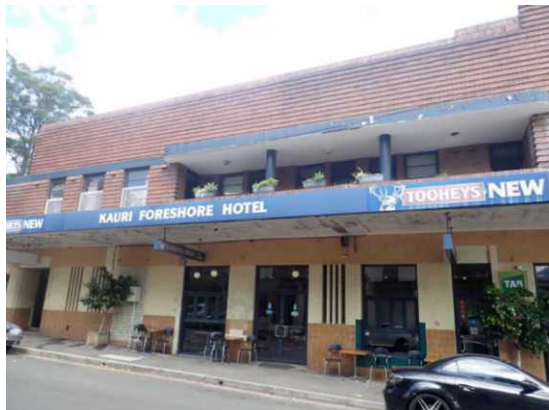
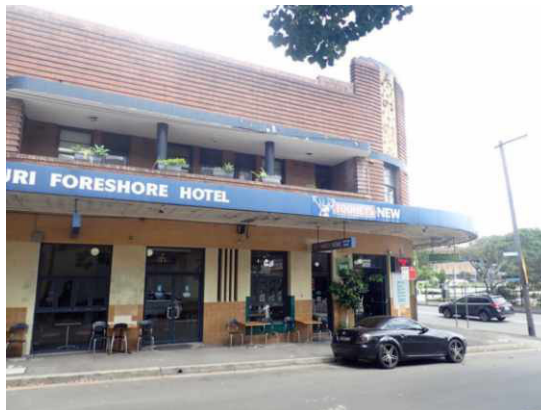
Building: Main Building
 Location: NE 3
 Finding: Photographic Documentation
 Information: Photographic Documentation

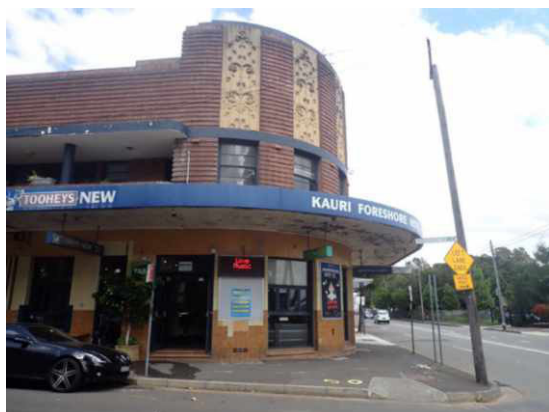
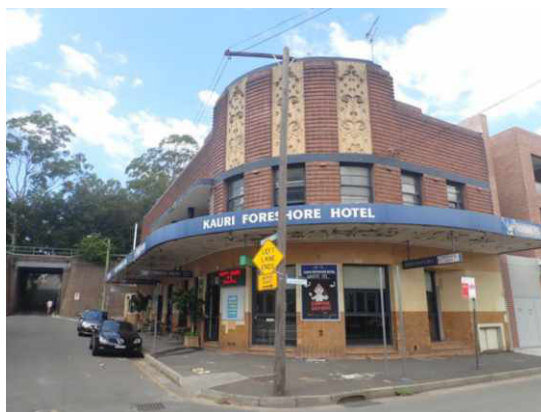
Building: Main Building
 Location: NE 4
 Finding: Photographic Documentation
 Information: Condition of the area at the time of the inspection.

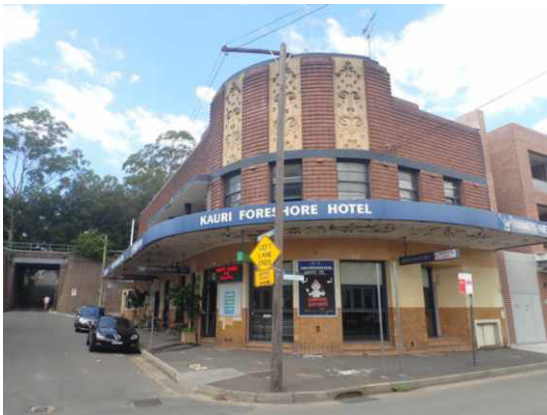
Building: Main Building
 Location: N 5
 Finding: Photographic Documentation
 Information: Condition of the area at the time of the inspection.

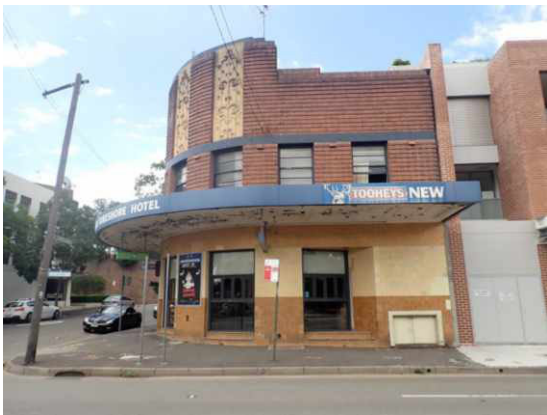
Building: Main Building
Location: NW 6
Finding: Photographic Documentation
Information: Condition of the area at the time of the inspection.

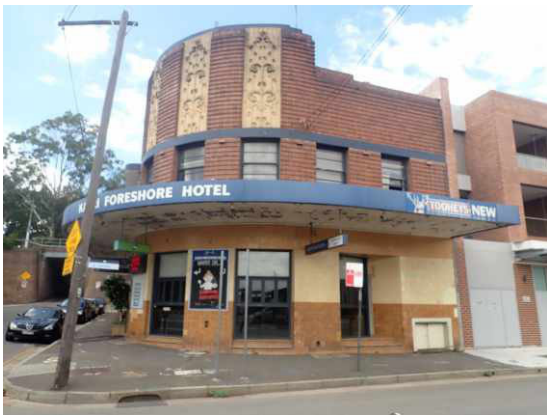
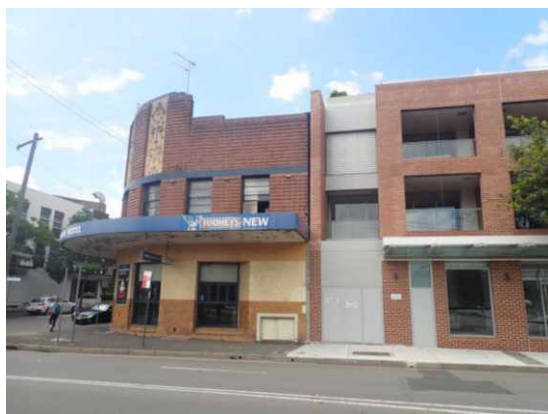
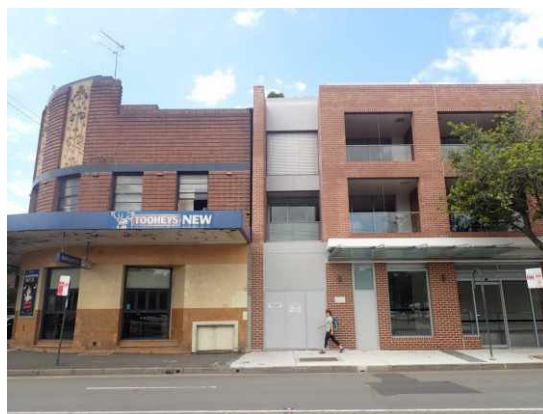
Building: Main Building
Location: NW 7
Finding: Photographic Documentation
Information: Condition of the area at the time of the inspection.

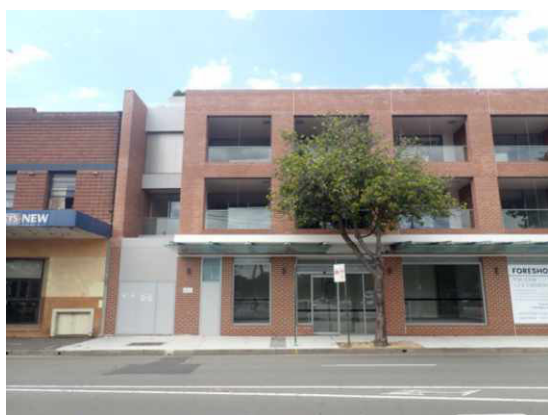
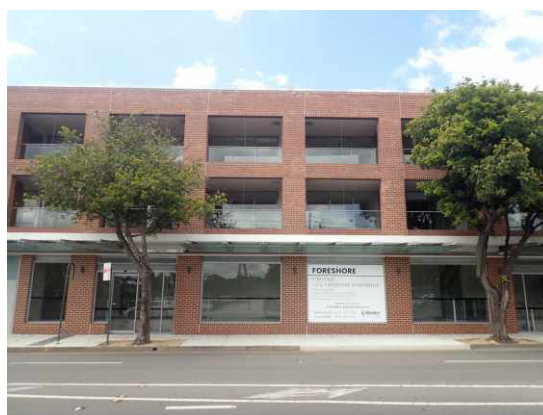
Building: Main Building
 Location: NW 8
 Finding: Photographic Documentation
 Information: Condition of the area at the time of the inspection.

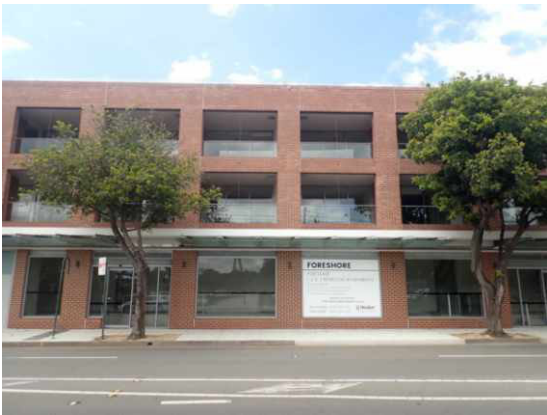
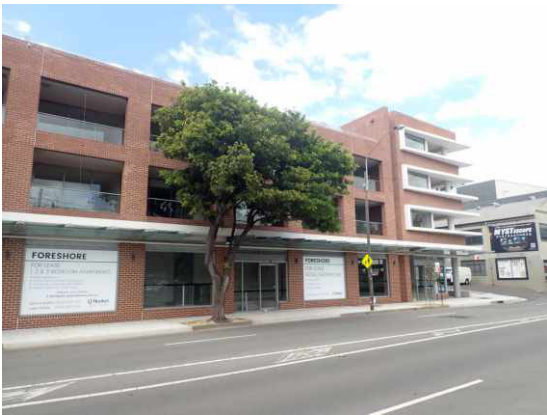
Building: Main Building
 Location: NW 9
 Finding: Photographic Documentation
 Information: Condition of the area at the time of the inspection.
