Dilapidation Inspection Report

Inspection Date: Thu, 20 Feb 2020

Property Address: 84-86 Wentworth Park Rd, Glebe NSW
2037, Australia

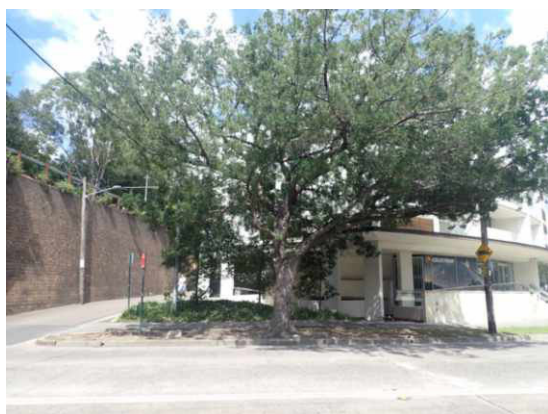
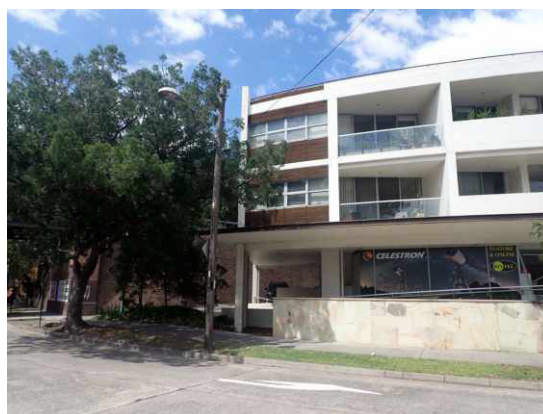
Building: Main Building
 Location: N 1
 Finding: Photographic Documentation
 Information: Condition of the area at the time of the inspection.

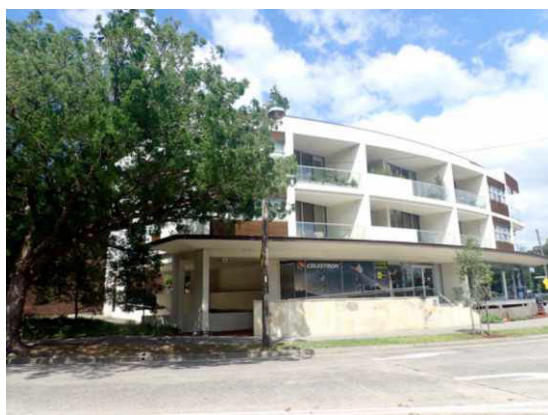
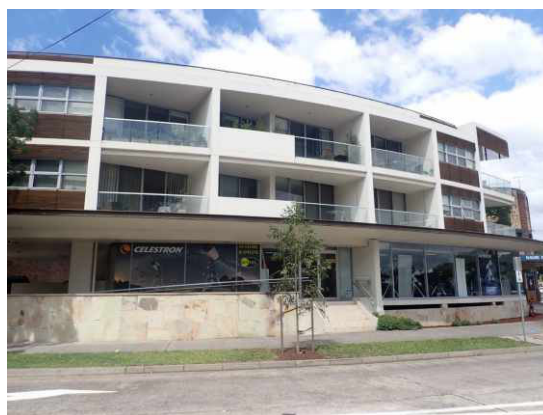
Building: Main Building
 Location: N 2
 Finding: Photographic Documentation
 Information: Condition of the area at the time of the inspection.

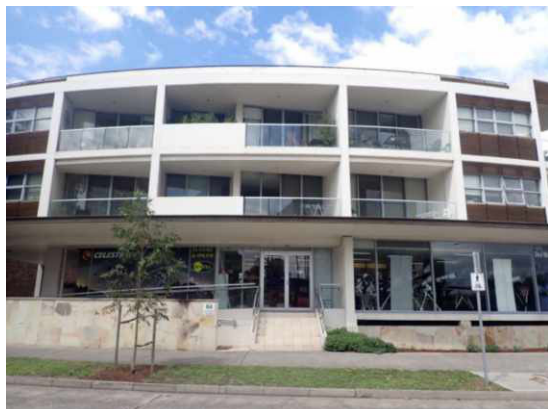
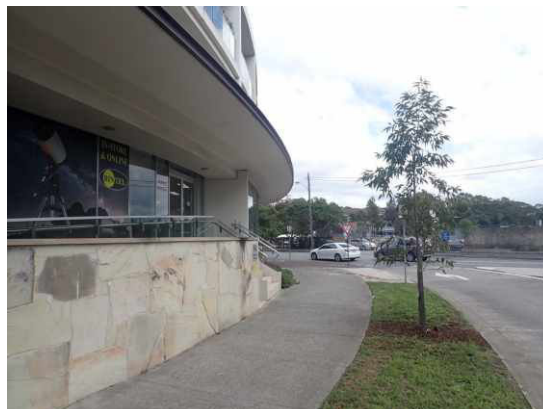
Building: Main Building
 Location: N 3
 Finding: Photographic Documentation
 Information: Photographic Documentation

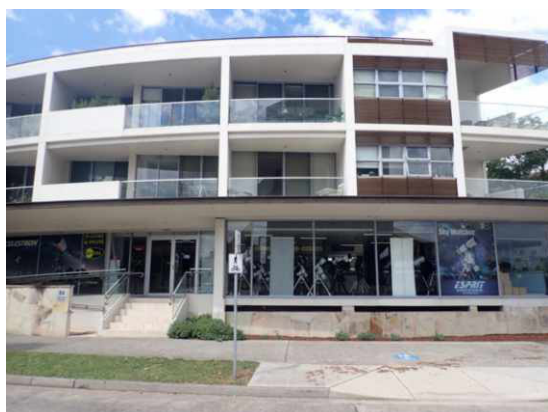
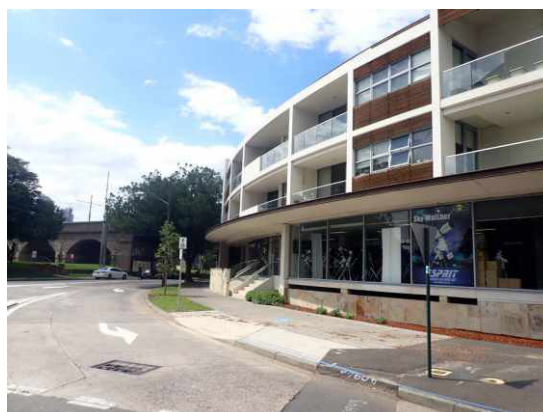
Building: Main Building
 Location: N 4
 Finding: Photographic Documentation
 Information: Condition of the area at the time of the inspection.

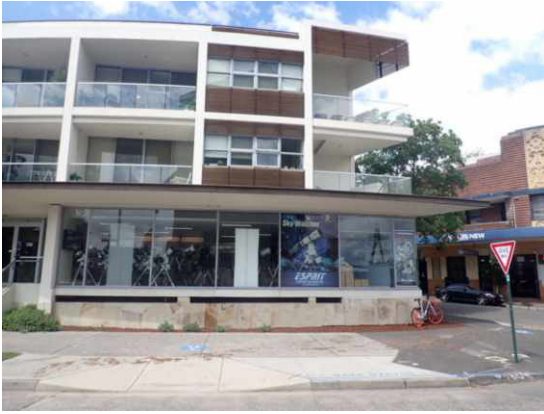
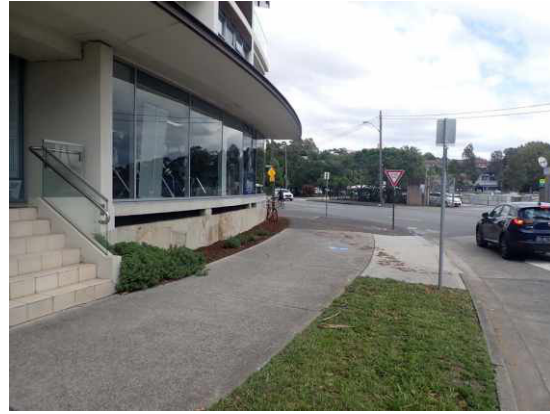
Building: Main Building
 Location: N 5
 Finding: Photographic Documentation
 Information: Condition of the area at the time of the inspection.

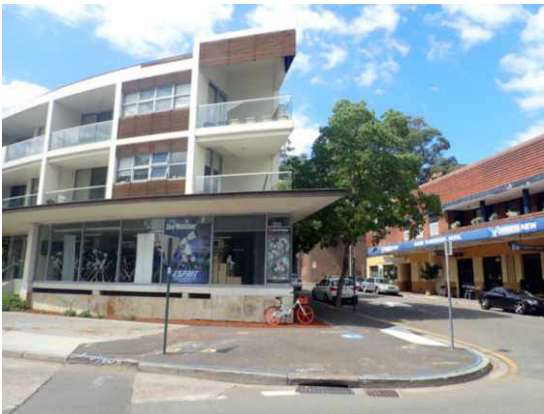
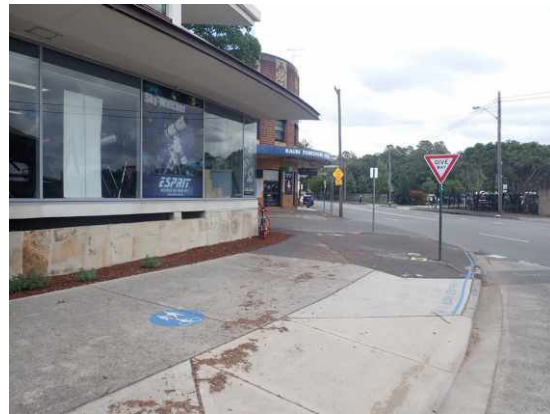
Building: Main Building
Location: N 6
Finding: Photographic Documentation
Information: Condition of the area at the time of the inspection.

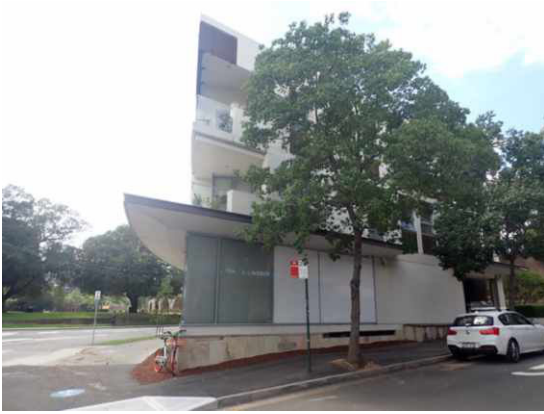
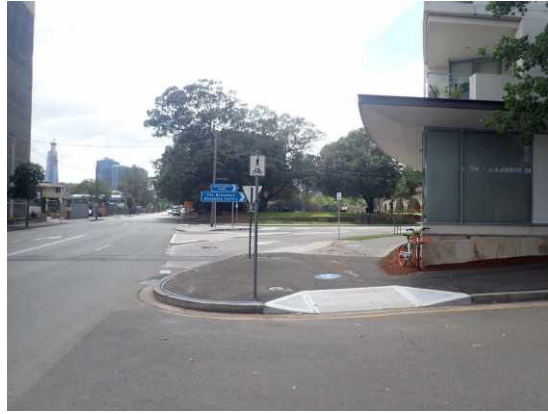
Building: Main Building
Location: E 7
Finding: Photographic Documentation
Information: Condition of the area at the time of the inspection.

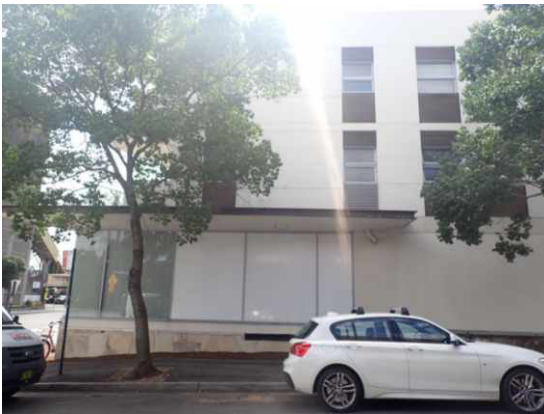
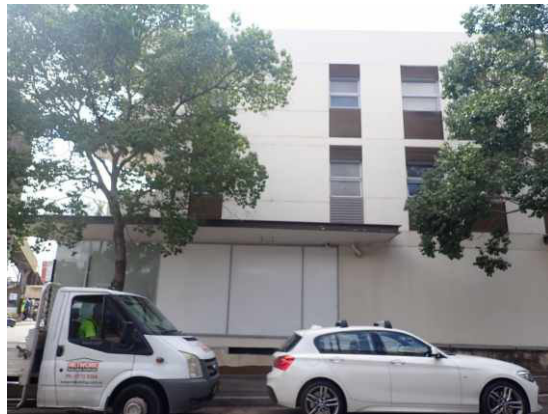
Building: Main Building
 Location: E 8
 Finding: Photographic Documentation
 Information: Condition of the area at the time of the inspection.

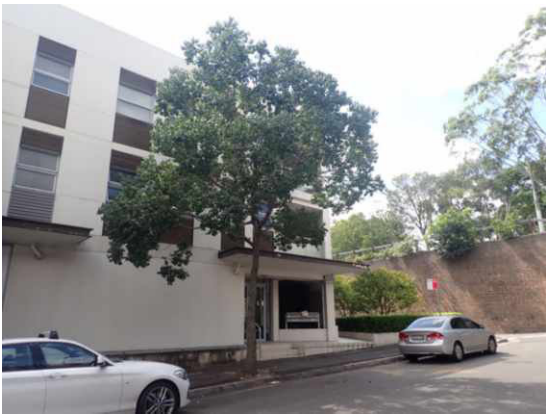
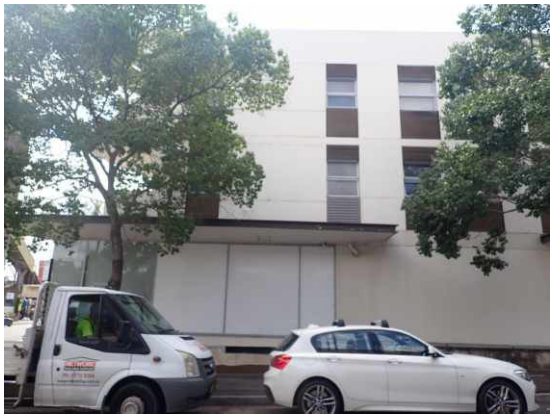
Building: Main Building
 Location: E 9
 Finding: Photographic Documentation
 Information: Condition of the area at the time of the inspection.

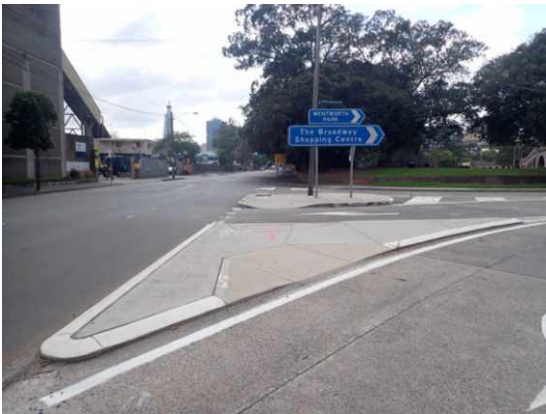
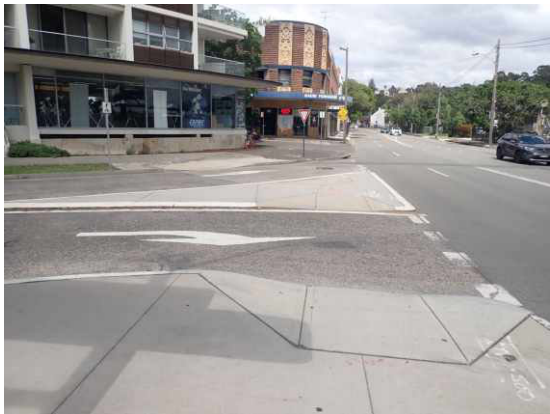
Building: Main Building
Location: IS 1
Finding: Photographic Documentation
Information: Condition of the area at the time of the inspection.

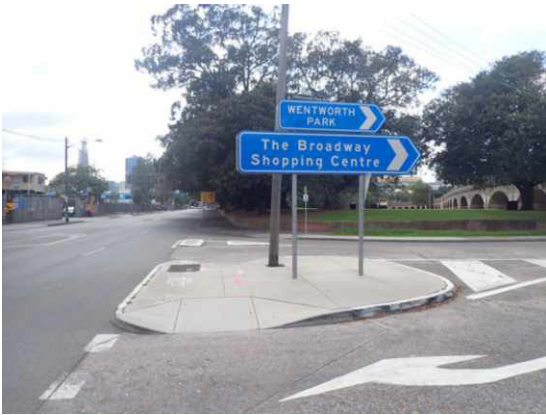
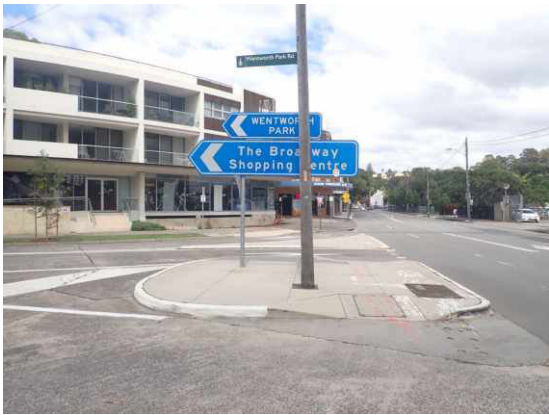
Building: Main Building
Location: IS 2
Finding: Photographic Documentation
Information: Condition of the area at the time of the inspection.

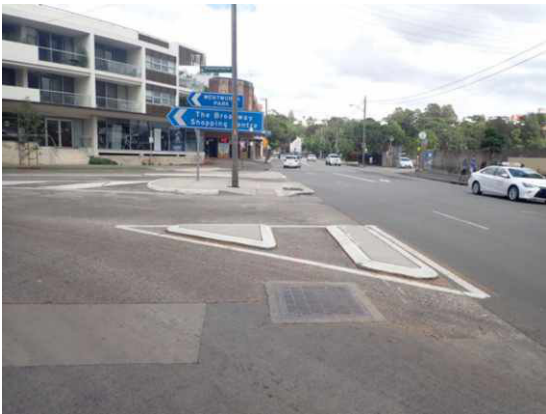
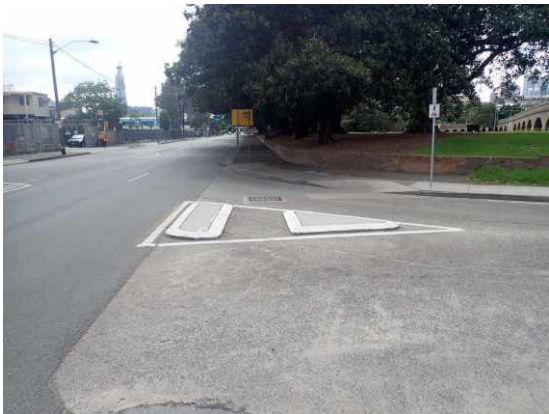
Building: Main Building
Location: IS 3
Finding: Photographic Documentation
Information: Condition of the area at the time of the inspection.
