# **Air Quality Review**

# East Guyong Quarry

November 2017

Ref No. 869/14

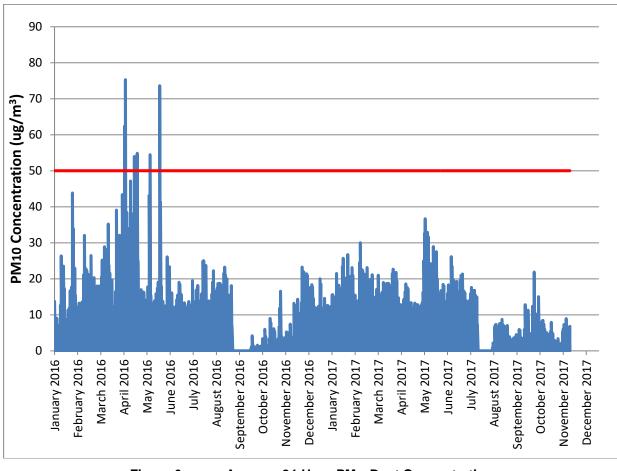
Figure 6 Average 24-Hour PM<sub>10</sub> Dust Concentration

A review of the long-term data presented in the Annual Review documents for the Quarry indicates that particulate matter levels recorded by the monitor remained consistently low until November 2015, at which time the long-term average level increased to be more consistently in the range of  $10\mu g/m^3$  to  $30\mu g/m^3$ . This was coincident with an increase in monthly production at the Quarry as production levels reached a more consistent level.

Excluding the identified exceedances, results during 2016 and 2017 to date have been consistent with the recent average range of  $10\mu g/m^3$  to  $30\mu g/m^3$  which is below the levels predicted in the Air Quality Assessment for the original application. Results during April of 2016 were consistently higher than the average range and closer to  $30\mu g/m^3$  to  $40\mu g/m^3$ .

It is noted that, for a short period during August and September 2016 and July and August 2017, no data could be recorded while the monitoring equipment was serviced and recalibrated. While this time cannot be avoided and is necessary to ensure the results remain accurate, this remains a brief period during each year when monitoring results are not recorded.
