# Wagga Wagga Quarry

## ANNUAL REVIEW

July 2015

<b>Document Title</b>	Environmental Management Annual Review – Wagga Wagga Quarry			
<b>Document Number</b>				
<b>Document Owner</b>	Hanson Construction Materials Pty Ltd			
<b>Revision</b>	<b>Issue Date</b>	<b>Originator</b>	<b>Reviewed</b>	<b>Approved</b>
Final	30/06/2015	P. Cox	A. Driver	A. Driver

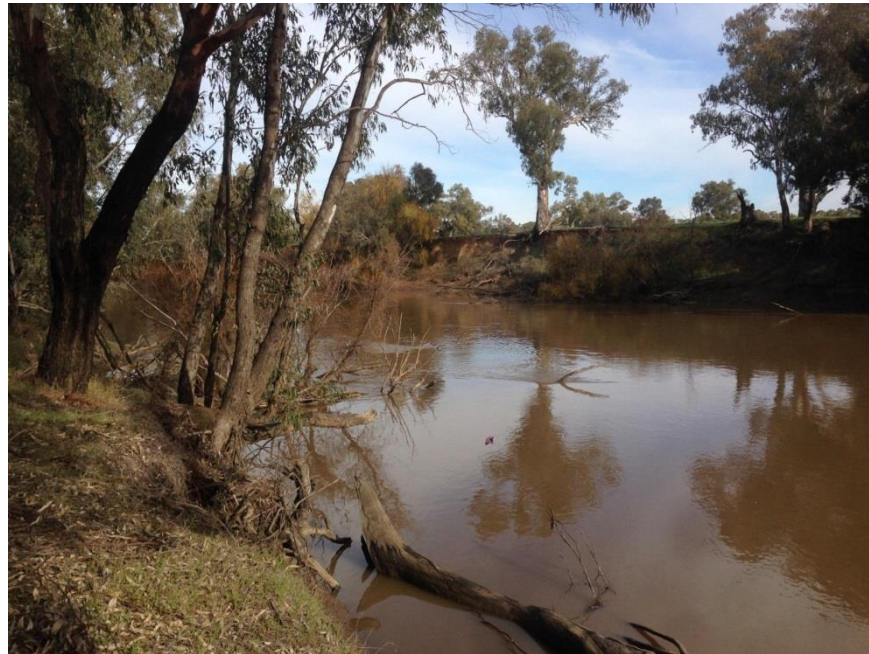
Figure 1: Murrumbidgee River

Hanson Construction Materials Pty Ltd (Hanson) own and operate a sand and river gravel quarry located on the floodplain of the Murrumbidgee River five kilometres (km) west of the city of Wagga Wagga, in the Riverina region of NSW, approximately 460km southwest of Sydney (refer to **Figure 1**).

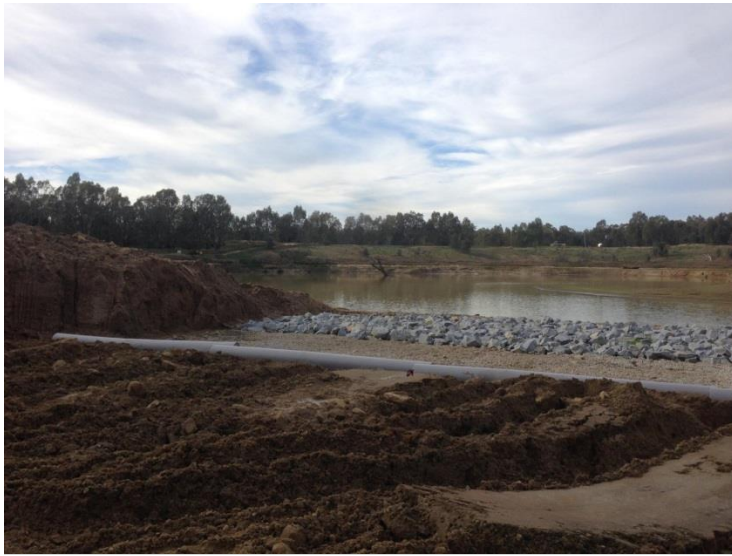
Figure 4: Riverbank repair works - facing pit 1.

The works require an access road to transport construction materials, construction/stability of the riverbank, and rehabilitation and revegetation of the Murrumbidgee riverbank. The access road was constructed in early 2014 to facilitate vehicular access to the work site, and has been maintained during this reporting period. The riverbank construction/stability works are 70% complete with oversize rock being used to stabilise the direct path for river overflow (see **Figure 4 and 5**).

The works have continued throughout the reporting period and at the time of writing, the riverbank repair works are approximately 70% complete.

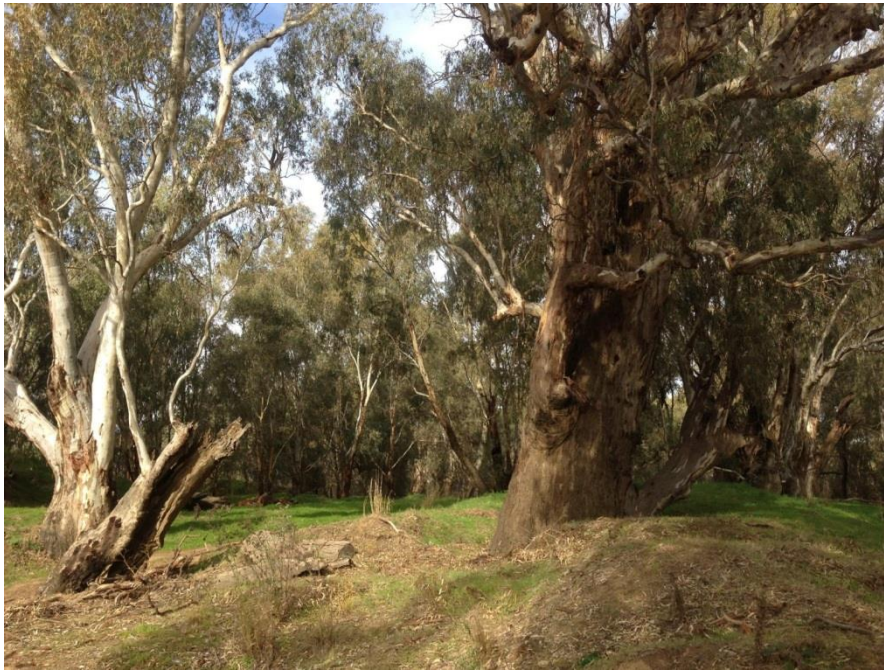
**Figure 6: Existing Riverbank Environment at Wagga Wagga Quarry**

Self-seeding has been the predominant rehabilitation strategy applied at Wagga Wagga quarry. **Figure 6** below illustrates the existing vegetation in the Murrumbidgee riparian zone at Wagga Wagga quarry. Mature *Eucalyptus camaldulensis* dominate the banks of the Murrumbidgee River (as seen in **Figure 6**). Pollination by insects, birds and small mammals, enables the species to release numerous fertilised seeds per year. Should the conditions be acceptable, these seeds will germinate into viable saplings. The succession of vegetation in these areas will develop soil structure integrity and promote associated ecological system benefits.

1. **Maintain:** Predominately the site has maintained native vegetation where feasible. Vegetation along the river bank has for the most part of the quarry remained untouched. This vegetation is important to maintain structural stability along the river bank, particularly in times of high rainfall/river flows (**Figure 6**).

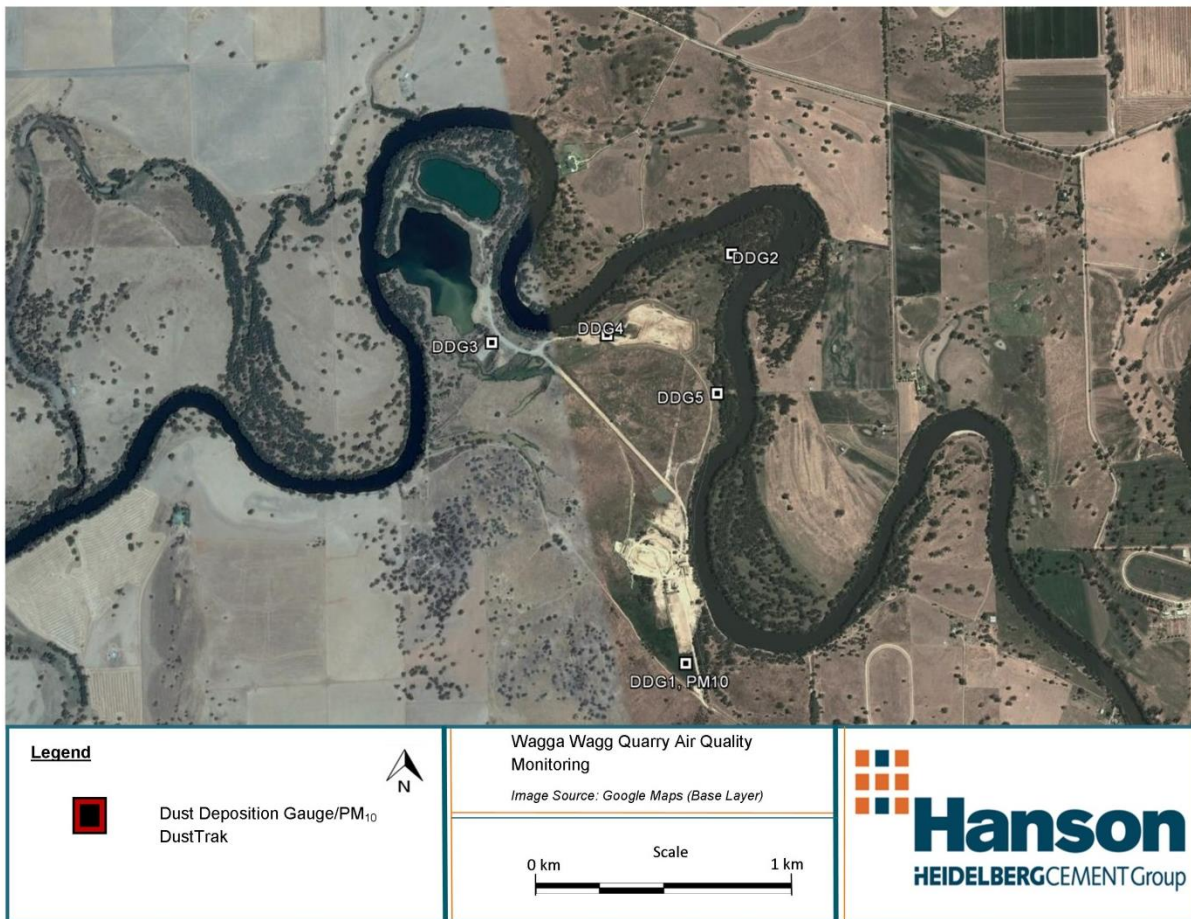
**Figure 8: Dust Deposition Gauges Current Location on Site**

DDG1, DDG2, DDG3, DDG4 and DDG 5 are dust deposition gauges, that are externally analysed monthly by Charles Sturt University, providing results for Deposited Matter including ash, combustible matter, insoluble solids, soluble solids and total matter.

Month	Location	Result	Comments
July 2014	DDG4	5.8 g/m <sup>2</sup> /month	The location of DDG4 ( <b>Figure 5</b> ), is such that the gauge is directly exposed to high dust generating activities from the quarry pit. The close proximity to the pit exposes DDG4 to high dust concentrations. Additionally an alternate haul road was being used until the currently operational haul road was put into service. The alternate haul road exposed DDG4 to elevated quantities of deposited dust.
	DDG3	5.8g/m <sup>2</sup> /month	DDG3 is located along the access road utilised in the river redemption repair works. Dust deposition exceedances at DDG3 are temporary and are expected to fall within compliance limits upon completion of the river redemption works.  Three instances of 60+km/h winds in November from the west may have contributed to high readings at DDG3.
December	DDG2	5.6 g/m <sup>2</sup> /month	DDG2 is located at the northern most point of the quarry. It unusual for DDG2 to experience exceedances, however likely related to northerly wind patterns.

DDG3	7.7 g/m <sup>2</sup> /month	DDG3 is located along the access road utilised in the river redemption repair works. Dust deposition exceedances at DDG3 are temporary and are expected to fall within compliance limits upon completion of the river redemption works.  The water truck was being re-built over the summer reducing the application of dust suppression on site.
January	DDG1	5.1 g/m <sup>2</sup> /month	The location of DDG1 is near the quarry plant. Slight exceedance in deposited dust at this gauge is indicative of high production levels and regional climatic conditions. Prevailing winds from the WNW at the sampling time transport increased dust into the DDG1 recording vicinity.  The water truck was being re-built over the summer reducing the application of dust suppression on site.

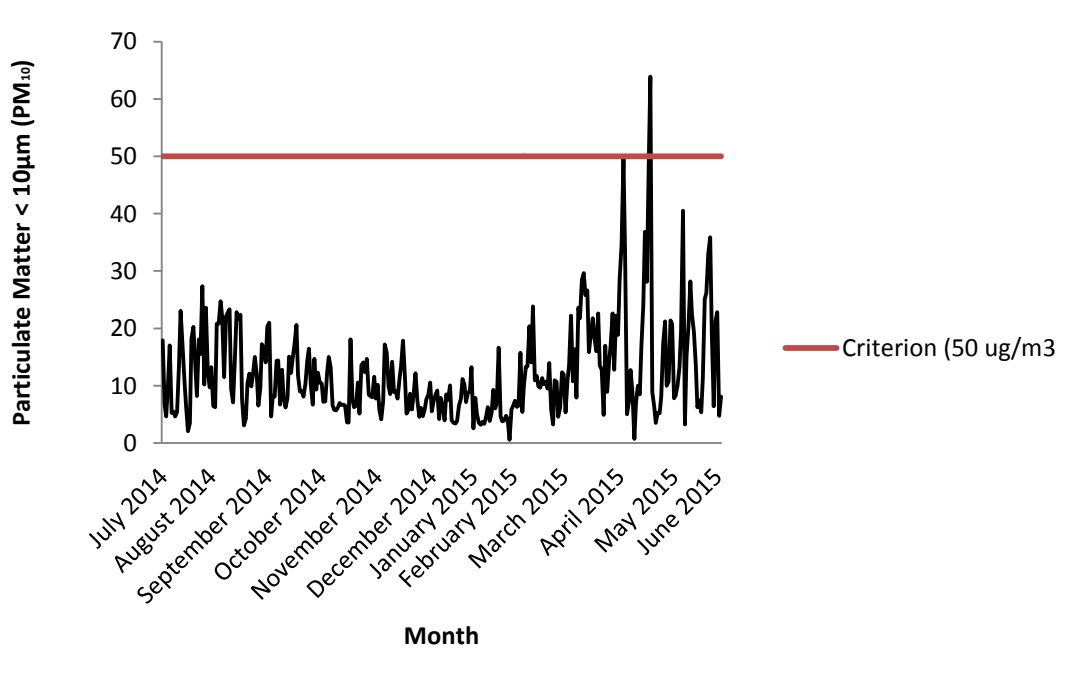
Figure 9: PM<sub>10</sub> Monitoring Results, calculated as a daily average.

The DustTrak monitor records PM<sub>10</sub> readings every 15 minutes. There was one exceedance in the 24 hour PM<sub>10</sub> averaging period. The DustTrak monitor recorded 63.9 µg/m<sup>3</sup> on the 17<sup>th</sup> April 2015 over a 9 hour period between midnight and 9am (**Figure 5**). Winds during this time were blowing from the ENE and would blow dust from the exposed ground to the north to the monitor. Otherwise there are no environmental or climatic factors explain high readings at this time. All other PM<sub>10</sub> readings over the reporting period (1 July 2014 – 30 June 2015) comply with the 50 µg/m<sup>2</sup> average daily limits which are shown in **Table 9**.

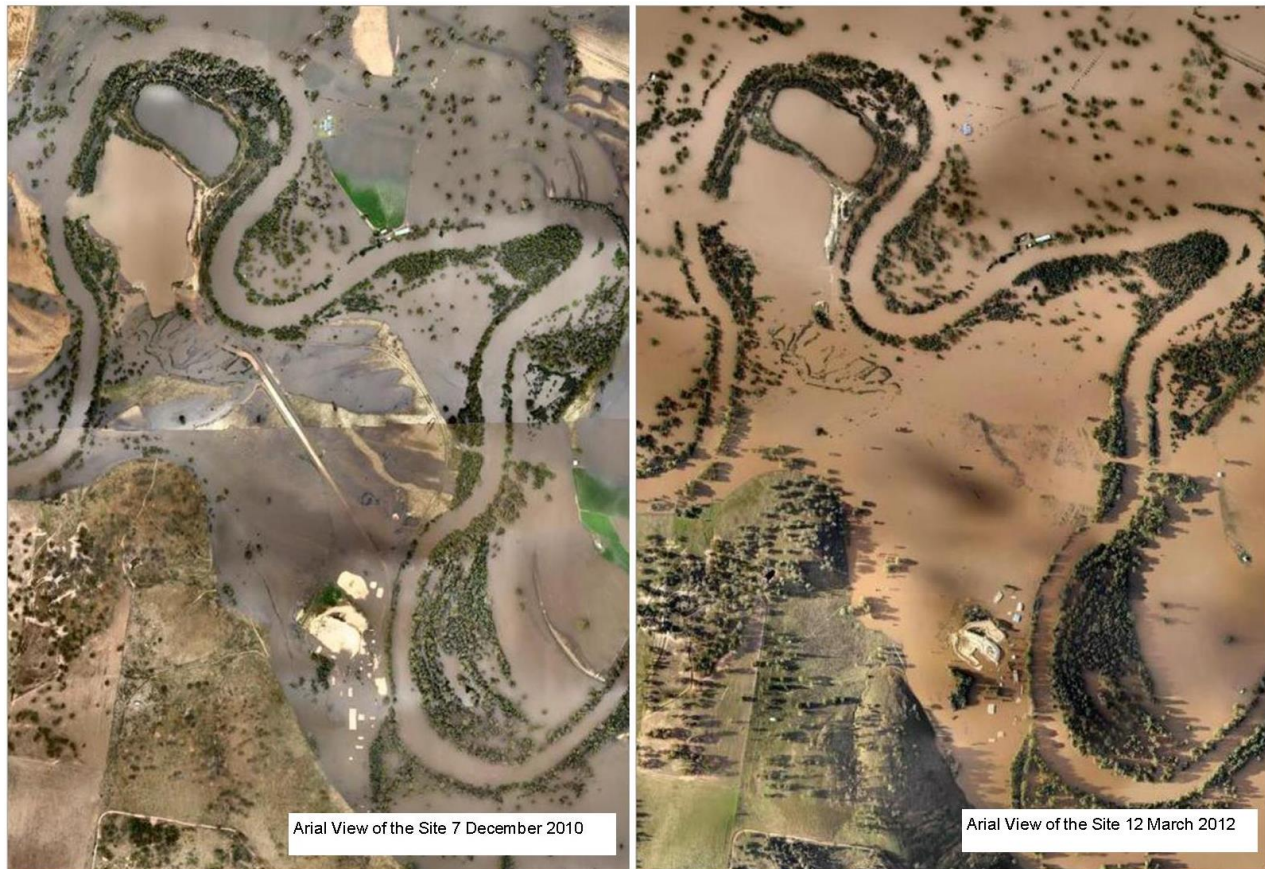
**Figure 10: 2010 and 2012 Flooding of Wagga Wagga Quarry**

- December 2010 where the Murrumbidgee River reached 9.702m (15.5 years ARI); and
- March 2012 in which the Murrumbidgee River reached 10.602m (58years ARI). Data was taken from the Wagga Wagga gauge (410001).

In both flooding events, inflow to Pit 1 occurred via the inlet spillway along the north-western side of the Pit, resulting in a free flowing opening between the Murrumbidgee River and quarry pit 2 (**Figure 7**).

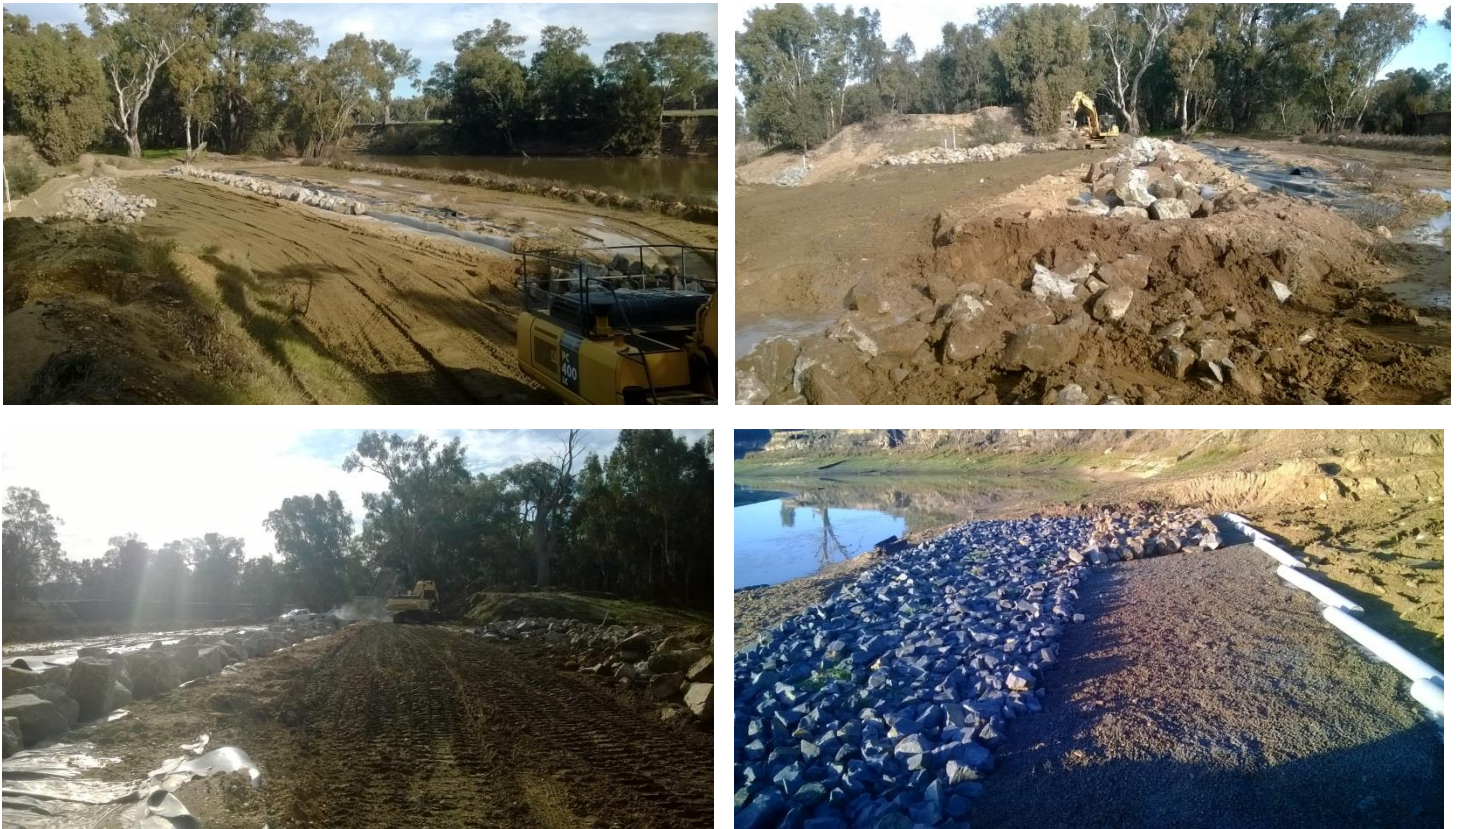
Figure 11: Riverbank repair works (photographs taken June 2015)

Approval has been granted from both Wagga Wagga City Council (March 2013) the NSW Office of Water (August 2013) for the upgrade of access track, construction of new riverbank, rehabilitation and revegetation of the Murrumbidgee River bank. Hanson appointed Martens Consulting Engineers to perform the required works for levee remediation and the works are approximately 70% complete.

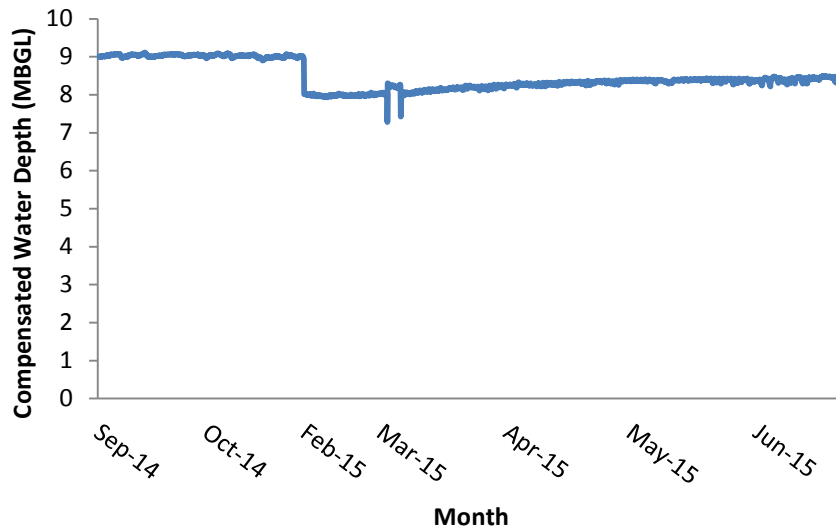
Figure 12: Borehole Monitoring 702

As the water bores have data missing they have been mapped individually in **Figures 12 - 15** below.

Bore	Minimum Groundwater Level (mBGL)	Maximum Groundwater Level (mBGL)	Observed Range (m)
702	7.285	9.11	1.825
704	6.392	8.09	1.698
705	10.126	11.348	1.222
707	12.173	13.984	1.811
