# Wagga Wagga Quarry

## ANNUAL REVIEW

June 2016

<b>Document Title</b>	Environmental Management Annual Review – Wagga Wagga Quarry			
<b>Document Number</b>	WWQAR2			
<b>Document Owner</b>	Hanson Construction Materials Pty Ltd			
<b>Revision</b>	<b>Issue Date</b>	<b>Originator</b>	<b>Reviewed</b>	<b>Approved</b>
Final	08/06/2016	P. Cox	29/06/2016	A. Driver

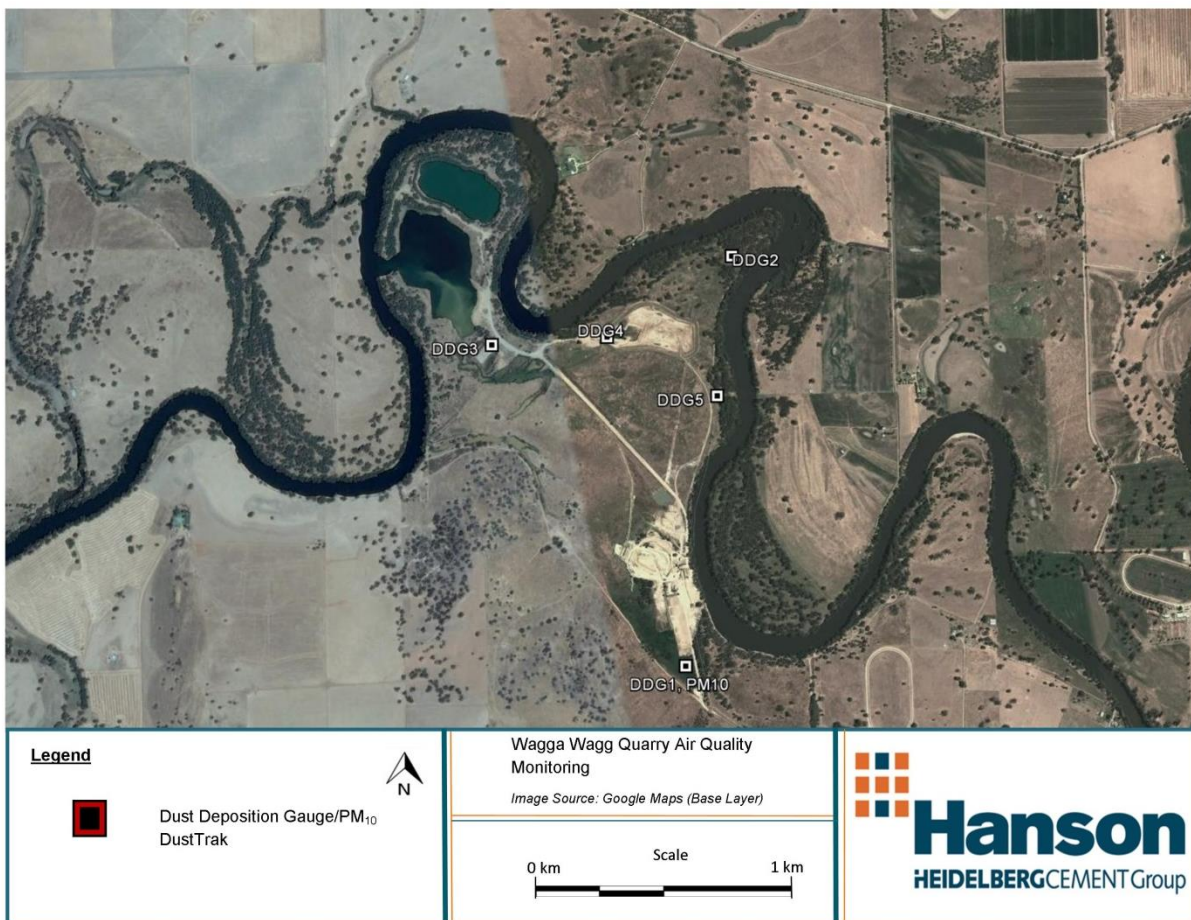
**Figure 7: Location of DDGs until 27th May 2016**

The Project's Dust Deposition Gauges have been moved during the reporting period (27<sup>th</sup> May 2016). **Figure 7: Location of DDGs until 27<sup>th</sup> May 2016** shows the locations of the DDGs prior to being relocated as per consultation with the EPA. **Figure 8: Relocated DDGs** shows the location of the DDGs from 27<sup>th</sup> May 2016 onwards.

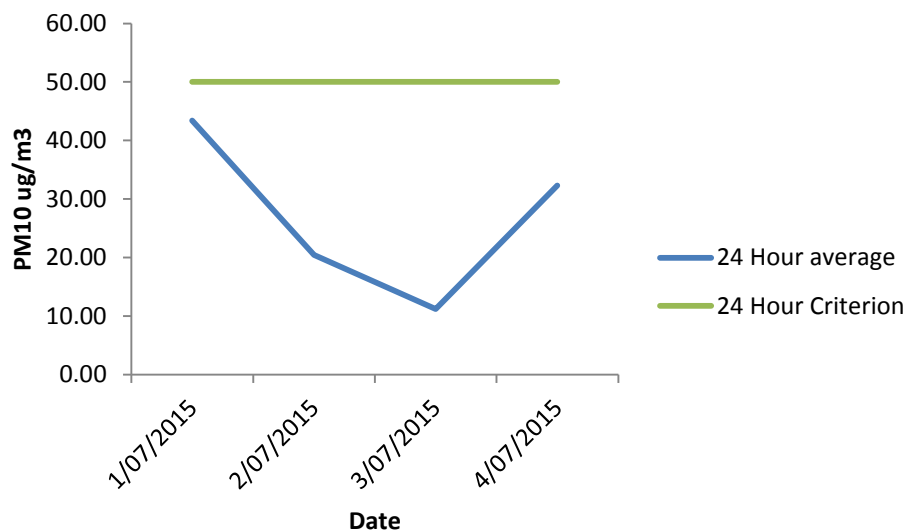
**Figure 10: DustTrak Results (24-Hour Average)**

There are circumstances when the DustTrak produces erroneous data. Erroneous data is that that is a negative number. These values have been excluded from both the short term 24hr average and long term annual average calculations expressed in Project Approval Schedule 3 condition 5. The DustTrak has been malfunctioning for the majority of the reporting period. Due to this the dustTrak was sent off for calibration mid-February 2016 – end of March 2016. At this time the DustTack was installed back on site, and still continued to produce erroneous data. This is currently being addressed with the manufacturer. The non-erroneous results occur 1 July 2015 – 4 July 2015 and have been assessed for this report.

The average PM<sub>10</sub> data was obtained from the DustTrak data. Readings are taken every 15 minutes. There are only four days of non-erroneous data however an assessment has been made. The annual average for PM<sub>10</sub> for the reporting period was 25.8µg/m<sup>3</sup>. This complies with the 30µg/m<sup>3</sup> annual limit as outlined in the Development Approval (**Table 10**).

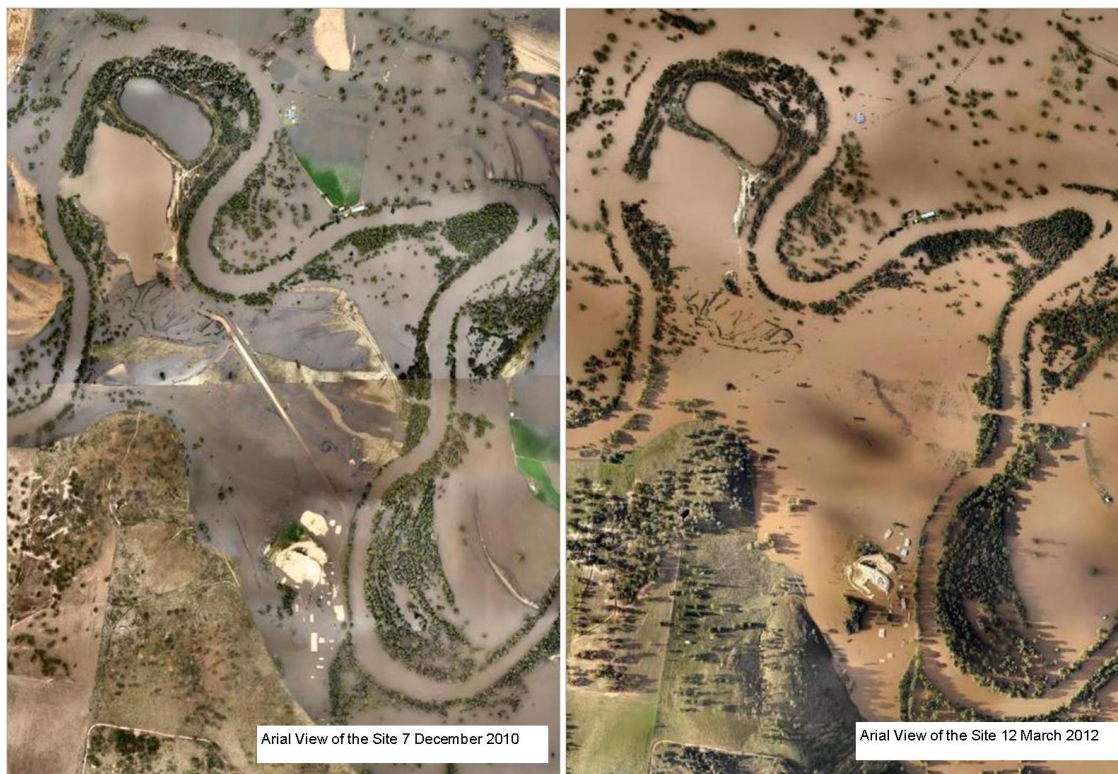
**Figure 11: 2010 and 2012 Flooding of Wagga Wagga Quarry**

In both flooding events, inflow to Pit 1 occurred via the inlet spillway along the north-western side of the Pit, resulting in a free flowing opening between the Murrumbidgee River and quarry pit 2 (**Figure 11**).

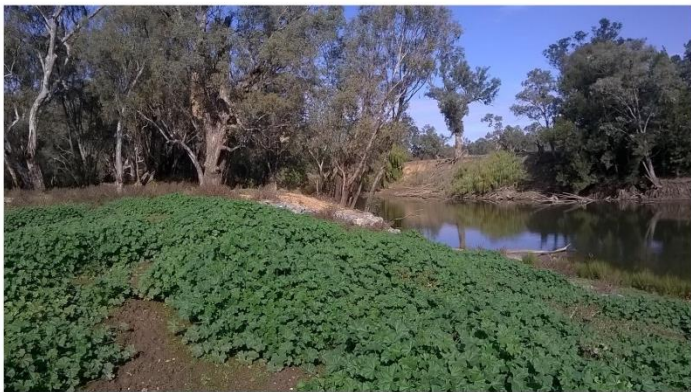
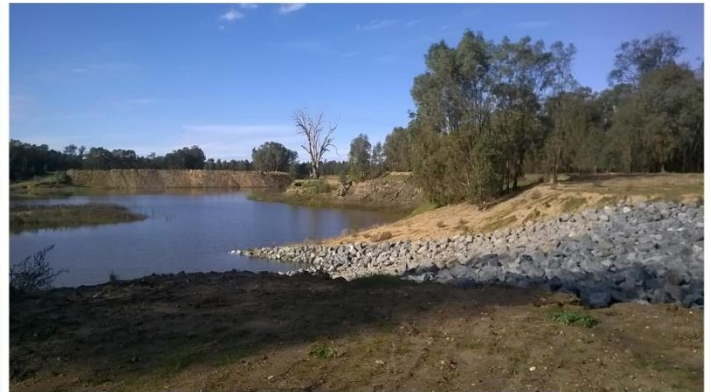
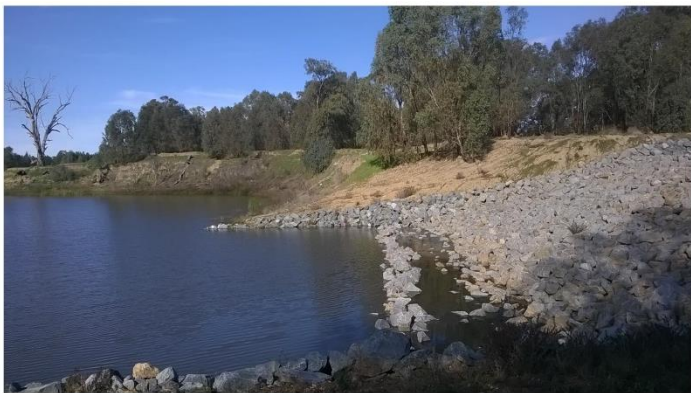
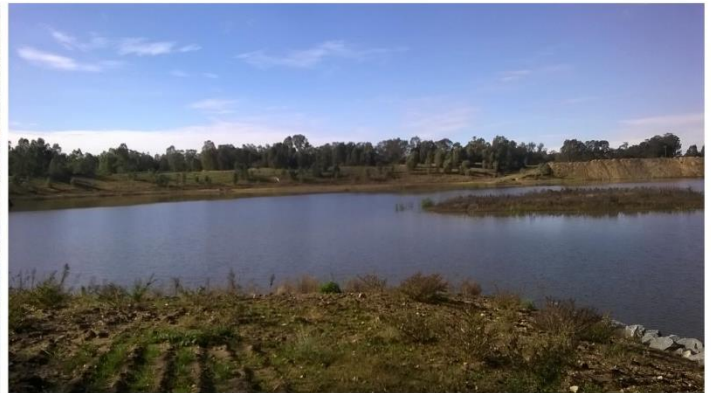
#### **Figure 12: Riverbank Repair Works (May 2016)**

Approval has been granted from both Wagga Wagga City Council (March 2013) the NSW Office of Water (August 2013) for the upgrade of access track, construction of new riverbank, rehabilitation and revegetation of the Murrumbidgee River bank. Hanson appointed Martens Consulting Engineers to perform the required works for levee remediation and the works are in their final stages. The progress was assessed in June 2016 by Martens and Associates in June 2015. **Figure 12** shows the river bank repair works at June 2016.

Plate 1: Vegetation covering the repaired river bank

Plate 2: Repaired river bank

Plate 3: Repaired river bank

Plate 4: Vegetation covering the repaired river bank

Environmental management including continued weed management and seeding or planting of vegetation at the repaired river bank repaired area is expected to occur during the next reporting period.

**River Bank Repair:** It is expected that the river bank will be completed finalised during the next reporting period to the satisfaction of NOW.

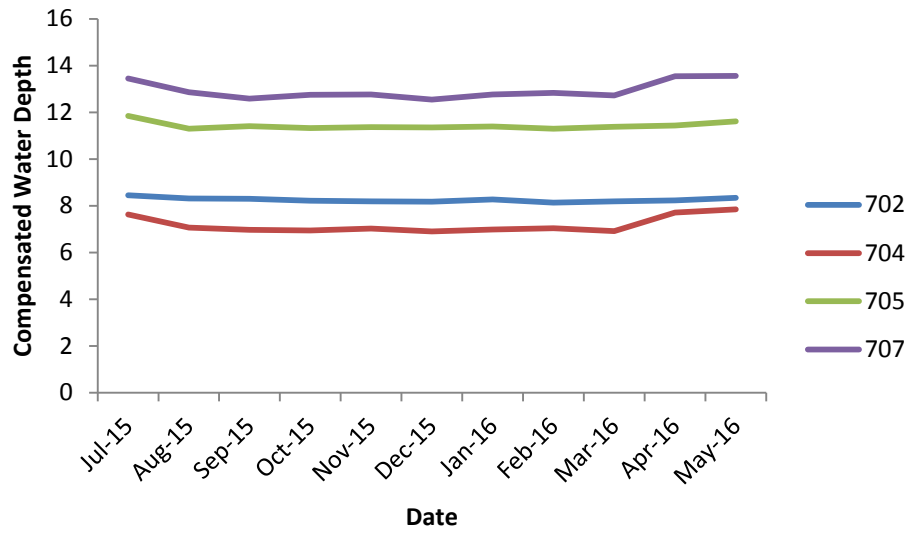
**Figure 13: Logger Data 2015-2016**

Logger ID	Operational Dates	Explanation
701	n/a	Logger 701 has recorded faulty compensated readings. Further assessment needs to be conducted on this logger.
702	01/07/2015 - 31/05/2016	Data complete <b>(Figure 13)</b>
704	01/07/2015 - 31/05/2016	Data complete <b>(Figure 13)</b>
705	01/07/2015 - 31/05/2016	Data complete <b>(Figure 13)</b>
707	01/07/2015 - 31/05/2016	Data complete <b>(Figure 13)</b>

Results suggest that there is little difference in the mean water readings between the 2014-2015 and the 2015 – 2016 reporting period. The observed range is slightly smaller in 3 of 4 bore holes over the 2015-2016 reporting period.
