Wagga Wagga Quarry

ANNUAL REVIEW

July 2018 - June 2019

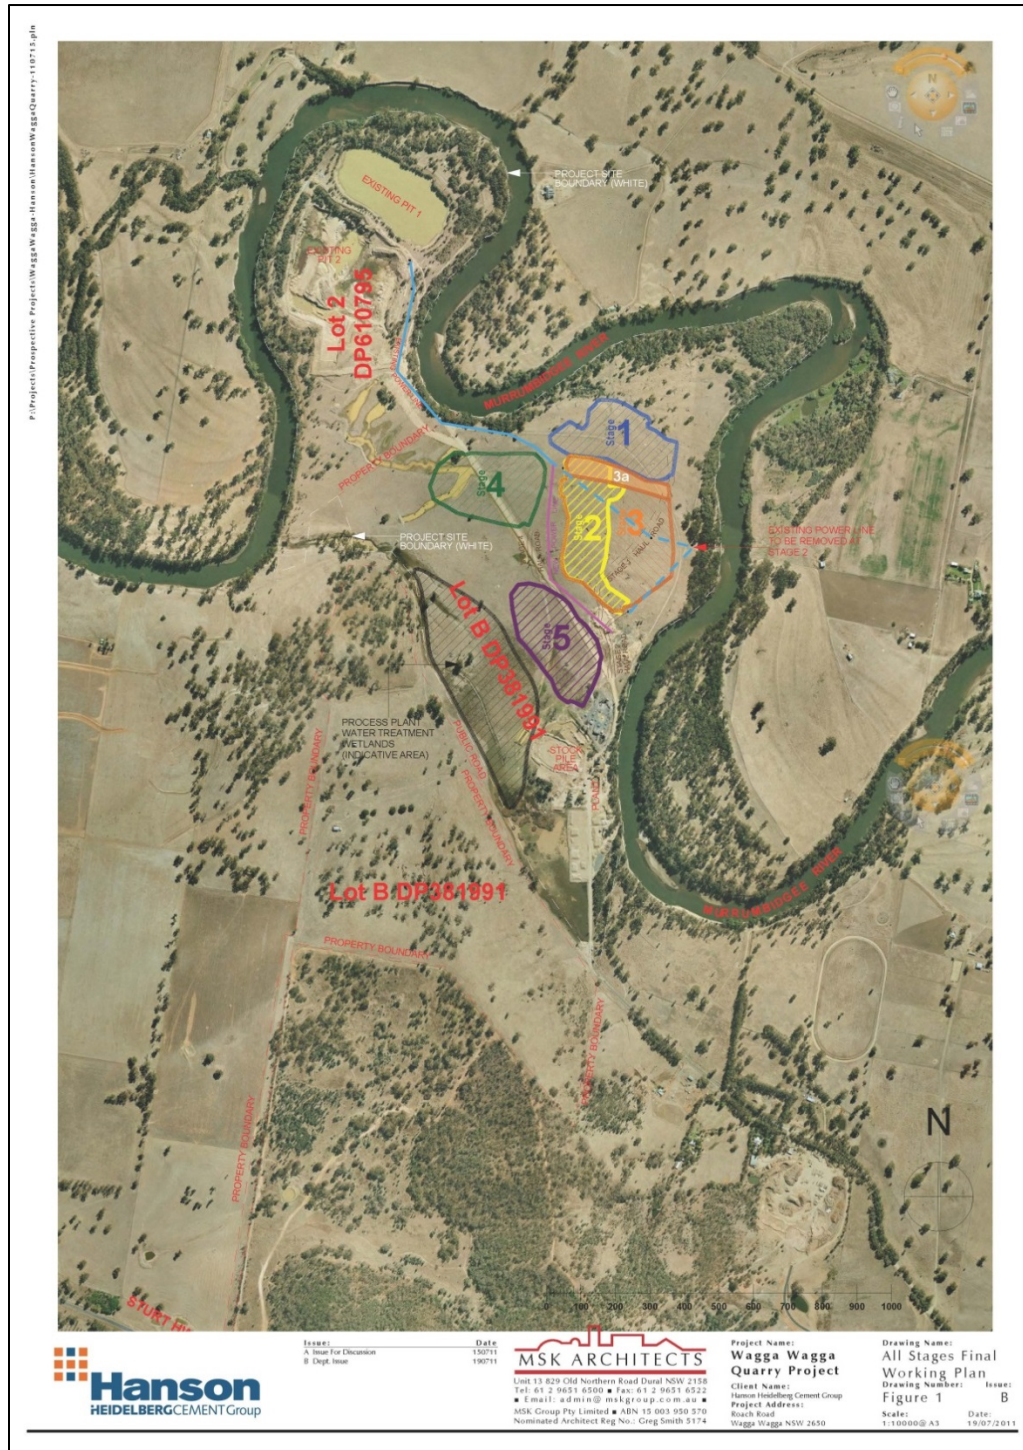
Figure 2: General Project Layout

The quarry has been in operation since 1987. The project site is bounded by private land to the south and the Murrumbidgee River to the north (**Figure 2**). The site is part of the Murrumbidgee River's alluvial floodplain and is situated within a large meander of the River with an elevation between 174 and 177 metres AHD. The land uses surrounding the site comprise a mixture of agricultural and residential properties, and areas of public recreation. The quarry is close to a significant new residential development, Riverview Estate, which is approximately 1.5 km south of the project site. The nearest receivers are shown on **Figure 3**.

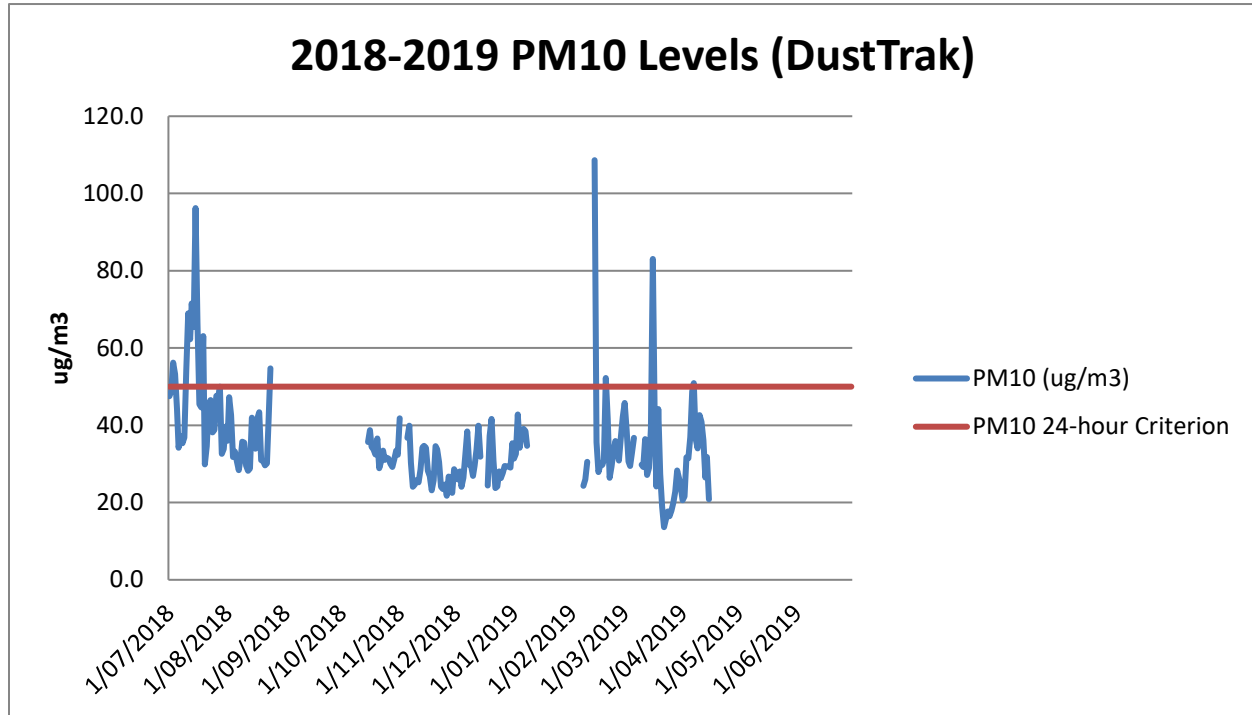
Figure 6: Site PM₁₀ monitoring over the 2018-2019 period.

PM₁₀ results for the 2018-2019 calendar year are depicted in **Figure 6** and **Figure 7**.

The average annual PM₁₀ reading for the 2018-2019 reporting period was obtained from the Quarry sites DustTrak monitoring system. The DustTrak monitor records PM₁₀ levels in 15 minute intervals during the reporting period.

The annual average for PM₁₀ was 35.0 µg/m³ which results in a non-compliance with the 30 µg/m³ annual limit as outlined in the Project Approval and EPL. It is important to note that, along with missing data due to drop out in transfer of data from the DustTrak to the online server, the annual average for the North Wagga Wagga BoM was 29.5 µg/m³ which indicates high background levels that have attributed to the Quarry's non-compliance.

In July 2019 the DustTrak online cloud system shut down due to the service provider no longer being in operation. This resulted in a loss of data between March and July. We have found an

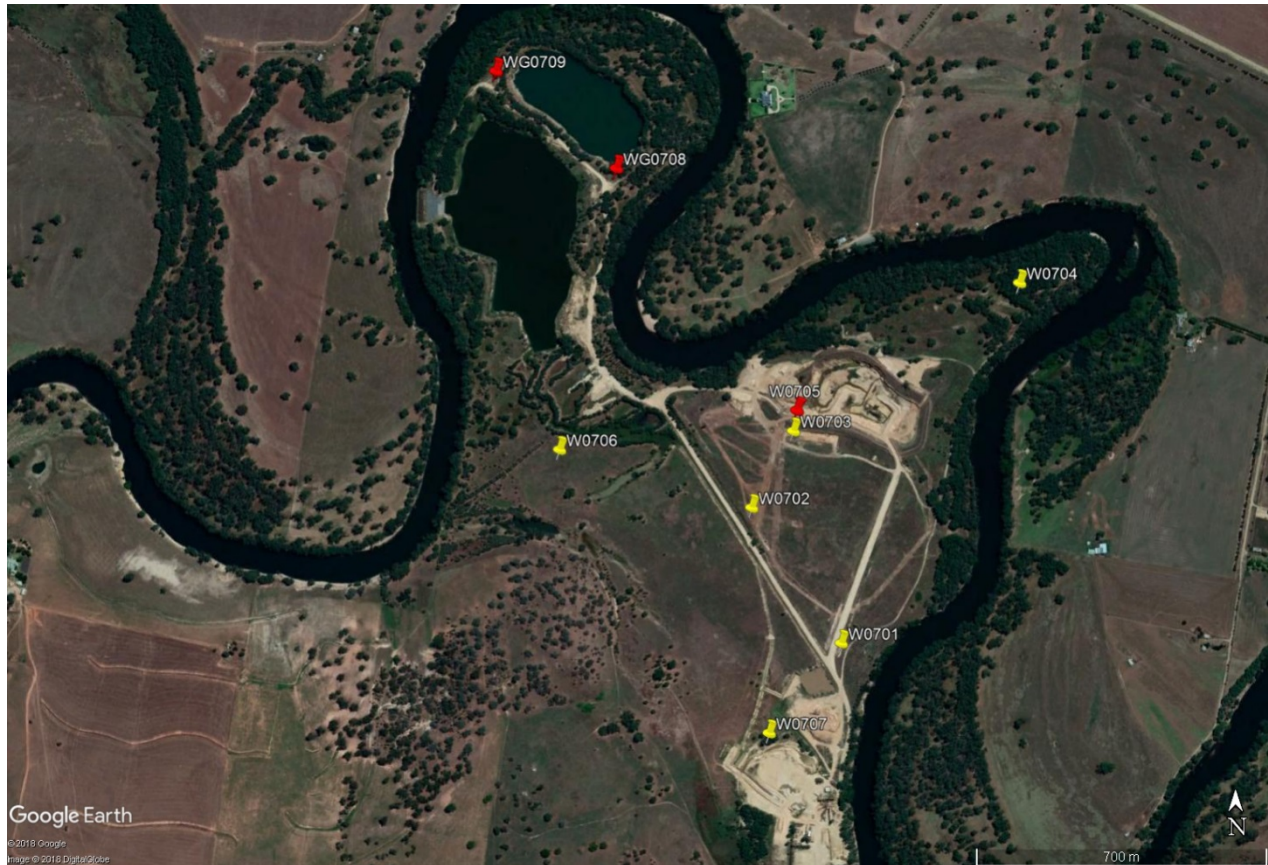
Figure 8: Location of Groundwater Monitoring Bores (no logger in 706)

Wagga Wagga Quarry has seven (7) active borehole water depth loggers located on site collecting and recording continuous water depth and temperature readings. The locations of these monitoring boreholes are depicted in **Figure 7**.

A replacement logger for W0705 was installed at the quarry site in the second quarter of 2019 (**Figure 7**). W0703 has been monitored in place of W0705 but will be removed as works for Cell 2 commence in the second half of 2019.

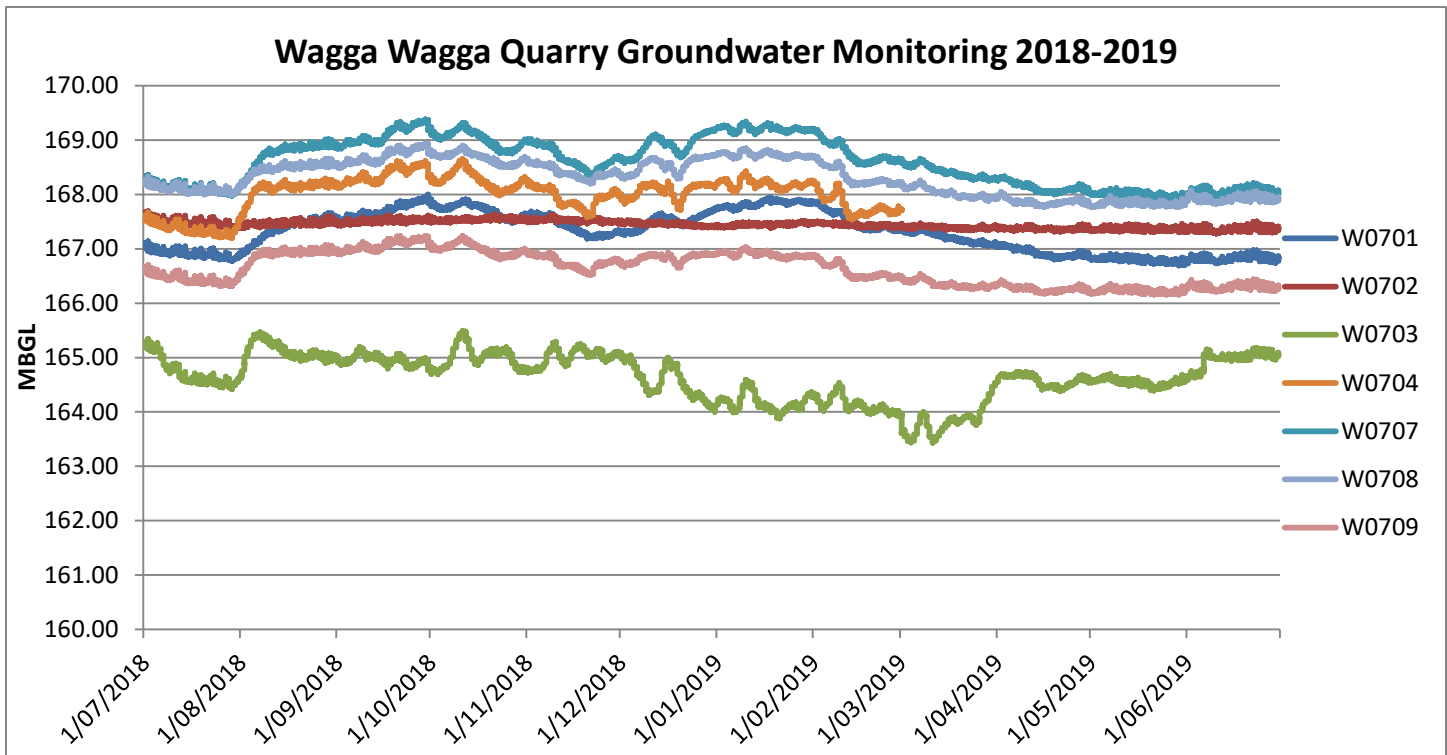
Figure 9: Groundwater Monitoring Bore Results

Groundwater data is recorded hourly using Dipper Logger Heron Software. This data is stored in the Dipper Logger and is collected periodically and uploaded digitally. The compensated water depth (MB GL) of groundwater from the seven monitoring bores is depicted in **Figure 8**.

The groundwater level drawdown data is shown in **Table 27**. The groundwater level drawn down difference between the standing water levels (SWL) at the time of the borehole construction and the averages for 2017-2018 indicates there has been a slight drawdown for W0701 and W0702 but well above the predicted drawdown with the EIS. W0704 and W0707 have seen a gain in water levels.
