**Hanson Lysterfield Quarry  
Community Reference Group**

**MINUTES OF MEETING**

# Project Update

# Operational Report

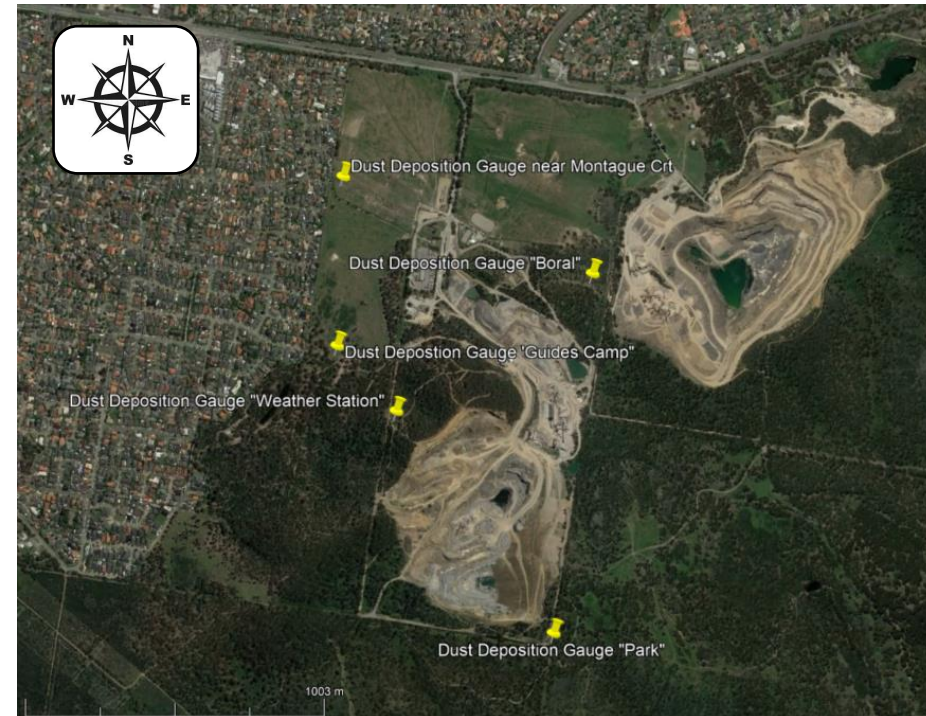
Comments.

Date range 06/04/2023 – 08/05/2023

Adopted EPA Vic Guideline. 4g/m<sup>2</sup>/month

All gauges low.

■ Ash (g/m<sup>2</sup>/month)■ Insoluble Solids (g/m<sup>2</sup>/month)

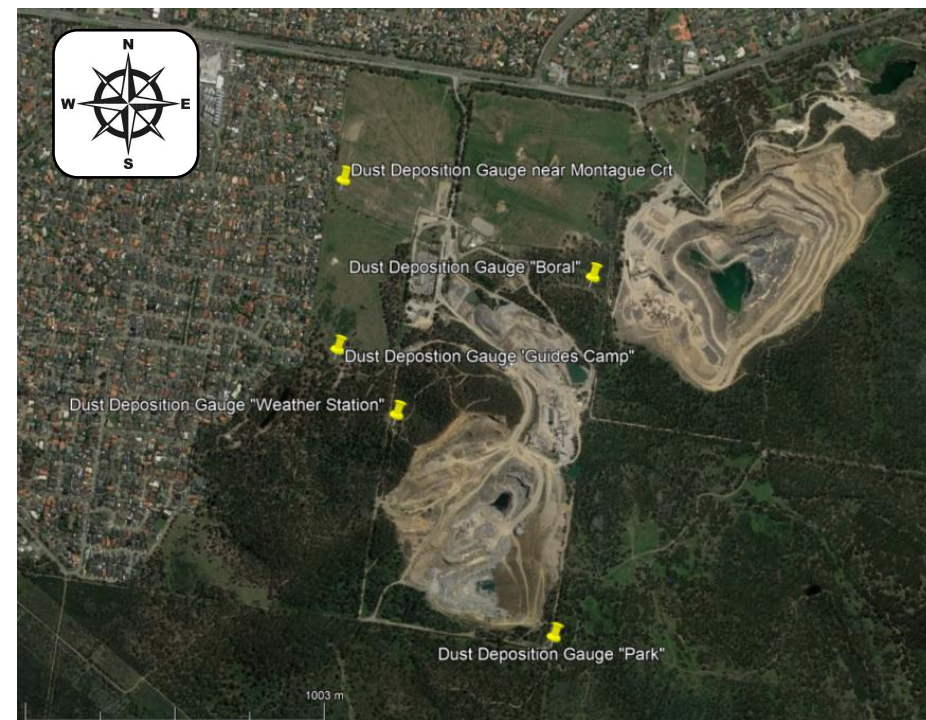
Comments.

Date range 09/03/2023 – 06/04/2023

Adopted EPA Vic Guideline. 4g/m<sup>2</sup>/month

All gauges low.

■ Ash (g/m<sup>2</sup>/month)■ Insoluble Solids (g/m<sup>2</sup>/month)

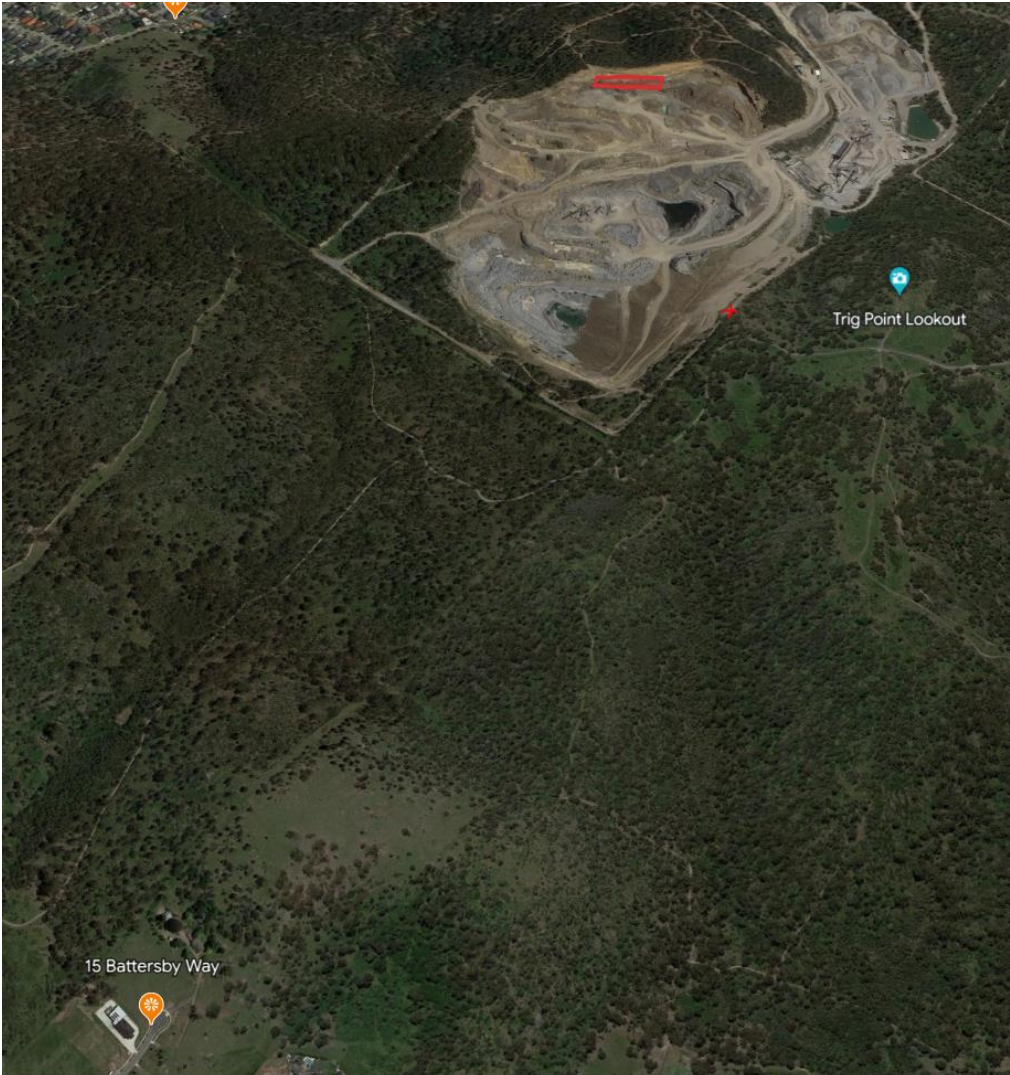
Monitoring Location	PPV (mm/s)	Peak Air Vibration (dBL)	Distance to Blast (m)	Monitor Serial No
15 Sandford Close	0.80	100.01	769	CJ6-C044
16 Somerset Court	3.06	104.93	566	CJ6-B003
9 Reservoir Crescent	0.87	103.88	925	CJ6-C042
15 Battersby Way	0.18	121.19*	1835	CJ6-A001
Quarry Gate (Wellington Rd)	0.42	96.54	1105	CJ6-C015

- The Battersby Way reading is inordinately high considering the significant separation distance of 1.83km.
- In terms of real air pressure, the reading (22.9 Pa) is 6.5 times greater than the next highest reading at Somerset Court (3.53 Pa).
- Terrock personnel located at Battersby Way at blast time reported the noise emission to be “very loud”.
- Reached out to a CRG member from that area who confirmed they were home and that the blast was louder than usual

NJ advised that the Battersby Way reading was inordinately high considering the significant separation distance of 1.83km. In terms of real air pressure, the reading of 22.9Pa was 6.5 times greater than the next highest reading at Somerset Court (3.53Pa).

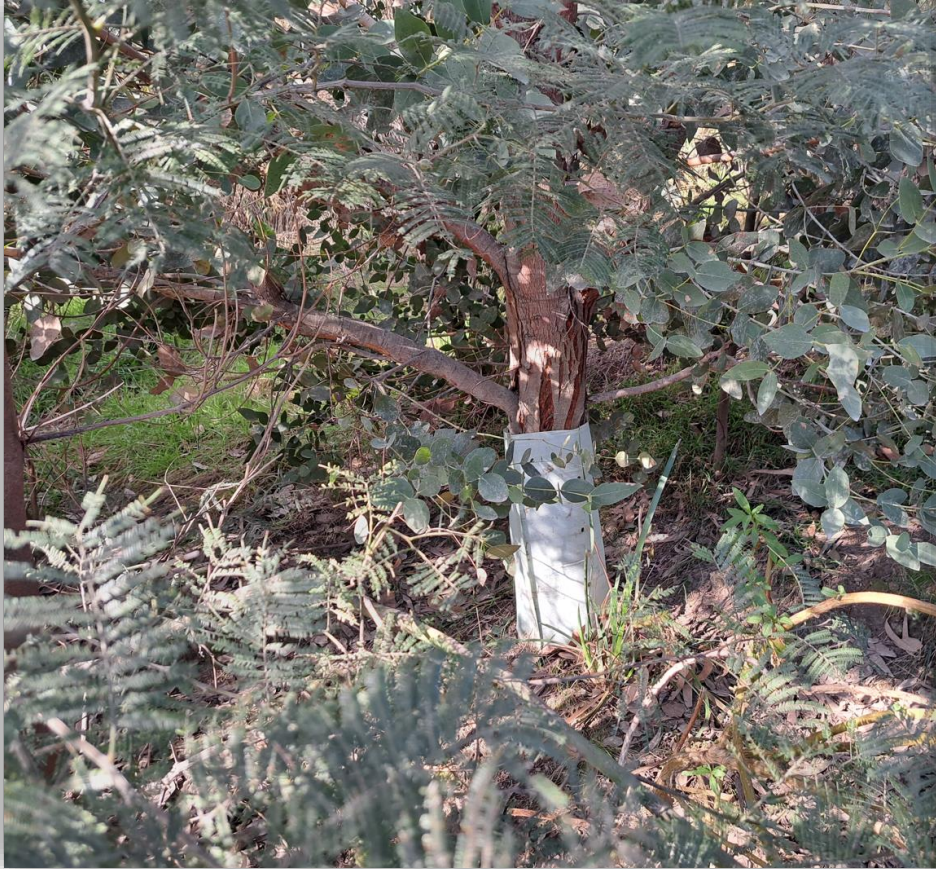
# Eastern Face Rehabilitation

- Tree protectors removed from rehab area
- 1400 plants (trees & shrubs) planted on southern end of Eastern Face in May/June

Eucalyptus radiata, Acacia mearnsii, A. suaveleons, A. verniciflua, Goodia lotifolia, Banksia marginata, Pultanea gunnii, Austral Indigo, Cassinia arcuata, Olearia argophylla, Coprosma quadrafida

NJ advised that, following CRG recommendation, the tree protectors are being removed from the rehabilitation area and that 1400 plants comprising trees and shrubs were planted on the southern end of the eastern face rehabilitation area in May and June.
