CALGA SAND QUARRY

VIBRATION MONITORING OF RIPPING OPERATIONS

REPORT NO. 01127-VM
VERSION C

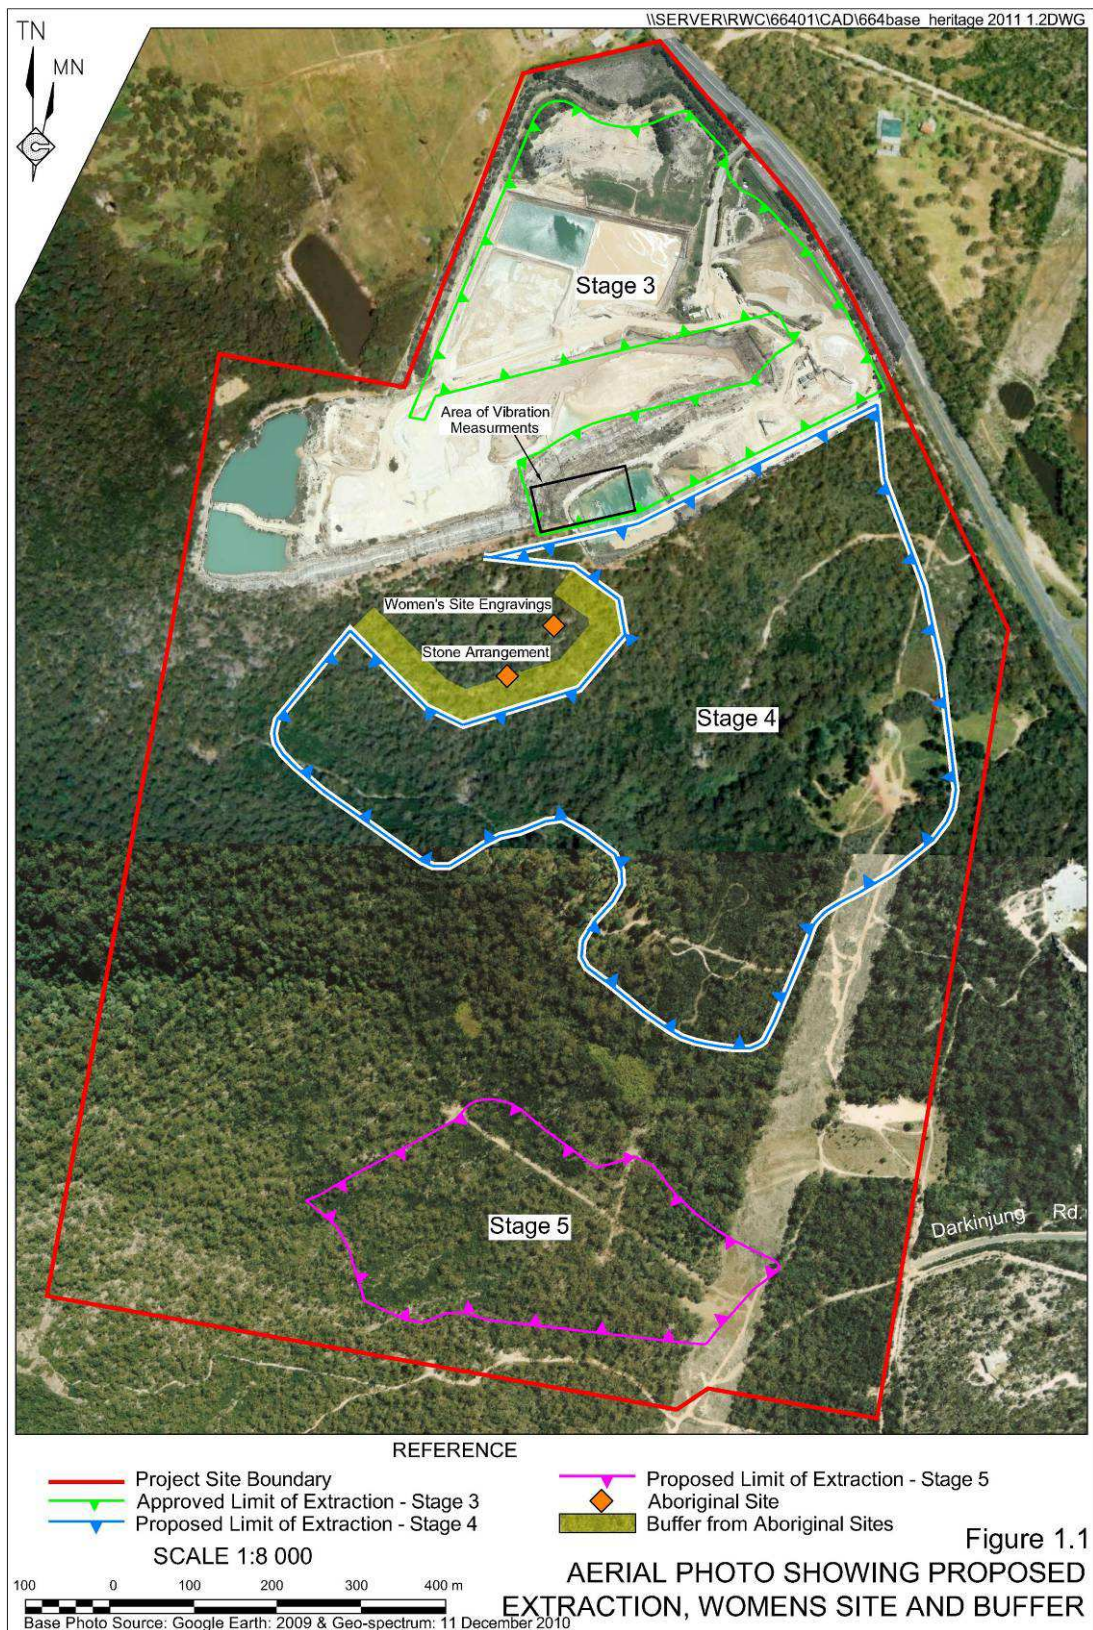
Figure 1-1 Aerial Photo showing Proposed Extraction, Aboriginal Site and Buffer

Rocla Materials Pty Limited (Rocla) is seeking approval to extend the existing operations at the Calga Sand Quarry into an adjoining area referred to as Stages 4 and 5 of the proposed Southern Extension (Refer **Figure 1-1**). A site of Aboriginal importance which includes some rock engravings in the sandstone is located adjacent to the proposed Stage 4 extraction area. We understand that this site has been described as "a women's site" and so we have not been able to inspect the rock engravings.

Because of the significance of this site, Rocla has opted to provide a buffer of at least 40m between the site and the closest point of proposed sand extraction. Concerns have been raised by interested Aboriginal Stakeholders in relation to the potential for vibration damage to the engravings as a result of ripping within the quarry, even allowing for the proposed buffer. Ripping sandstone with a bulldozer would create the greatest level of vibration within the quarry.

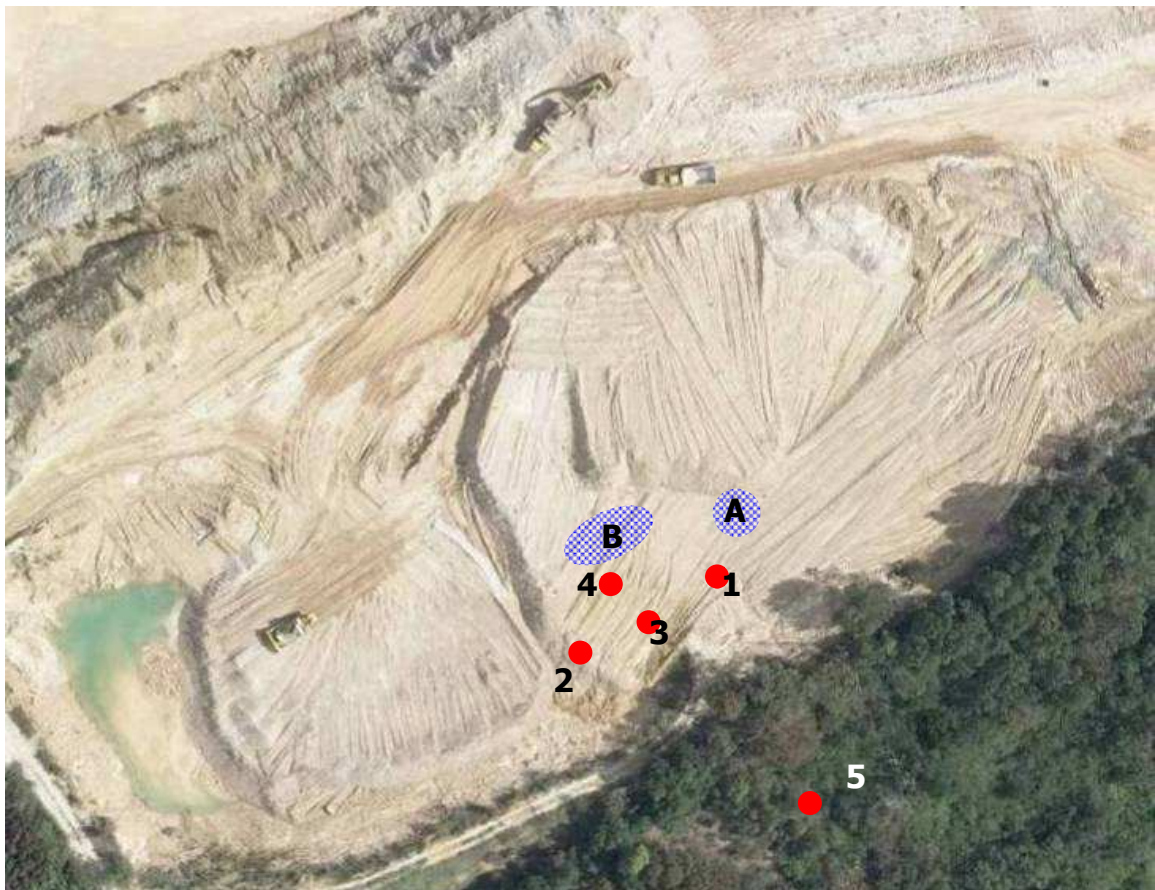
Figure 2-1 Approximate Ripping and Vibration Monitoring Locations

Two areas of the existing quarry were identified for the measurement of ground vibration from ripping operations as shown in **Figure 2-1**. The bulldozer used was a Komatsu 375-5 weighing 72 tonnes. The two areas are located approximately north of the women's site and provided an excellent opportunity to establish vibration levels in the sandstone that continues from the existing quarrying to the proposed quarry extension.

Two measurement areas were selected to reflect the variability in "ripability" of the sandstone, i.e. hard and soft.

Vibration monitoring was undertaken at a similar elevation to the ripping Area A at a range of slant distances from approximately 15m to 120m, as shown in Figure 2-1. The approximate locations are also shown in the photo below (photo taken from Location 2 looking towards ripping area A).

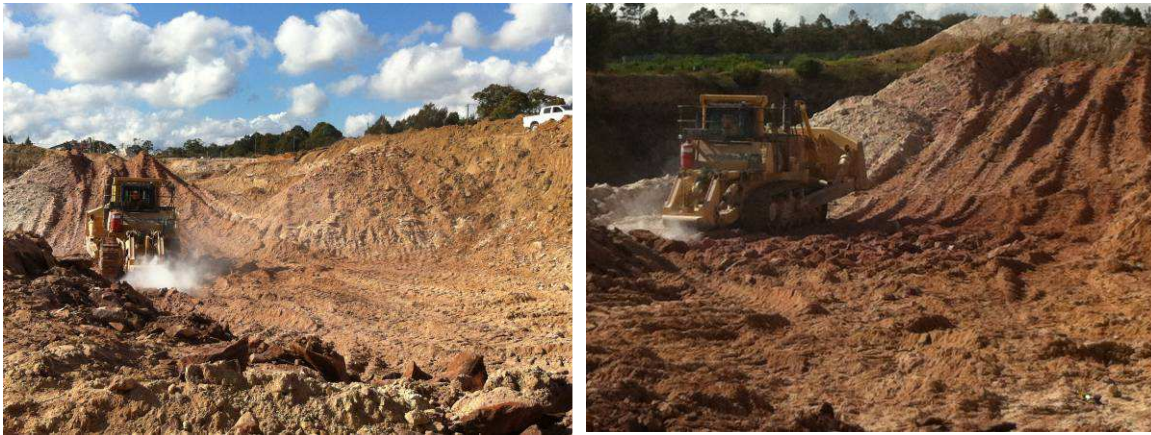
The Area A (334163E, 6301289N) was at the higher elevation similar to the four nearby monitoring locations and comprised some softer sandstone to the north with some harder sandstone in the southern portion. This part of the quarry occurred at any elevation of approximately 205 to 209m AHD. Photos of the ripping activities are shown below.

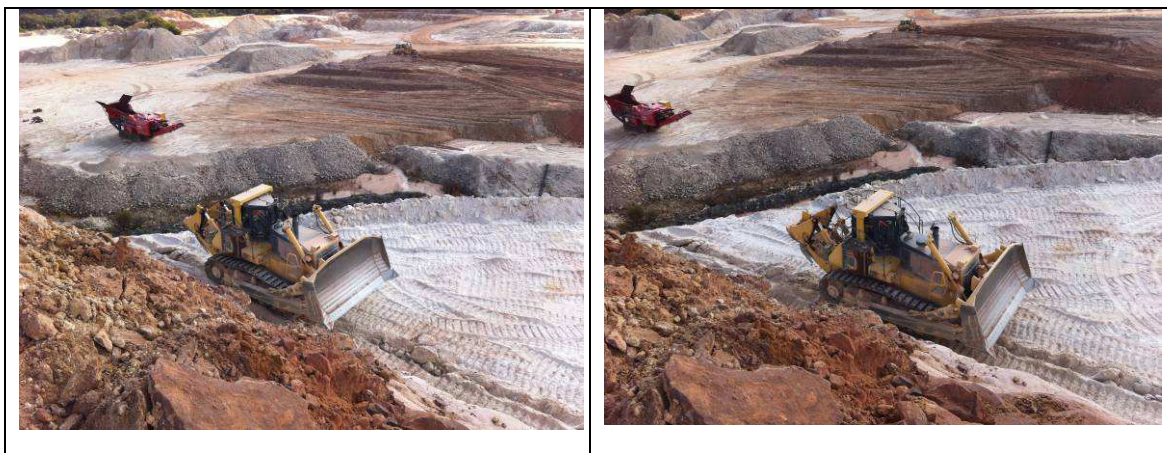
Area B (334128E, 6301303N) was at approximately 197m AHD and approximately 10m lower than the nearby monitoring locations and comprised of sandstone which is typical for much of the quarry area. Photos of the ripping activities in Area B are shown below.

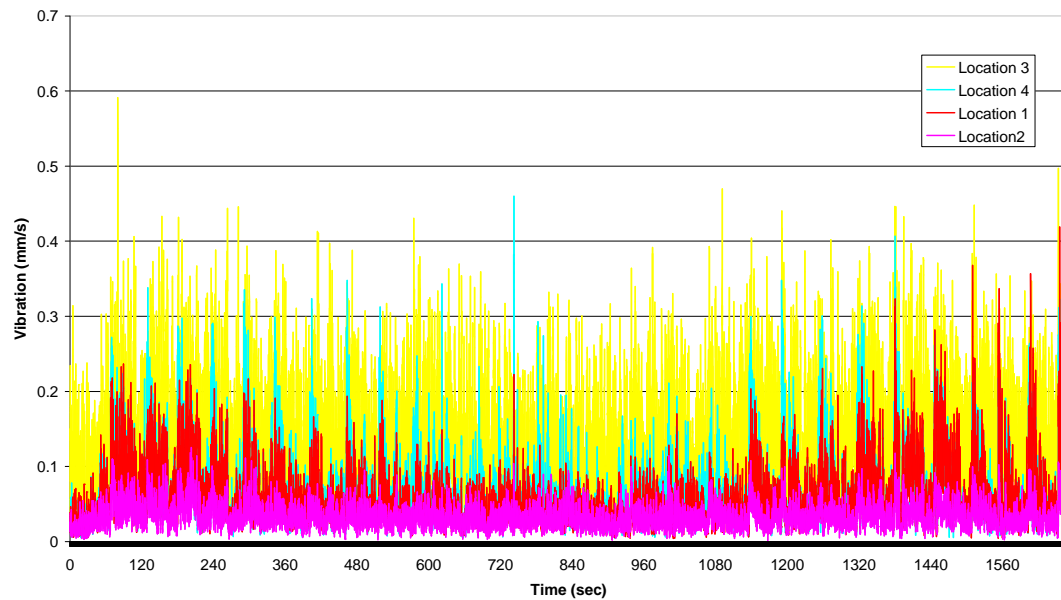
Figure 2-2 Results of Measurements at Area A

During all measurements, even at the closest location when ripping the harder rock, vibration levels did not exceed 1mm/s ppv. During most ripping operations, the highest vibration levels were experienced at the beginning of each rip as the tyne began to break up the sandstone with vibration levels typically in the range 0.4mm/s – 0.6mm/s. After this initial higher level, vibration levels during the remainder of each ripping operation reduced to typically 0.3mm/s or less at up to 20-30m and typically less than 0.1mm/s at 40m.

Typical 10-minute durations from the Samurai system at the 4 locations within the quarry are shown **Figure 2-2** and **Figure 2-3**. More detailed graphs are shown in **Appendix A**.

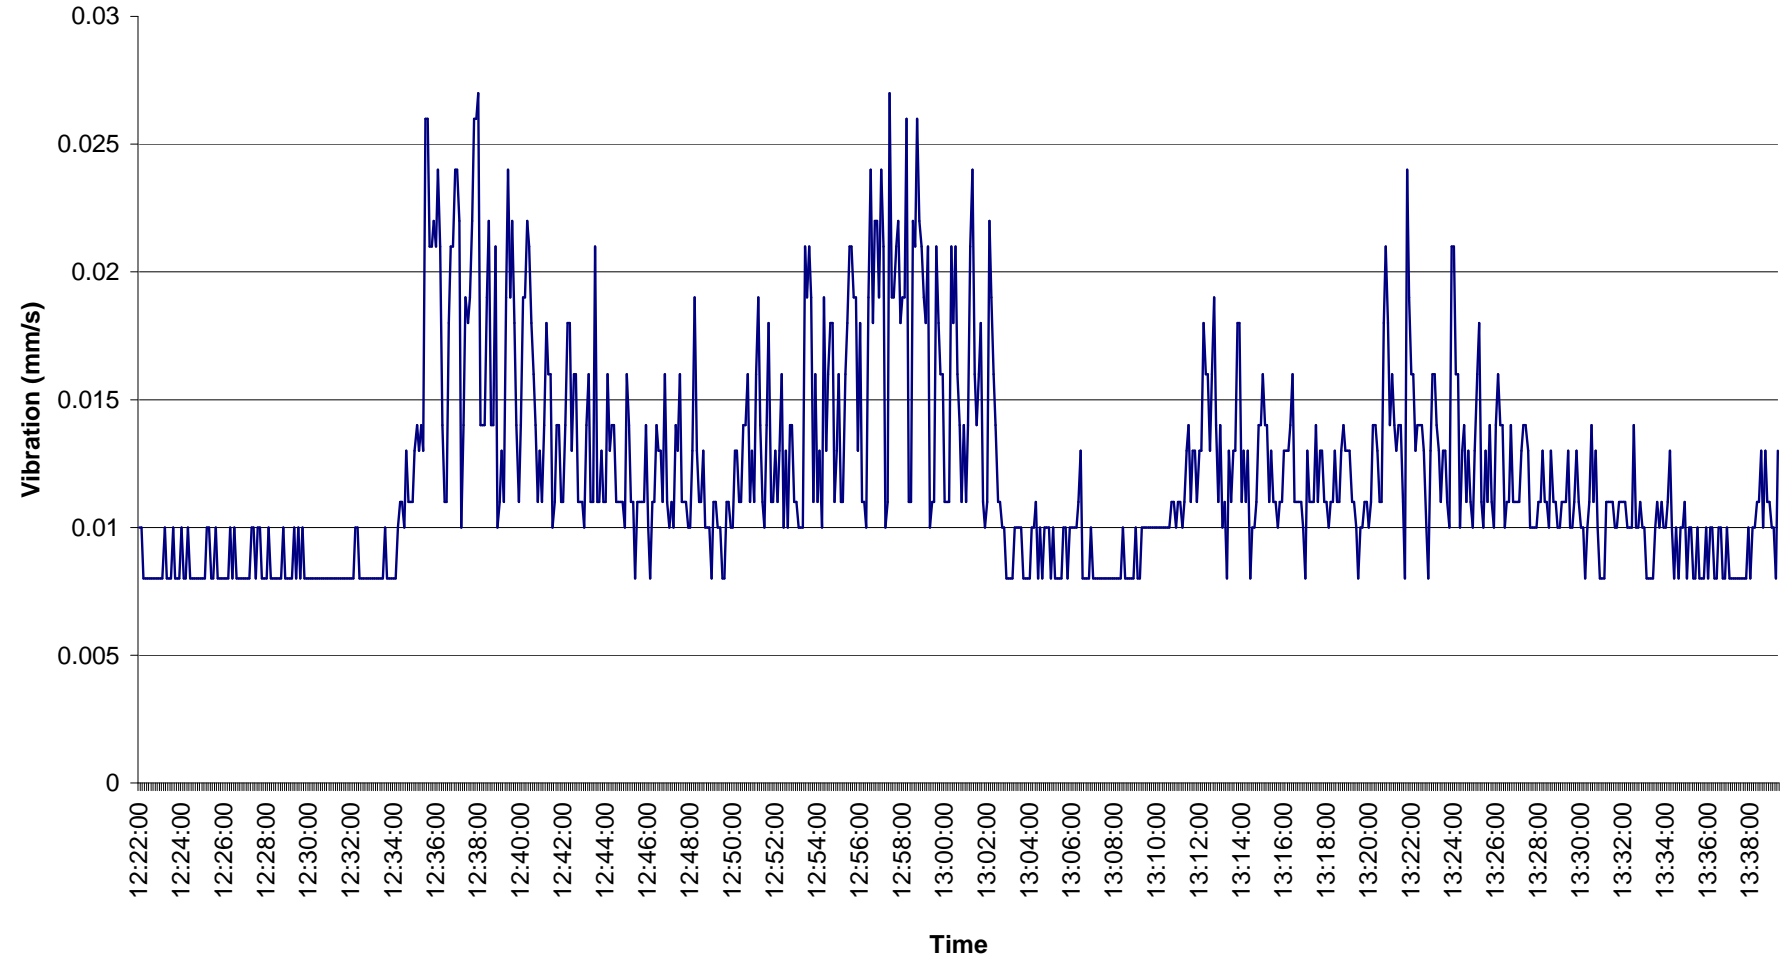
Vibration Measurements at Location 5

Appendix A also shows the time history at Location 5. At 120-144m AHD the levels were less than 0.03mm/s.
