Annual Review for the period 1 January 2014 to 31 December 2014

East Guyong Quarry

Annual Review for the period 1 January to 31 December 2014

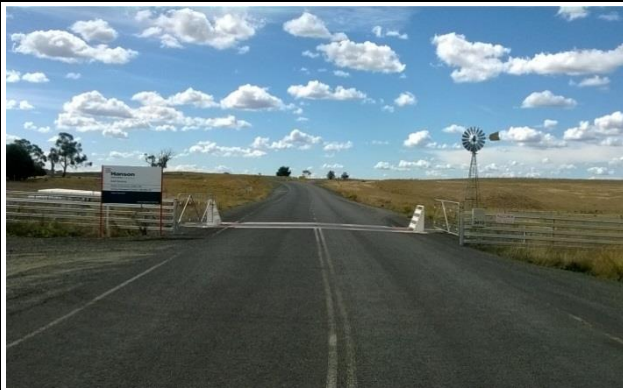
Plate 1 View of site entrance including lockable gate and sealed Site Access Road
(Ref: E869G_001)

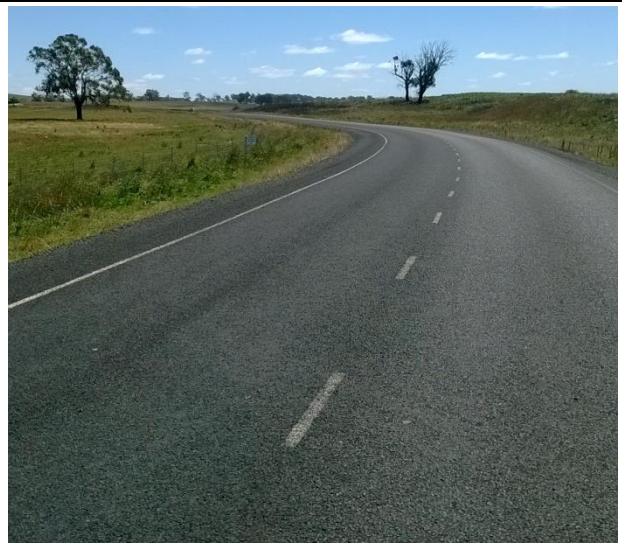
Plate 2 View of sealed Site Access Road
(Ref: E869F_002)

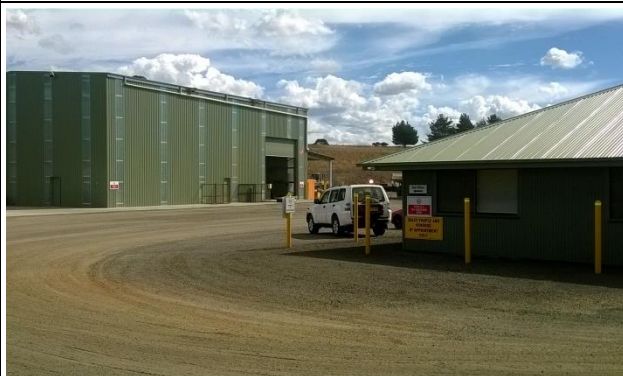
Plate 3 View of Site Office and Workshop buildings
(Ref: E869G_003)

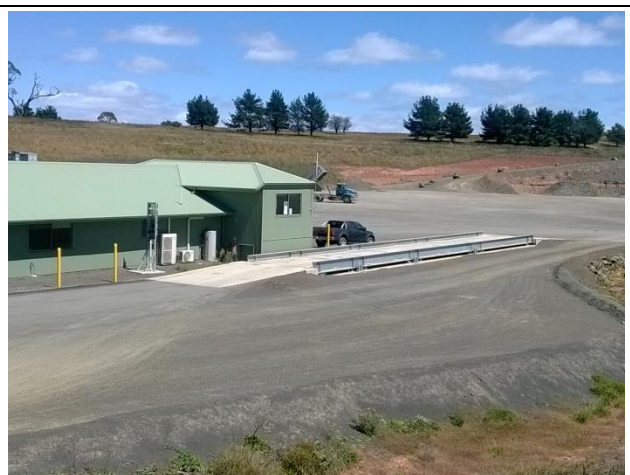
Plate 4 View of Weighbridge and Site Office building
(Ref: E869F_007)

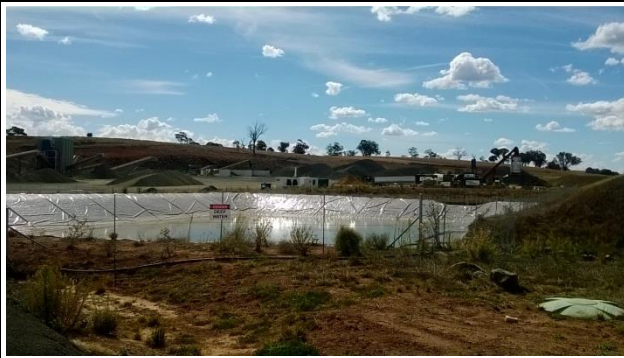
Plate 5 View of Water Storage Dam and Sediment Basin (foreground) with the northern section of the Infrastructure Area in the background (Ref: E869G_004)

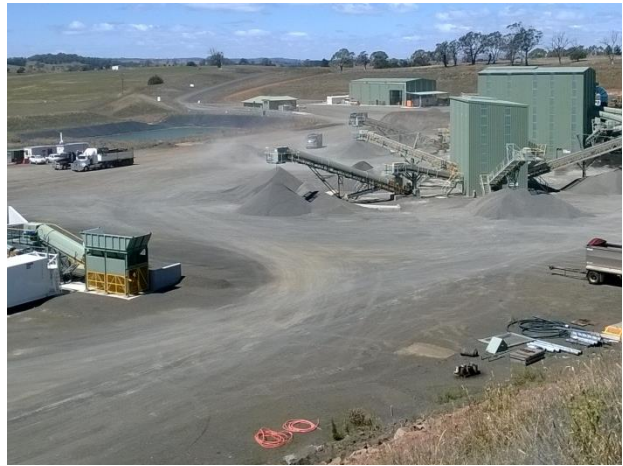
Plate 6 View of the southern section of the Infrastructure Area including the Pre-Coat Plant (left) and Fixed Processing Plant (right) in foreground and Water Storage Dam, Workshop, Site Office and Weighbridge in the background (Ref: E869F_006)

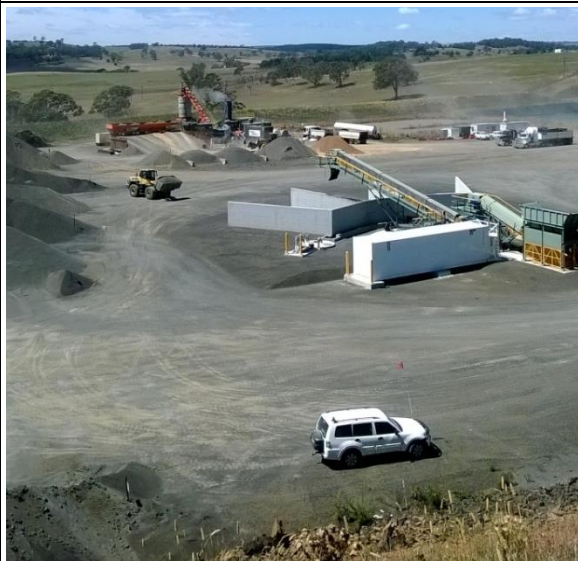
Plate 7 View of the northern section of the Infrastructure Area including the Pre-Coat Plant, various aggregate stockpiles and Pugmill (background) (Ref: E869F_005)

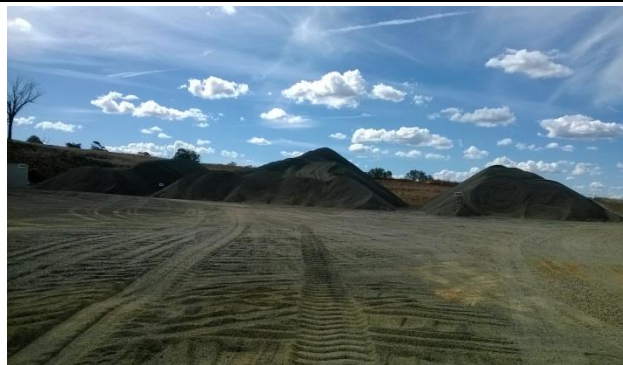
Plate 8 View of aggregate stockpiles within the northern section of the Infrastructure Area (Ref: E869G_010)

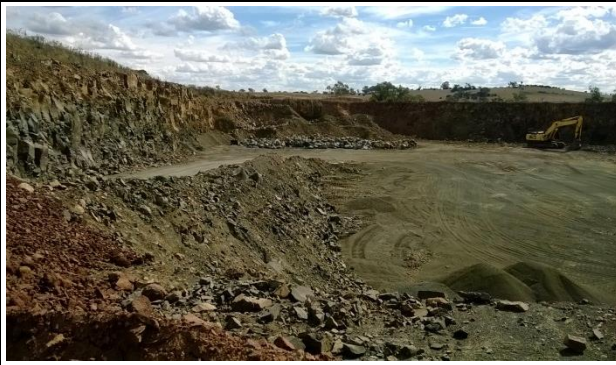
Plate 9 View of the southern and western faces of the Extraction Area facing west
(Ref: E869G_008)

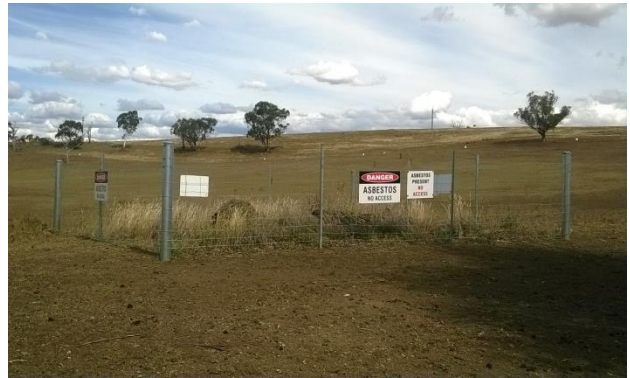
Plate 10 View of fencing and warning signs limiting access to a rock outcrop that contains naturally occurring asbestos
(Ref: E869G_006)

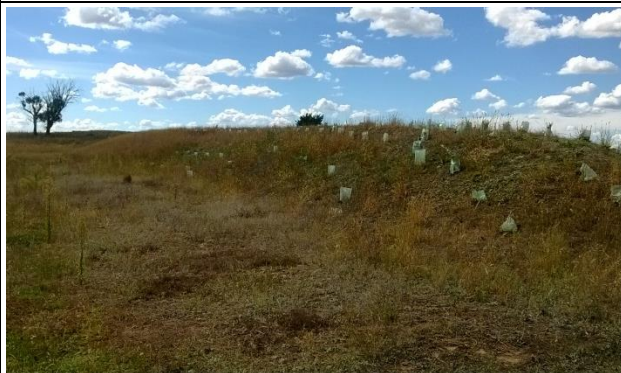
Plate 11 View of the tubestock planted on the amenity bund located along the Site Access Road
(Ref: E869G_002)

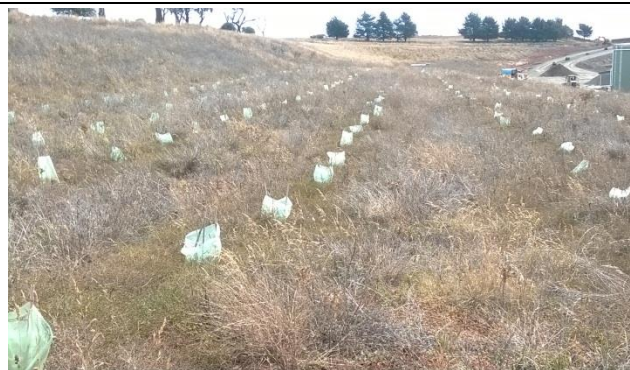
Plate 12 View of tubestock planting on the amenity bund located on the southern boundary of the Infrastructure Area
(Ref: E869G_011)

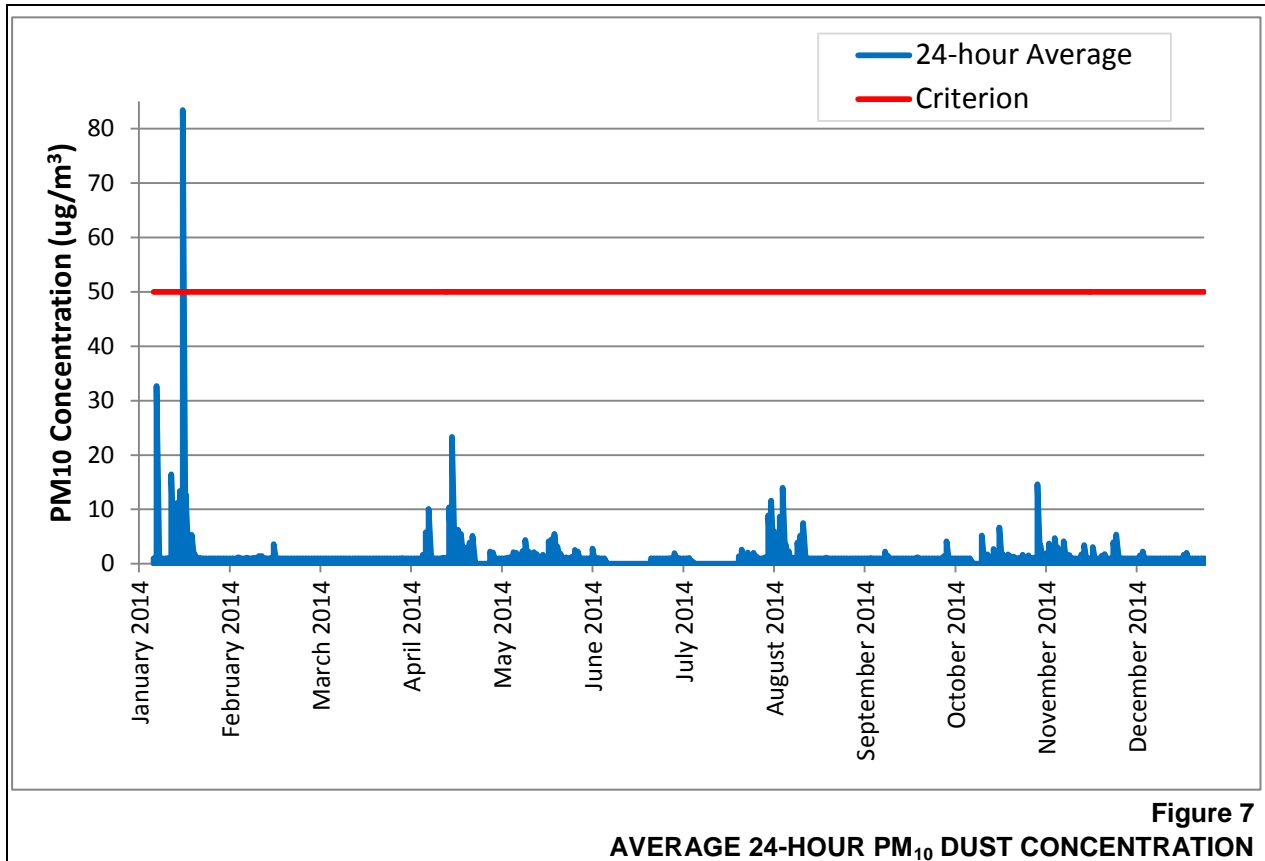
The concentration of PM₁₀, namely that component of suspended particulates with an aerodynamic diameter of 10µm or less, commenced at monitoring location PM1 on 24 January 2012 using a DustTrac PM₁₀ monitor (**Figure 5**). **Figure 7** presents the results of the PM₁₀ dust monitoring during the Reporting Period.

Adverse weather conditions at the end of December 2013 and early 2014 resulted in problems with the DustTrac PM₁₀ monitor and meant that PM₁₀ monitoring results are not available for the period from 28 December 2013 to 6 January 2014. This period coincided with the Christmas closure of the Quarry and no staff were available to check the status of the monitor. As a result, the excluded period commences during the holiday and was not rectified until staff returned on 6 January 2014.

The average 24-hour PM₁₀ concentrations in the vicinity of the Site during the Reporting Period were typically less than the criterion of 50µg/m³, with the exception of one instance on 16 January 2014 where the monitor registered 83µg/m³ of particulate matter. Quarry staff recorded that this day was the first day of return work after the Christmas holiday period and that no significant construction, blasting or crushing activities took place. It is noted that during that period smoke from a bush fire in the vicinity of Girribung Creek within Wollemi National Park had spread smoke in the vicinity of the Quarry Site. Other peaks in particulate matter during the Reporting Period coincided with bushfire events in the vicinity, although particulate matter levels did not approach the criteria levels in these instances.

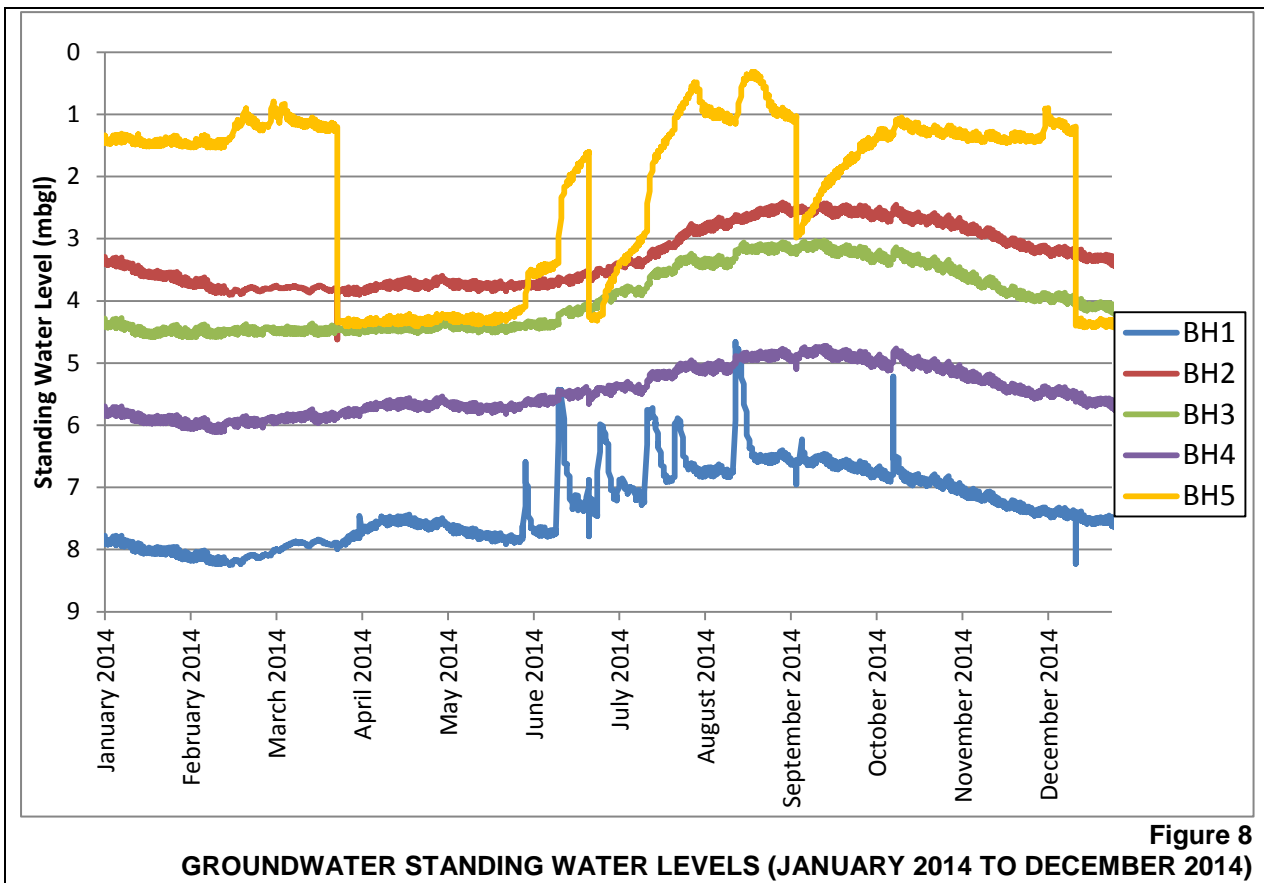
Figure 8 presents the results of monitoring of standing water levels within bore holes BH1 to BH5 (bore locations are provided on **Figure 5**). Monitoring was undertaken using automated data loggers which record standing water levels every six hours.

Short term fluctuations in the standing water levels within BH1 were recorded between June and October 2014. Upon closer inspection of daily rainfall during this period these 'spikes' in standing water levels occurred on days of heavy rainfall and are consistent with surface water flow into the bore hole. The Company is investigating the cause of this inflow of surface water and will undertake any remedial action necessary to ensure this does not continue.

The Company notes that all ground-disturbing activities were well above the regional water table during the Reporting Period. As a result, the Company contends that the fluctuations in groundwater levels are wholly attributable to natural causes.
