## ASBESTOS FIBRE AIR MONITORING REPORT

**Client:** Hanson Construction Materials Pty Ltd

**Job Location:** East Guyong Quarry, Mitchell Highway, East Guyong NSW

**Report Date:** Tuesday 21st August 2012

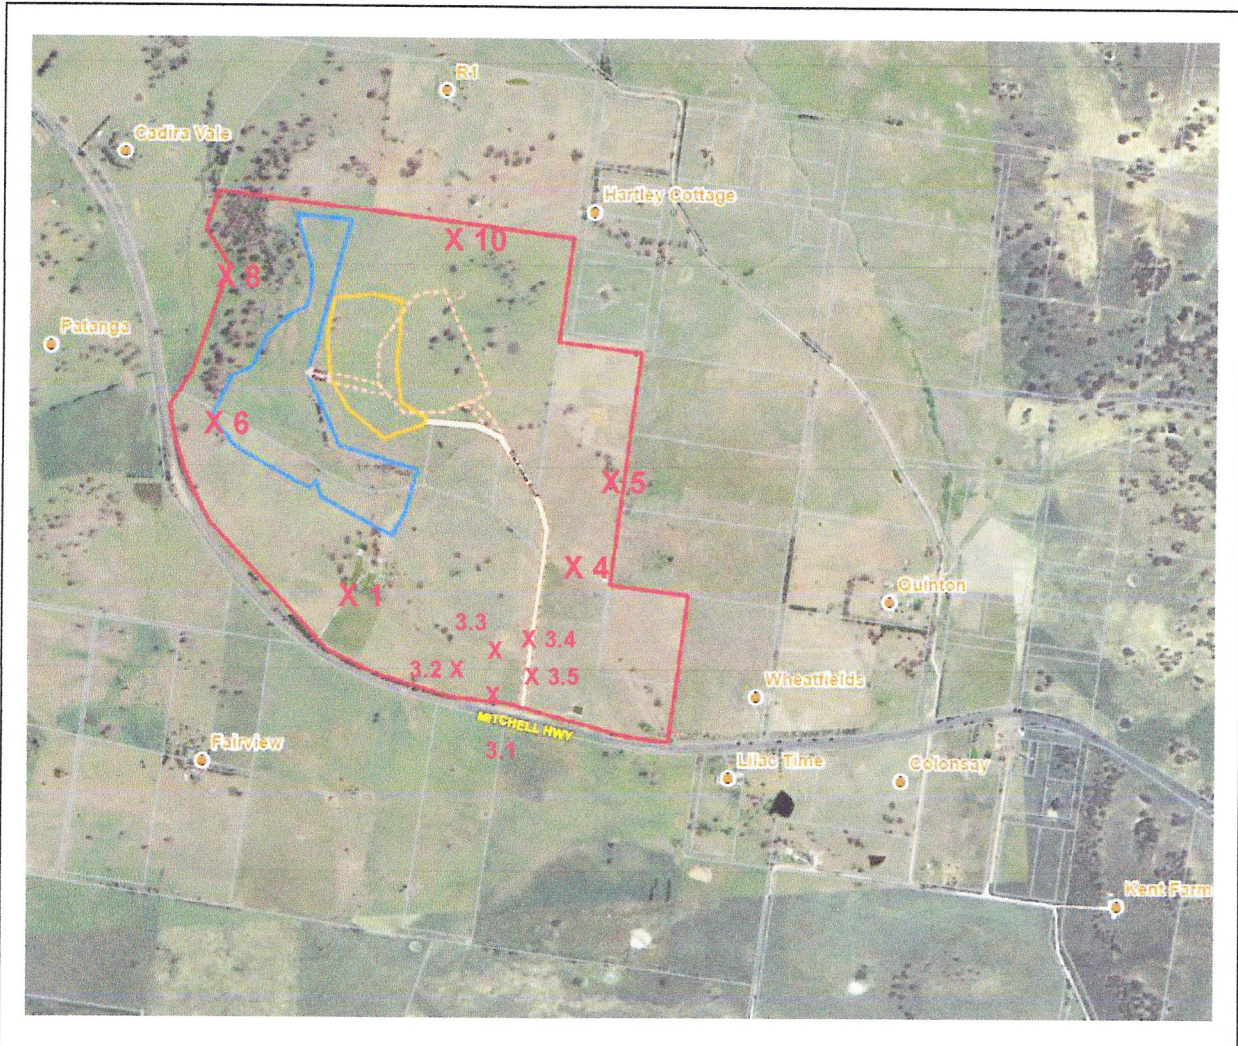
**Figure 1 – Air Monitoring Locations**

**Air Monitoring Sampling Plan  
East Guyong Quarry Site**

<b>Location 1:</b>	709,104mE ; 6300,660mN	<b>Location 3.1:</b>	709,488mE ; 6300,361mN
<b>Location 4:</b>	709,729mE ; 6300,716mN	<b>Location 3.2:</b>	709,470mE ; 6300,416mN
<b>Location 5:</b>	709,870mE ; 6300,905mN	<b>Location 3.3:</b>	709,544mE ; 6300,487mN
<b>Location 6:</b>	708,803mE ; 6301,185mN	<b>Location 3.4:</b>	709,608mE ; 6300,512mN
<b>Location 8:</b>	708,824mE ; 6301,587mN	<b>Location 3.5:</b>	709,620mE ; 6300,427mN
<b>Location 10:</b>	709,465mE ; 6301,633mN
