Asbestos Fibre Air Monitoring Report

Our Ref: C107605:J111804.203-20150731
Client: Hanson Construction Materials Pty Ltd

Job Location: East Guyong Quarry, Mitchell Highway, East Guyong NSW

Test Date: Friday 31st July 2015

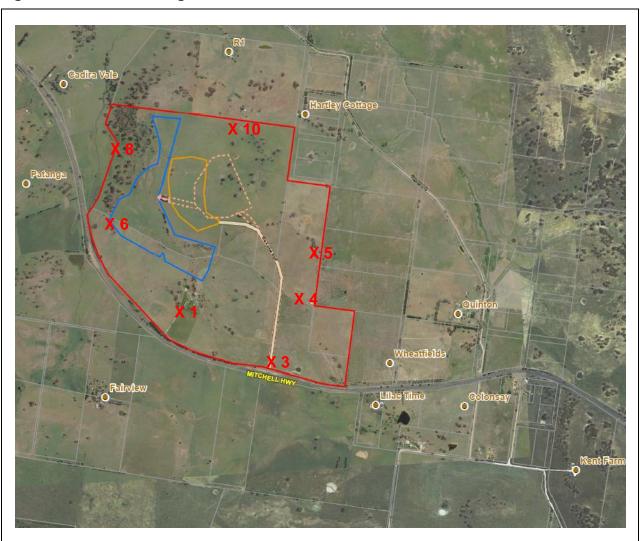
Figure 1 – Air Monitoring Location

Legend Air Monitoring Sampling Plan Air monitoring locations East Guyong Quarry Site **Project Boundary** Monitoring Date: Quarry Boundary Friday 31st July 2015 Infrastructure Area Boundary Air Monitoring Location Coordinates Location 1: 709,104mE; 6300,660mN Location 6: 708,803mE; 6301,185mN Location 3: 709,601mE; 6300,370mN Location 8: 708,824mE; 6301,587mN Location 4: 709,729mE; 6300,716mN Location 10: 709,465mE; 6301,633mN Location 5: 709,870mE; 6300,905mN **Weather Conditions** General Overcast / showers Wind Direction
