Asbestos Fibre Air Monitoring Report

Our Ref: C107605:SO2002443.002-20160801
Client: Hanson Construction Materials Pty Ltd
Client Address: Locked Bag 5260, Parramatta NSW 2124

Job Location: East Guyong Quarry, Mitchell Highway, East Guyong NSW

Report Date: Monday, 8 August 2016 Test Date: Monday, 1 August 2016

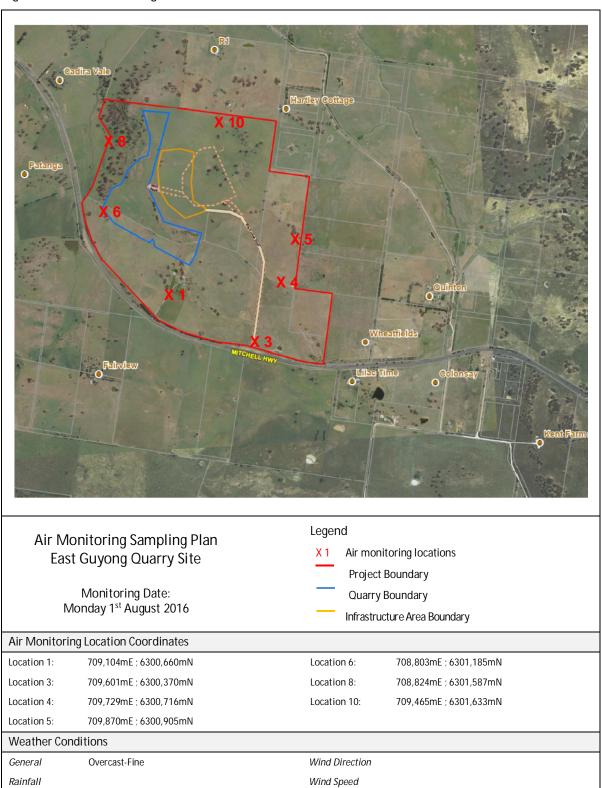
Figure 1 – Air Monitoring Location

Filter No.	Test Type Sample Location	Sample Period Start-Finish	Average Flow Rate (L/min)	Fibres/ Fields	Result(s) Fibres/mL			
Asbestos background – Background asbestos air monitoring throughout various locations across the site.								
C000256789	Field Blank	_	-	0.0/100	-			
C000256916	Location 1 – Near Southern Boundary of Site, Access Road to Residence (No.3472) off Mitchell Highway, approx. 120 metres North of South Site Boundary – On barbed wire fence	0707 – 1445	1.00	0.5/100	< 0.01			
C000256908	Location 3 – Near Southern Boundary (SE Corner) of Site, Adjacent to New Access Road Entry (No.3410) off Mitchell Highway, approx. 30 metres from South Site Boundary – On barbed wire fence	0711 – 1449	1.00	0.0/100	< 0.01			
C000256887	Location 4 – Near Eastern Boundary (near SE Corner) of Site, approx. 70 metres West of Shed, Access Road – On barbed wire fence	0716 – 1456	1.00	0.0/100	< 0.01

C000256879	Location 5 – Near Eastern Boundary (near Centre) of Site, approx. 50 metres West of East Site Boundary – On fencing post	0722 – 1502	1.00	0.0/100	< 0.01			
C000256885	Location 6 – Western Boundary of Proposed Quarry Pit (near Western Site Boundary) – On barbed wire fence	0729 – 1510	1.00	0.0/100	< 0.01			
C000256795	Location 8 – Western Boundary (near NW Corner) of Site – On barbed wire fence	0734 – 1516	1.00	0.0/100	< 0.01

Filter No.	Test Type Sample Location	Sample Period Start-Finish	Average Flow Rate (L/min)	Fibres/ Fields	Result(s) Fibres/mL
C000257107	Location 10 – Near Northern Boundary of Site (near NE Corner Site) – On fencing post	0741 – 1521	1.00	0.0/100	< 0.01
