## Asbestos Fibre Air Monitoring Report

Our Ref: C107605:SO2006056.001-20170929  
 Client: Hanson Construction Materials Pty Ltd  
 Client Address: Locked Bag 5260, Parramatta NSW 2124  
 Attention: Pere Riini – Quarry Manager  
 Job Location: East Guyong Quarry, Mitchell Highway, East Guyong NSW  
 Report Date: Tuesday, 10 October 2017  
 Analysis Date: Monday, 9 October 2017  
 Monitoring Date: Friday, 29 September 2017  
 Sampling Type: Control & Exposure  
 Sampled By: Pumps On: Pere Riini (Hanson)                      Pumps Off: Pere Riini (Hanson)  
 Location of Analysis: Khartoum Rd North Ryde Laboratory

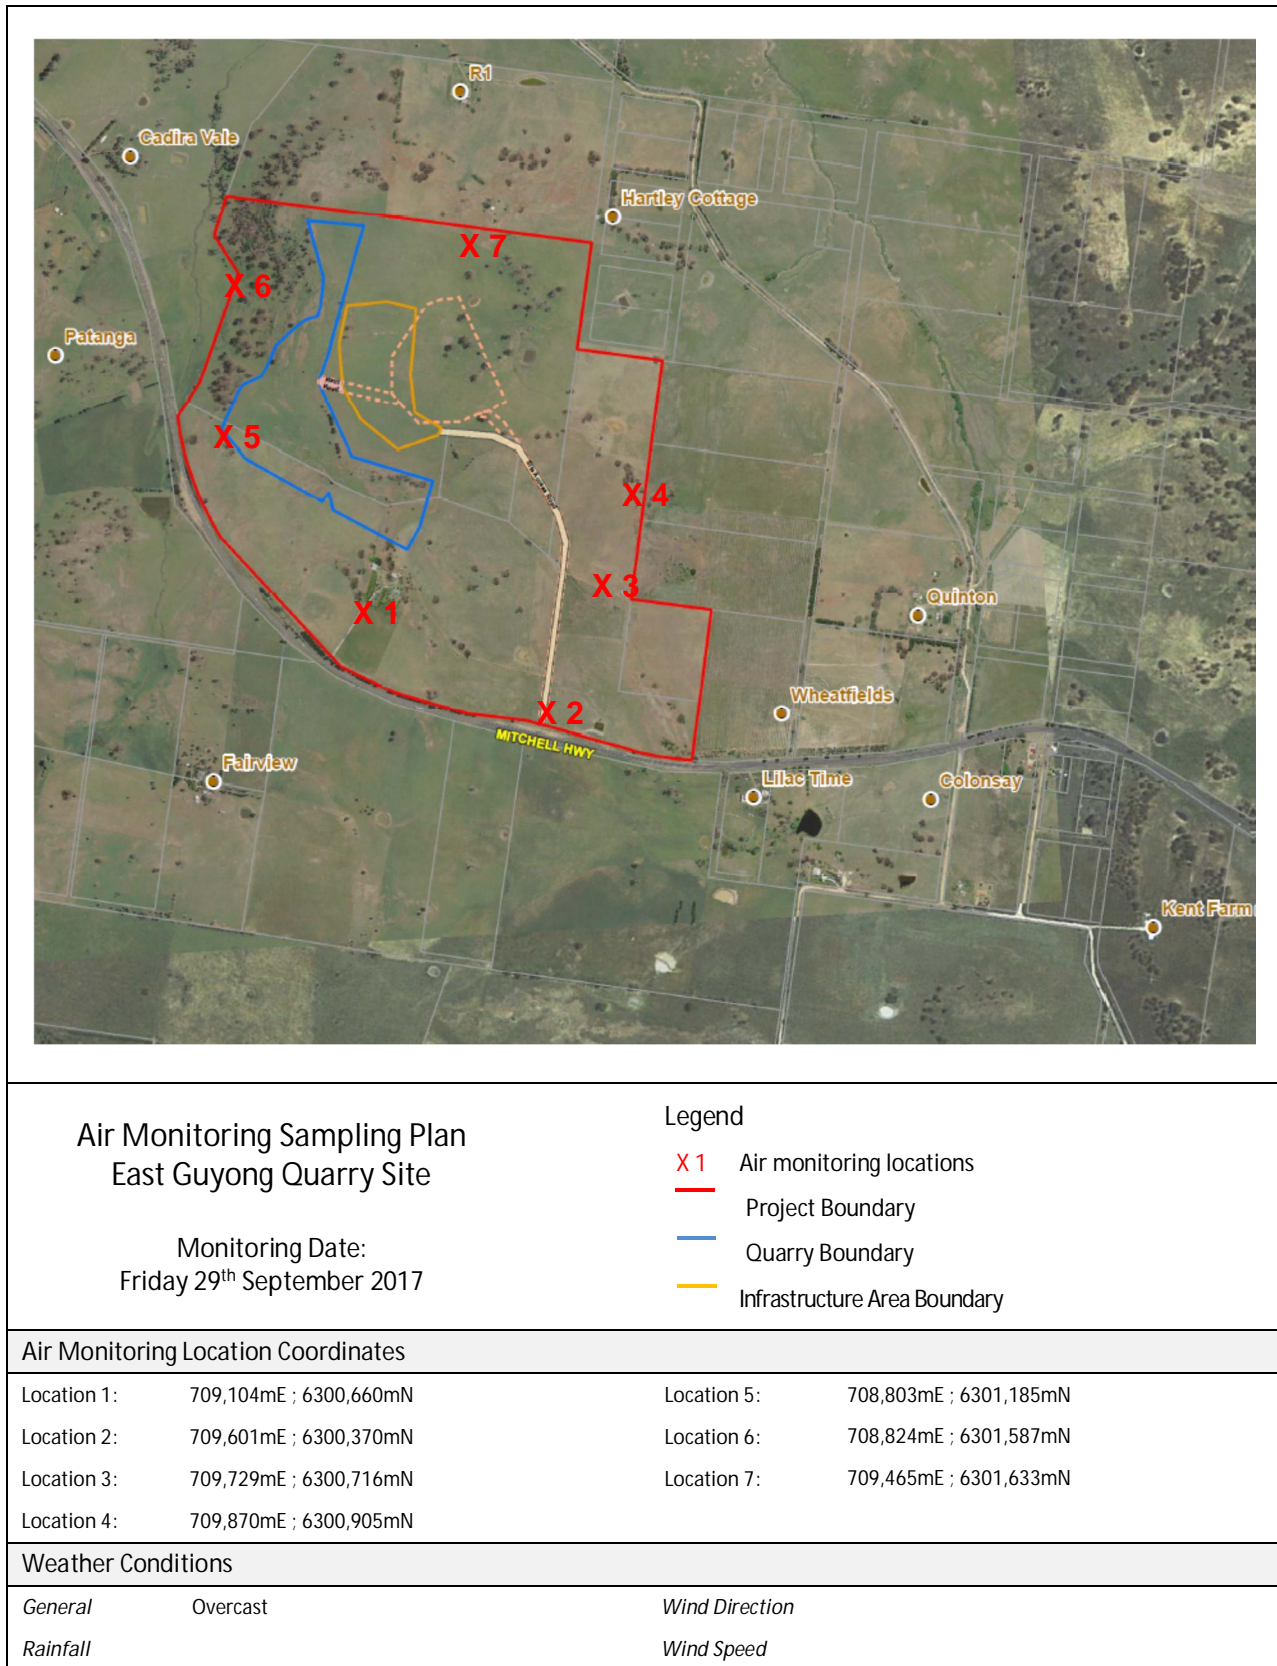
Figure 1 – Air Monitoring Location

Filter No.	Test Type Sample Location	Sample Period Start-Finish	Average Flow Rate (L/min)	Fibres/ Fields	Result(s) Fibres/mL
C0011 79325	Field Blank	–	–	0.0/100	–
Asbestos background – Background asbestos air monitoring throughout various locations across the site					
C0011 79298	Location 1 – Near Southern Boundary of Site, Access Road to Residence (No.3472) off Mitchell Highway, approx. 120 metres North of South site boundary – On barbed wire fence	0731 – 1445	1.00	0.0/100	< 0.01
C0011 79341	Location 2 – Near Southern Boundary (SE corner) of Site, Adjacent to New Access Road Entry (No.3410) off Mitchell Highway, approx. 30 metres from South site boundary – On barbed wire fence	0738 – 1452	1.00	0.0/100	< 0.01
C0011 79305	Location 3 – Near Eastern Boundary (near SE corner) of Site, approx. 70 metres West of Shed, Access Road – On barbed wire fence	0745 – 1459	1.00	0.0/100	< 0.01
C0011 79348	Location 4 – Near Eastern Boundary (near Centre) of Site, approx. 50 metres West of East Site Boundary – On fencing post	0752 – 1509	1.00	0.0/100	< 0.01

C0011 79300	Location 5 – Western Boundary of Proposed Quarry Pit (near Western site boundary) – On barbed wire fence	0758 – 1516	1.00	0.0/100	< 0.01
C0011 79320	Location 6 – Western Boundary (near NW corner) of site – On barbed wire fence	0810 – 1521	1.00	0.0/100	< 0.01
C0011 79302	Location 7 – Near Northern Boundary of site (near NE corner of site) – On fencing post	0815 – 1526	1.00	0.0/100	< 0.01
C0011 79344	Personal – S. Lane, 980M FEL	0821 – 1536	1.00	0.0/100	< 0.01
