Asbestos Fibre Air Monitoring Report

Our Ref: C107605:SO2004366.002-20170403
Client: Hanson Construction Materials Pty Ltd
Client Address: Locked Bag 5260, Parramatta NSW 2124
Attention: Pere Riini – Quarry Manager
Job Location: East Guyong Quarry, Mitchell Highway, East Guyong NSW
Report Date: Monday, 10 April 2017
Analysis Date: Monday, 10 April 2017
Monitoring Date: Monday, 3 April 2017
Sampling Type: Control
Sampled By: **Pumps On:** Pere Riini (Hanson) **Pumps Off:** Pere Riini (Hanson)
Location of Analysis: Khartoum Rd North Ryde Laboratory

**Air Monitoring Sampling Plan
East Guyong Quarry Site**

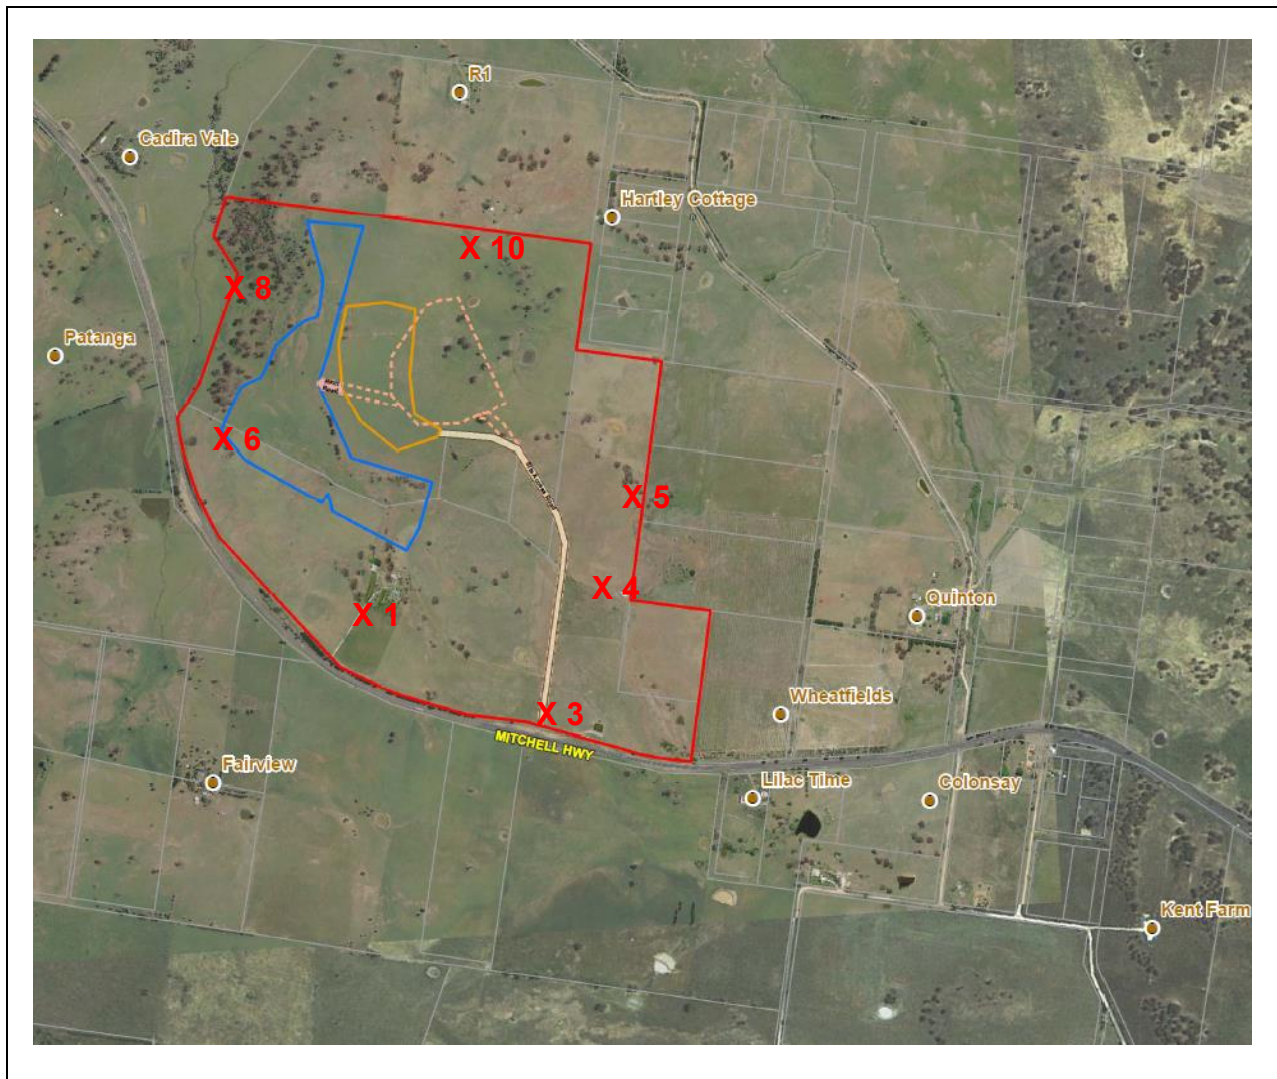
Figure 1 – Air Monitoring Location

**Monitoring Date:
Monday 3rd April 2017**

Air Monitoring Location Coordinates	
Location 1:	709,104mE ; 6300,660mN
Location 3:	709,601mE ; 6300,370mN
Location 4:	709,729mE ; 6300,716mN
Location 5:	709,870mE ; 6300,905mN
Location 6:	708,803mE ; 6301,185mN
Location 8:	708,824mE ; 6301,587mN
Location 10:	709,465mE ; 6301,633mN
