Asbestos Fibre Air Monitoring Report

Our Ref: C107605:SO2007248.002-20180403
Client: Hanson Construction Materials Pty Ltd
Client Address: Locked Bag 5260, Parramatta NSW 2124
Attention: Pere Riini – Quarry Manager
Job Location: East Guyong Quarry, Mitchell Highway, East Guyong NSW
Report Date: Tuesday, 10 April 2018
Analysis Date: Tuesday, 10 April 2018
Monitoring Date: Tuesday, 3 April 2018
Sampling Type: Control & Exposure
Sampled By: **Start:** Pere Riini (Hanson) **Finish:** Pere Riini (Hanson)
Location of Analysis: Khartoum Rd North Ryde Laboratory

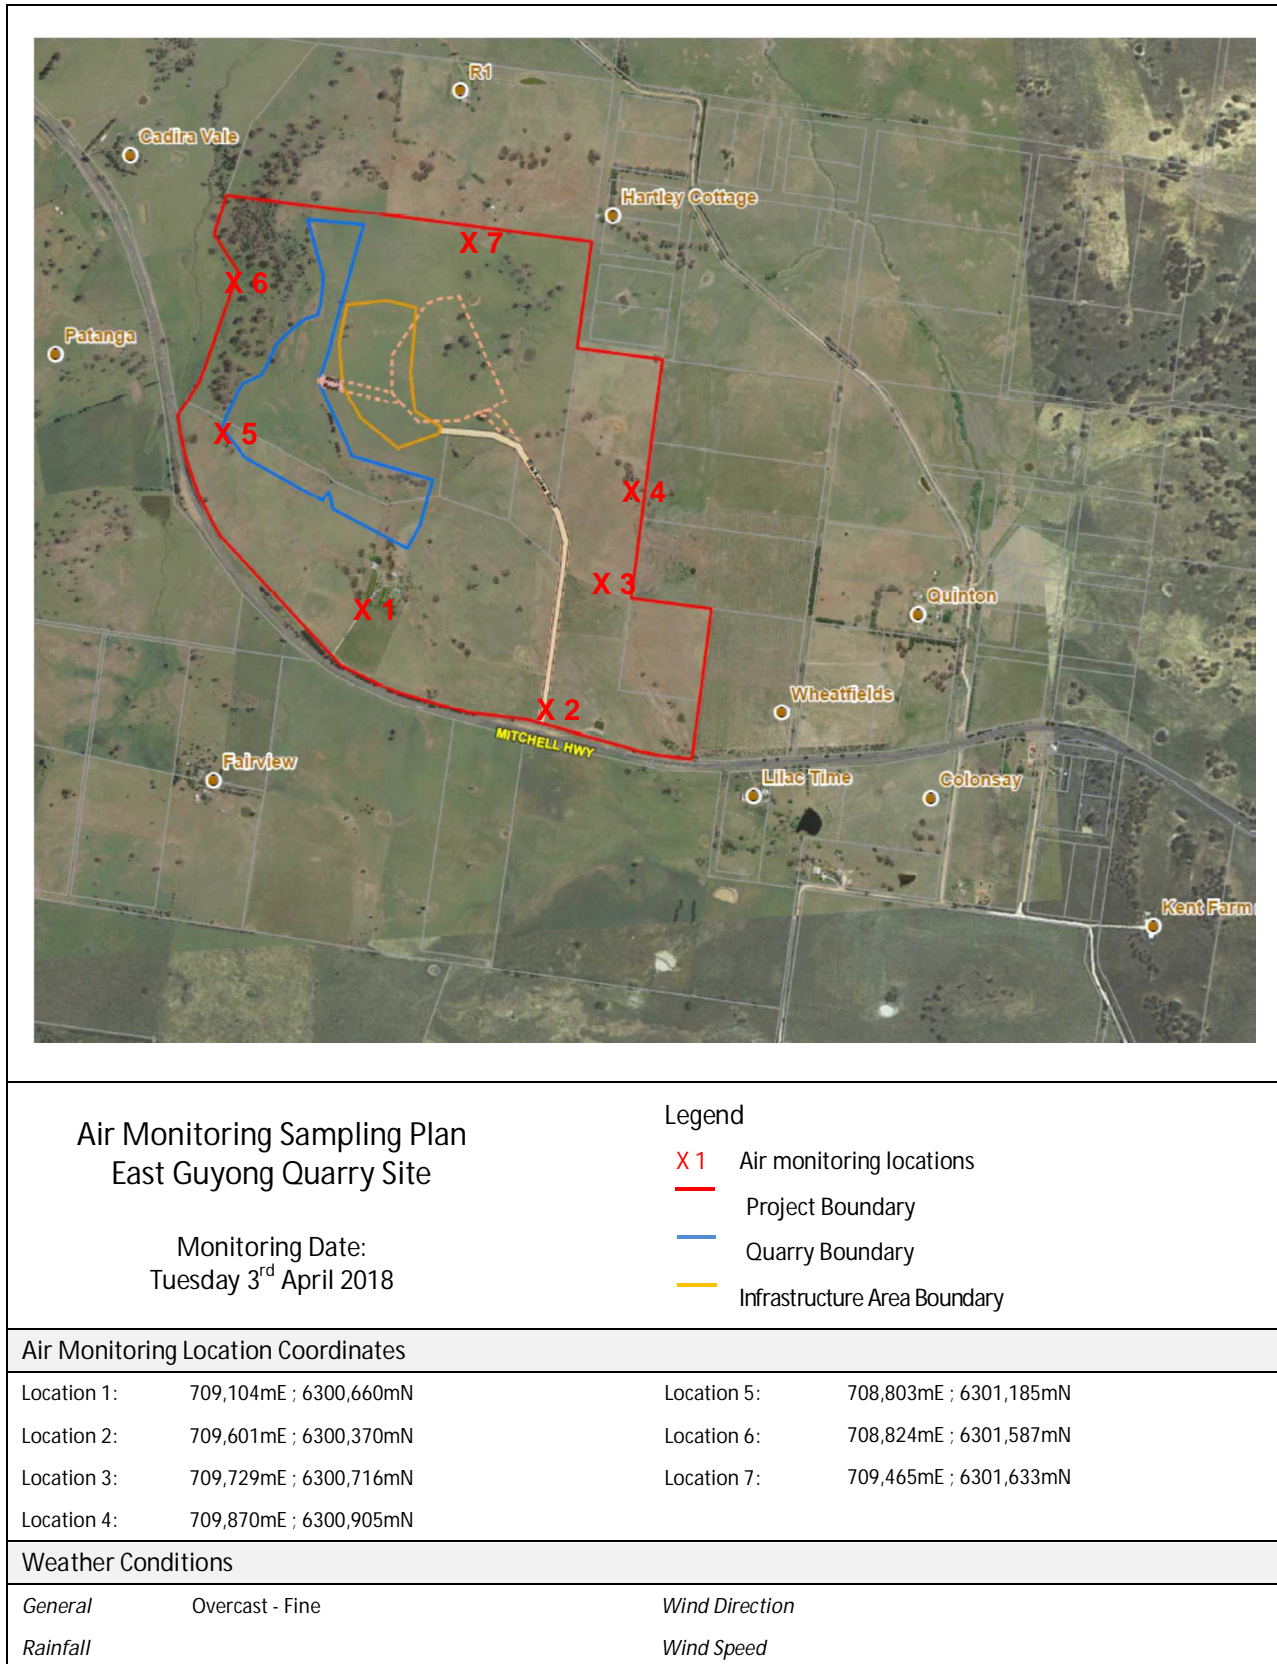
Figure 1 – Air Monitoring Location

Sample Filter No.	Test Type Sample Location	Sample Time Start-Finish	Sampling Rate (avg) (L/min)	Fibres/ Fields	Result(s) Fibres/mL
C004853751	Field Blank	–	–	0.0/100	–
Asbestos background – Background asbestos air monitoring throughout various locations across the site					
C003715053	Location 1 – Near Southern Boundary of Site, Access Road to Residence (No.3472) off Mitchell Highway, approx. 120 metres North of South site boundary – On barbed wire fence	0645 – 1501	1.00	1.0/100	< 0.01
C003714944	Location 2 – Near Southern Boundary (SE corner) of Site, Adjacent to New Access Road Entry (No.3410) off Mitchell Highway, approx. 30 metres from South site boundary – On barbed wire fence	0651 – 1508	1.00	2.0/100	< 0.01
C003715225	Location 3 – Near Eastern Boundary (near SE corner) of Site, approx. 70 metres West of Shed, Access Road – On barbed wire fence	0659 – 1515	1.00	1.0/100	< 0.01
C003715149	Location 4 – Near Eastern Boundary (near Centre) of Site, approx. 50 metres West of East Site Boundary – On fencing post	0706 – 1522	1.00	0.5/100	< 0.01

C003715162	Location 5 – Western Boundary of Proposed Quarry Pit (near Western site boundary) – On barbed wire fence	0712 – 1529	1.00	0.0/100	< 0.01
C004430969	Location 6 – Western Boundary (near NW corner) of site – On barbed wire fence	0718 – 1536	1.00	0.0/100	< 0.01
C002706350	Location 7 – Near Northern Boundary of site (near NE corner of site) – On fencing post	0725 – 1542	1.00	2.0/100	< 0.01
C003714972	Personal – R. Chapman, PC450-SE Excavator	0733 – 1551	1.00	2.0/100	< 0.01
