Asbestos Fibre Air Monitoring Report

Our Ref: C107605:SO2007248.001-20180329
Client: Hanson Construction Materials Pty Ltd
Client Address: Locked Bag 5260, Parramatta NSW 2124

Job Location: East Guyong Quarry, Mitchell Highway, East Guyong NSW

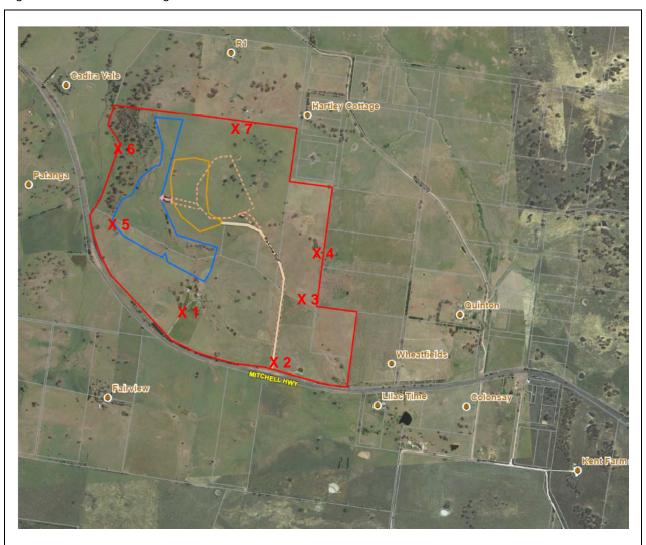
Figure 1 – Air Monitoring Location

Legend Air Monitoring Sampling Plan Air monitoring locations East Guyong Quarry Site **Project Boundary** Monitoring Date: Thursday 29th March 2018 **Quarry Boundary** Infrastructure Area Boundary Air Monitoring Location Coordinates Location 1: 709,104mE; 6300,660mN Location 5: 708,803mE; 6301,185mN Location 2: 709,601mE; 6300,370mN 708,824mE; 6301,587mN Location 6: Location 3: 709,729mE; 6300,716mN Location 7: 709,465mE; 6301,633mN 709,870mE; 6300,905mN Location 4: **Weather Conditions** General Fine Wind Direction Rainfall Wind Speed
