Red Hill Quarry

West Quarry Extension Area A

Screening and Rehabilitation Plan

March 2014

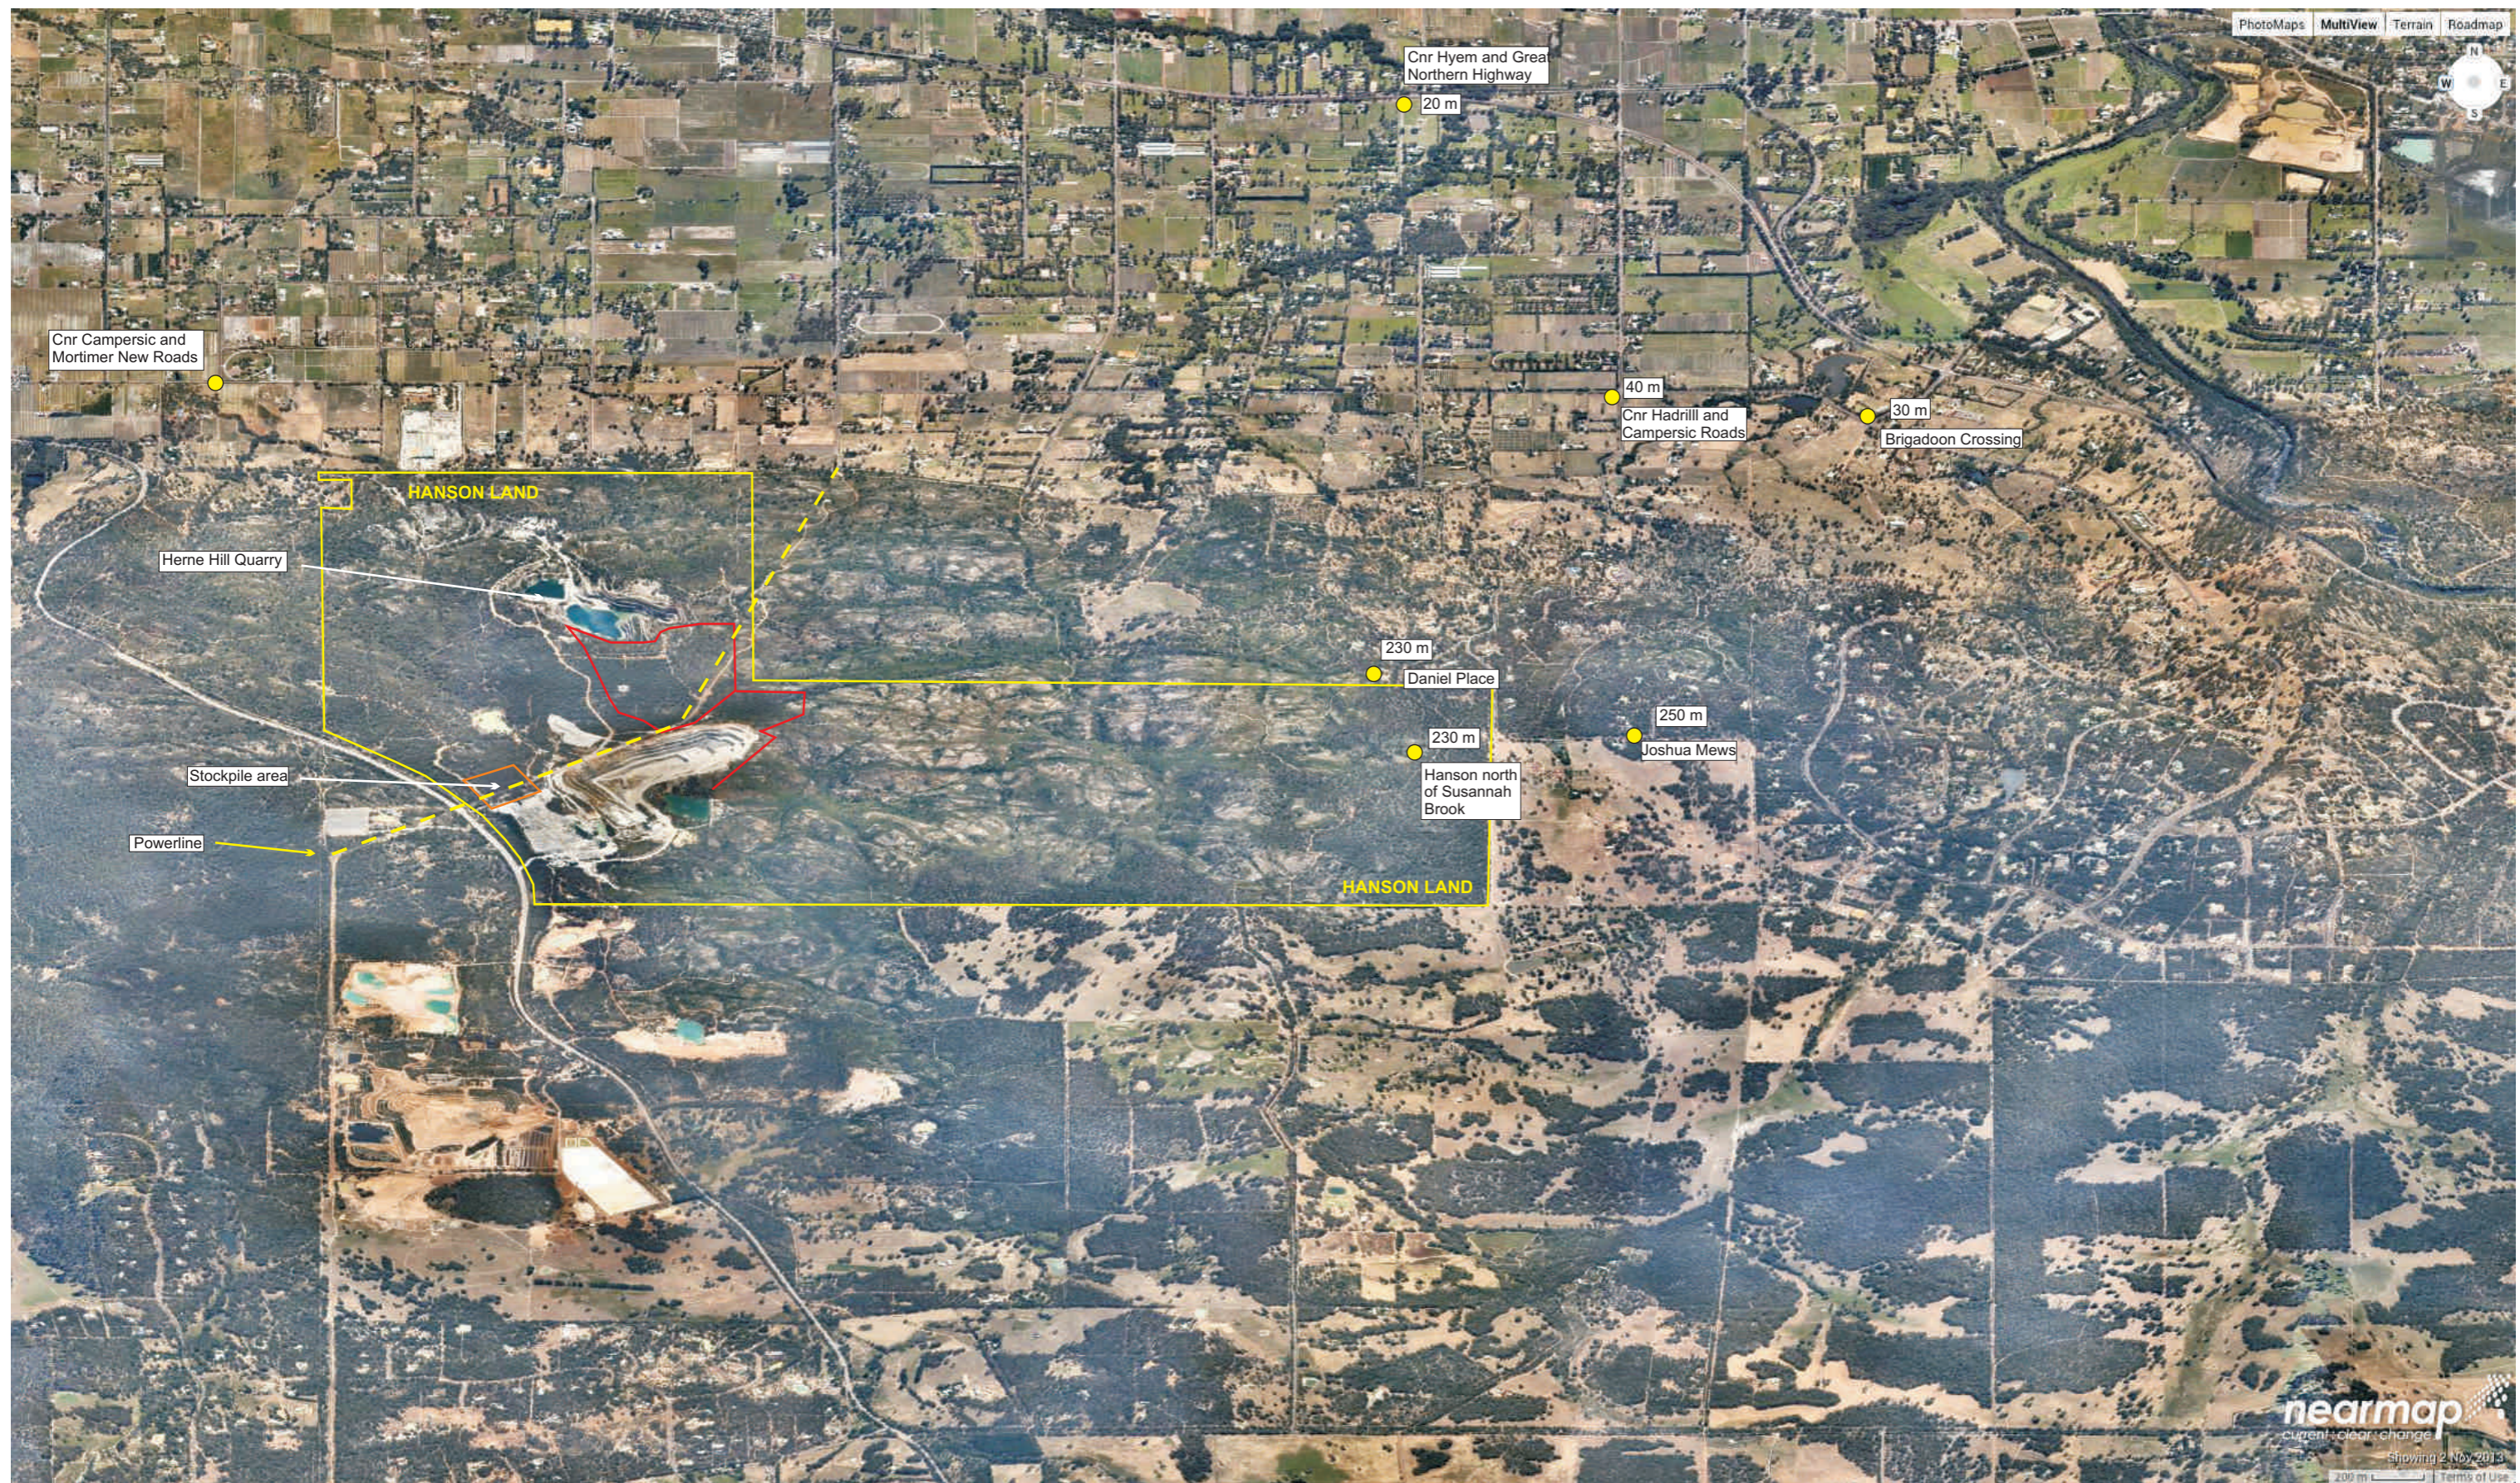
HANSON CONSTRUCTION MATERIALS RED HILL QUARRY AERIAL OVERVIEW	
Landform Research	March 2014
Baseplan Nearmap	Scale See Plan
FIGURE 2

Longer range visibility of the site can be glimpsed from the top of the plateau on the northern side of Susannah Brook where subdivision has occurred. Whilst the land identified as potentially able to be seen is much wider generally in a north and north westerly direction, in reality the actual area from which the pit can be seen is much smaller because of intervening remnant vegetation, planted trees, and the landform. See Figures 2 and 3.

The majority of this land is rural land or resource zoned land or rural living as shown on Figure 2.

POSSIBLE MITIGATION	COMMENTS
Maintaining suitably large buffers.	<ul style="list-style-type: none"> • Hanson currently holds approximately 800 hectares of the surrounding land predominantly to the west and north. 235 hectares of buffer was sold to the Government for incorporation into the Darling Range Regional Park in 2003. • Statement 912 requires that within 5 years not less than 28 hectares of degraded area, consisting largely of the old Herne Hill processing and stockpile areas, will be rehabilitated using local provenance species. • See Figure 2.
Locating and designing the quarry to minimise visual impact.	<ul style="list-style-type: none"> • The design of the pit takes into account the nature of the resource and the local landscape. For example whilst it is possible to place the quarry on top of the ridge this may not be desirable because the ridge has very deep overburden which has to be removed to access the fresh rock. • This would create a much larger pit and would result in a large amount of overburden that will have to be removed and itself is likely to become a temporary visual issue when a dump is formed. • Care is taken in the design process to not sterilise resources or create problems where rehabilitation has to be removed or major future earthworks required which in themselves may create an unacceptable visual issue. • See Figures 2 and 17.

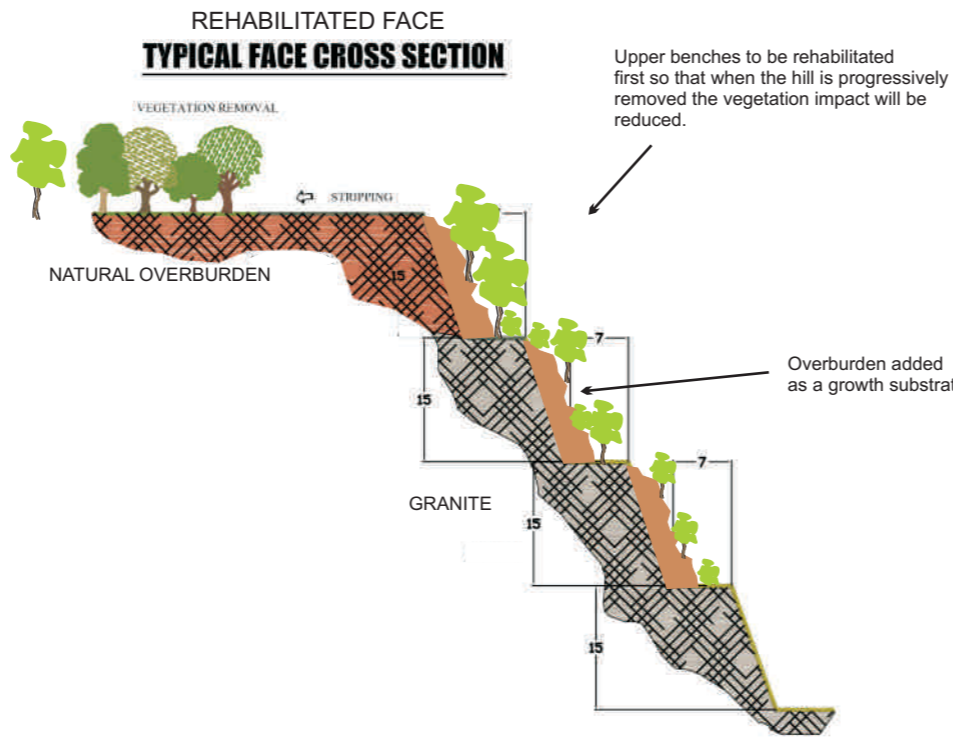
VIEWS OF THE REAR FACE

The elevation of the northern and western face influences how much of the active face is visible.
