Asbestos Fibre Air Sampling & Analysis Report

Our Ref: C107605:SO2008732.001 2018-09-27
 Client: Hanson Construction Materials Pty Ltd
 Client Address: Locked Bag 5260, Parramatta NSW 2124
 Attention: Pere Riini - Quarry Manager
 Job Location: East Guyong Quarry, Mitchell Highway, East Guyong NSW 2798
 Report Date: Monday, 8 October 2018
 Analysis Date: Friday, 5 October 2018
 Sampling Date: Thursday, 27 September 2018
 Sampling Type: Control
 Sampled By: Start: Pere Riini (Hanson) Finish: Pere Riini (Hanson)
 Location of Analysis: Base laboratory - Level 2, 11 Khartoum Road, North Ryde NSW 2113
 Licenced Asbestos Removal Contractor: N/A Notification No: N/A

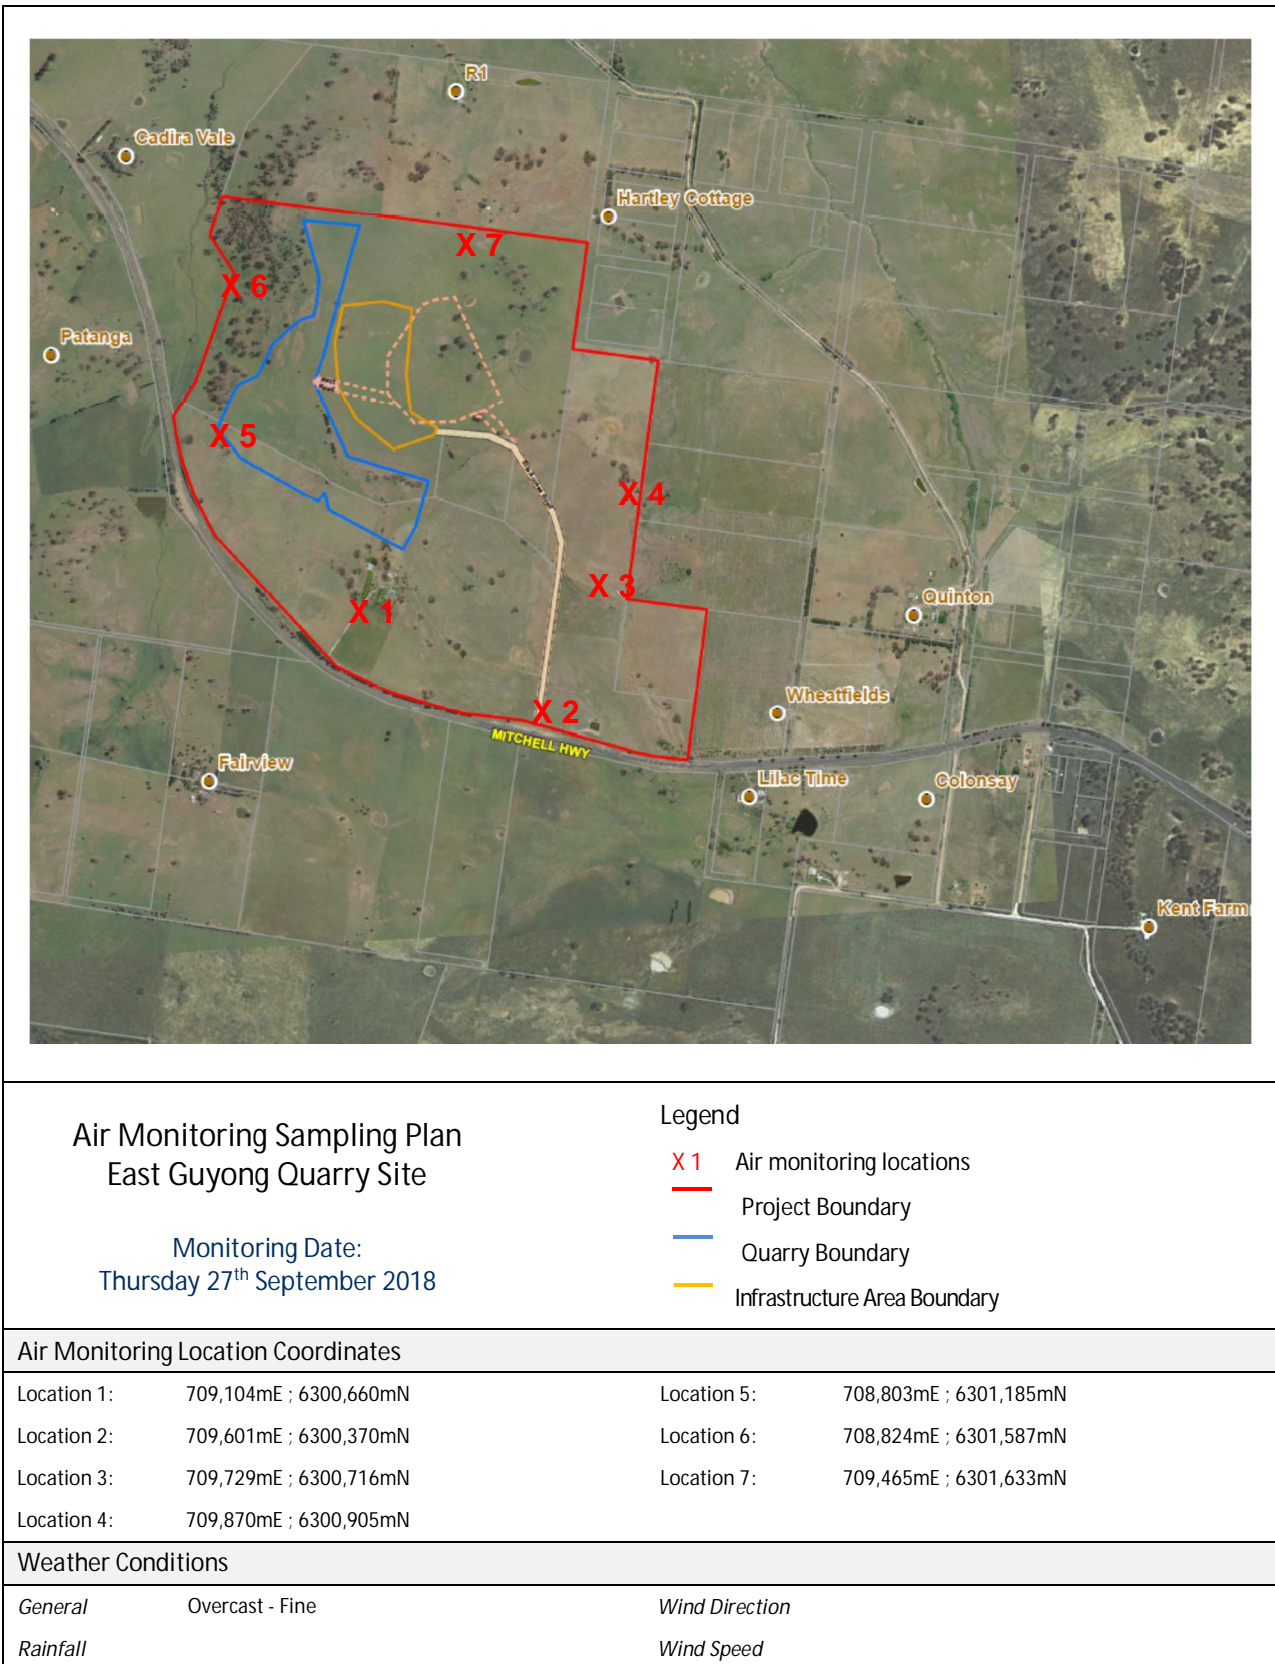
Figure 1 – Air Monitoring Location

Sample Filter No.	Test Type Sample Location	Sample Time Start-Finish	Sampling Rate (avg) (L/min)	Fibres/ Fields	Result(s) Fibres/mL
C004660516	Field Blank	-	-	0.0/100	-
Asbestos background - air monitoring throughout various locations across the site					
C003740551	Location 1 – Near Southern Boundary of Site, Access Road to Residence (No.3472) off Mitchell Highway, approx. 120 metres North of South Site Boundary – On barbed wire fence	0706 – 1522	1.00	0.0/100	< 0.01
C004660612	Location 2 – Near Southern Boundary (SE Corner) of Site, Adjacent to New Access Road Entry (No. 3410) off Mitchell Highway, approx. 30 metres from South Site Boundary – On barbed wire fence	0715 – 1534	1.00	1.0/100	< 0.01
C004660706	Location 3 – Near Eastern Boundary (near SE Corner) of Site, approx. 70 metres West of Shed, Access Road – On barbed wire fence	0723 – 1533	1.00	0.0/100	< 0.01
C004660543	Location 4 – Near Eastern Boundary (near Centre) of Site, approx. 50 metres West of East Site Boundary – On fencing post	0734 – 1546	1.00	1.0/100	< 0.01

C004852749	Location 5 – Western Boundary of Proposed Quarry Pit (near Western Site Boundary) – On barbed wire fence	0742 – 1557	1.00	0.0/100	< 0.01

Sample Filter No.	Test Type Sample Location	Sample Time Start-Finish	Sampling Rate (avg) (L/min)	Fibres/ Fields	Result(s) Fibres/mL
C004660596	Location 6 – Western Boundary (near NW Corner) of Site – On barbed wire fence	0754 – 1604	1.00	2.0/100	< 0.01
C003740787	Location 7 – Near Northern Boundary of Site (near NE Corner Site) – On fencing post	0803 – 1615	1.00	1.5/100	< 0.01
C004660598	Personal Monitor – S.Lane, 980H – Front end loader	0815 – 1627	1.00	0.0/100	< 0.01
