Asbestos Fibre Air Sampling & Analysis Report

Our Ref: C107605:SO2008732.002 2018-10-02
 Client: Hanson Construction Materials Pty Ltd
 Client Address: Locked Bag 5260, Parramatta NSW 2124
 Attention: Pere Riini - Quarry Manager
 Job Location: East Guyong Quarry, Mitchell Highway, East Guyong NSW 2798
 Report Date: Monday, 8 October 2018
 Analysis Date: Friday, 5 October 2018
 Sampling Date: Tuesday, 2 October 2018
 Sampling Type: Control
 Sampled By: Start: Pere Riini (Hanson) Finish: Pere Riini (Hanson)
 Location of Analysis: Base laboratory - Level 2, 11 Khartoum Road, North Ryde NSW 2113
 Licenced Asbestos Removal Contractor: N/A Notification No: N/A

**Air Monitoring Sampling Plan
East Guyong Quarry Site**

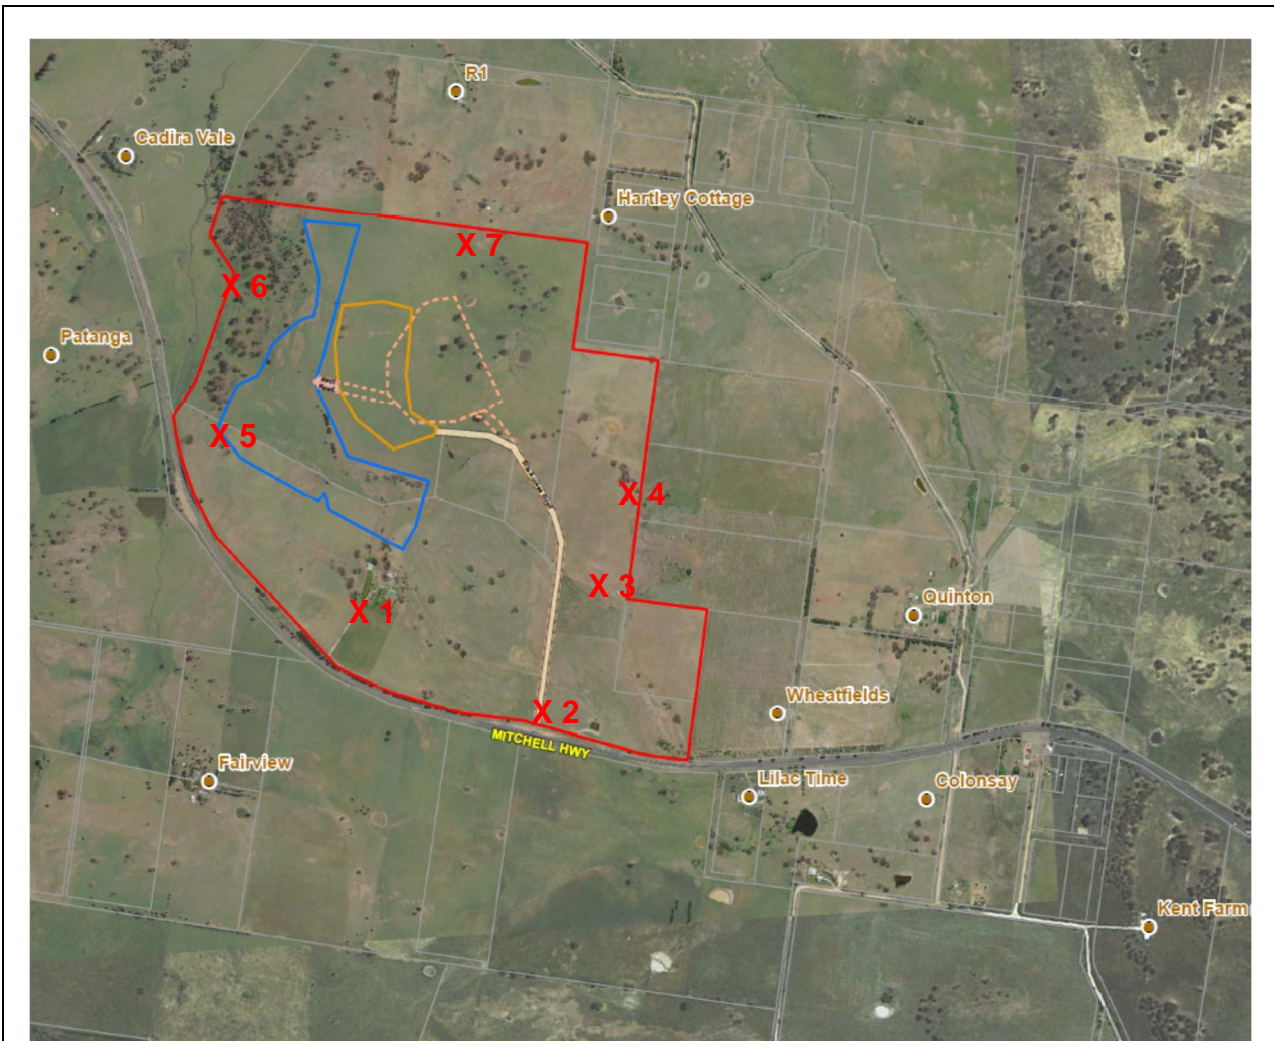
Figure 1 – Air Monitoring Location

Location 1:	709,104mE ; 6300,660mN	Location 5:	708,803mE ; 6301,185mN
Location 2:	709,601mE ; 6300,370mN	Location 6:	708,824mE ; 6301,587mN
Location 3:	709,729mE ; 6300,716mN	Location 7:	709,465mE ; 6301,633mN
Location 4:	709,870mE ; 6300,905mN
