## Asbestos Fibre Air Sampling & Analysis Report

**Our Ref:** C107605:SO2010154.002 2019-04-01  
**Client:** Hanson Construction Materials Pty Ltd  
**Client Address:** Locked Bag 5260, Parramatta NSW 2124  
**Attention:** Pere Riini - Quarry Manager  
**Job Location:** East Guyong Quarry, 3410 Mitchell Highway, East Guyong NSW 2798  
**Report Date:** Wednesday, 10 April 2019  
**Analysis Date:** Monday, 8 April 2019  
**Sampling Date:** Monday, 1 April 2019  
**Sampling Type:** Control  
**Sampled By:** **Start:** Pere Riini (Hanson) **Finish:** Pere Riini (Hanson)  
**Location of Analysis:** Base laboratory - Level 2, 11 Khartoum Road, North Ryde NSW 2113  
**Licensed Asbestos Removal Contractor:** N/A **Notification No:** N/A

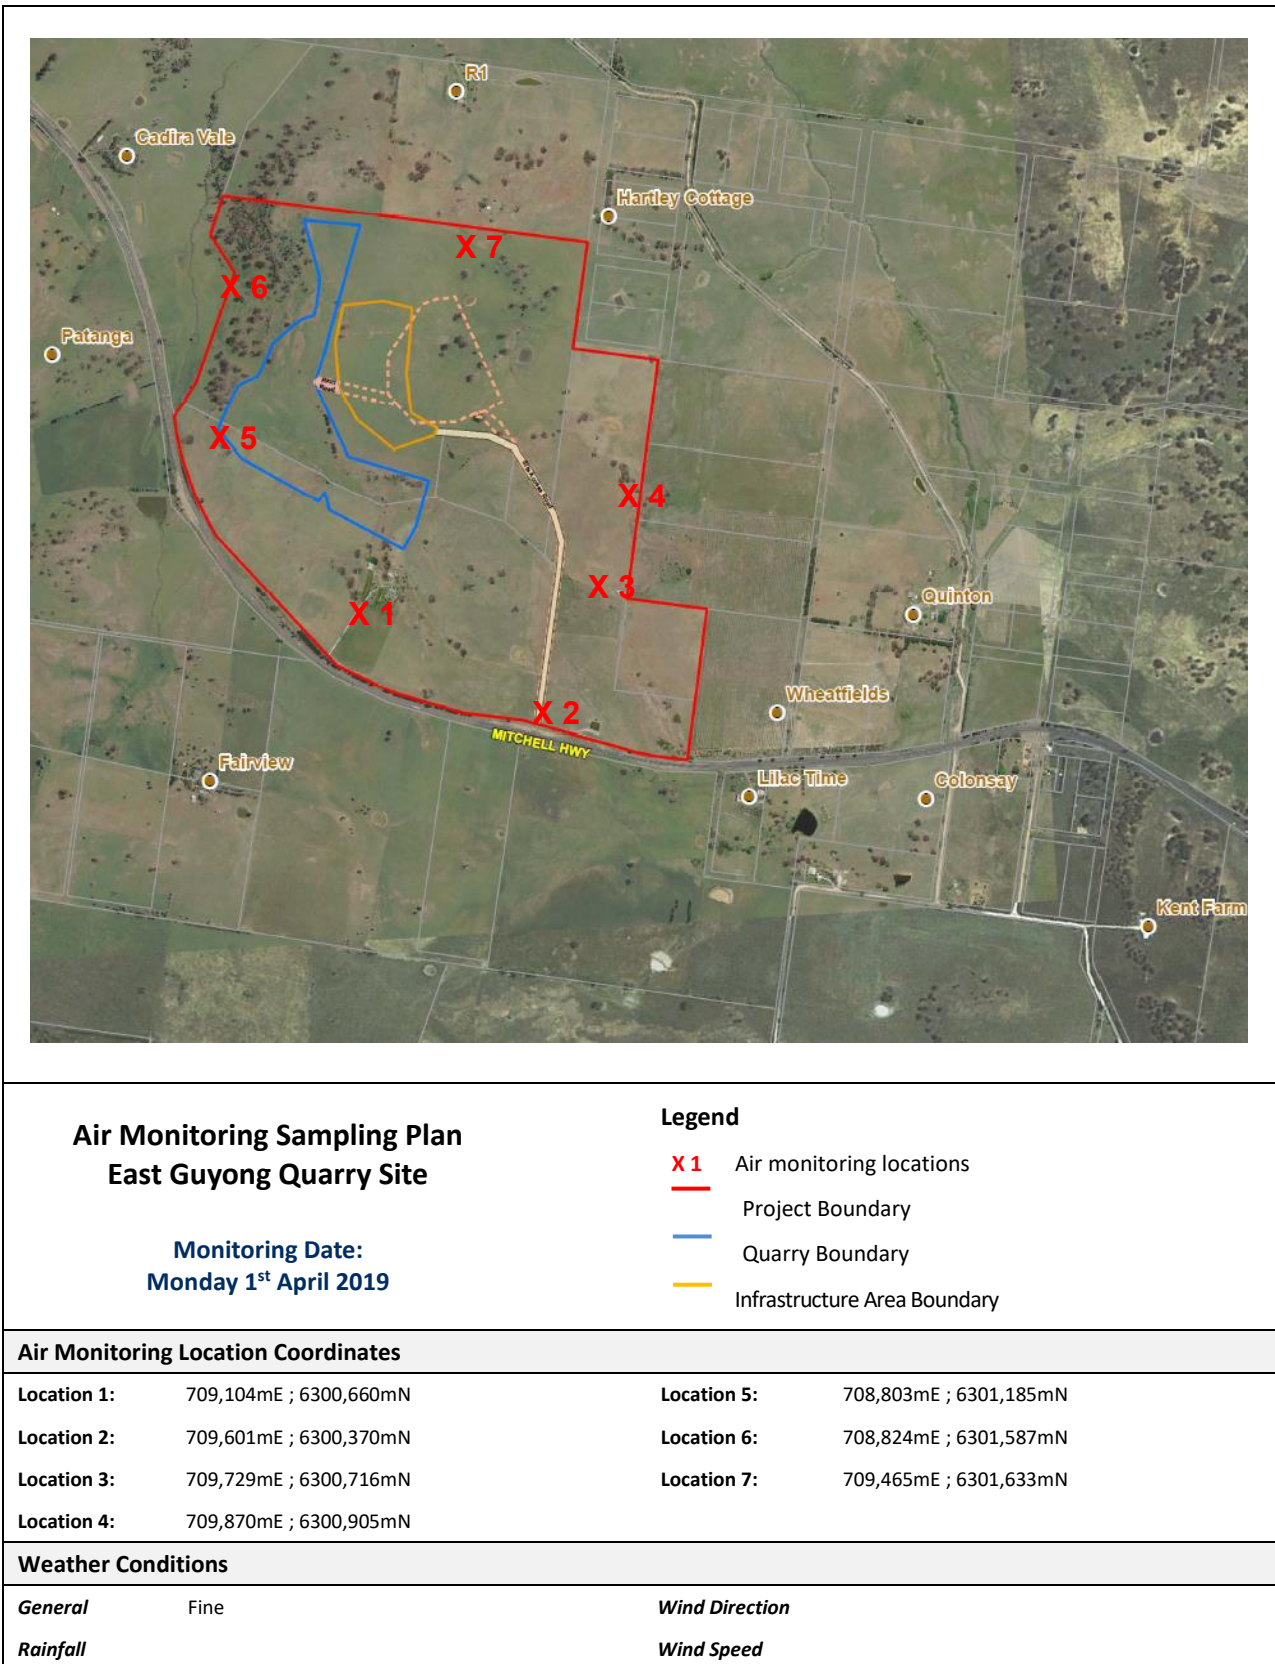
**Figure 1 – Air Monitoring Locations**

Sample Filter No.	Test Type Sample Location	Sample Time Start-Finish	Sampling Rate (avg) (L/min)	Fibres/ Fields	Result(s) Fibres/mL
C005078557	Field Blank (25mm)	–	–	0.0/100	–
Asbestos background – air monitoring throughout various locations across the site					
C005078745	Location 1 – Near Southern Boundary of Site, Access Road to Residence (No.3472) off Mitchell Highway, approx. 120 metres North of South Site Boundary – On barbed wire fence	0701 – 1449	1.00	0.0/100	<0.01
C005078624	Location 2 – Near Southern Boundary (SE Corner) of Site, Adjacent to New Access Road Entry (No. 3410) off Mitchell Highway, approx. 30 metres from South Site Boundary – On barbed wire fence	0712 – 1457	1.00	1.0/100	<0.01
C006212334	Location 3 – Near Eastern Boundary (near SE Corner) of Site, approx. 70 metres West of Shed, Access Road – On barbed wire fence	0721 – 1508	1.00	0.0/100	<0.01
C005078604	Location 4 – Near Eastern Boundary (near Centre) of Site, approx. 50 metres West of East Site Boundary – On fencing post	0729 – 1519	1.00	1.0/100	<0.01

C005078659	Location 5 – Western Boundary of Proposed Quarry Pit (near Western Site Boundary) – On barbed wire fence	0737 – 1524	1.00	1.0/100	<0.01

Sample Filter No.	Test Type Sample Location	Sample Time Start-Finish	Sampling Rate (avg) (L/min)	Fibres/ Fields	Result(s) Fibres/mL
C005078607	Location 6 – Western Boundary (near NW Corner) of Site – On barbed wire fence	0748 – 1536	1.00	0.0/100	<0.01
C005078689	Location 7 – Near Northern Boundary of Site (near NE Corner Site) – On fencing post	0754 – 1547	1.00	0.0/100	<0.01
C005078864	Personal Monitor – PC 450, Excavator – R. Chapman	0810 – 1559	1.00	0.0/100	<0.01
