Asbestos Fibre Air Sampling & Analysis Report

Our Ref: C107605:SO2014738.001 East Guyong Quarry AIR 2020-09-23
Client: Hanson Construction Materials Pty Ltd
Client Address: Locked Bag 5260, Parramatta NSW 2124
Attention: Joshua Coops – Quarry Supervisor
Job Location: East Guyong Quarry, 3410 Mitchell Highway, East Guyong NSW 2798
Report Date: Friday, 25 September 2020
Analysis Date: Friday, 25 September 2020
Sampling Date: Wednesday, 23 September 2020
Sampling Type: Control (Static)
Sampled By: **Start:** Joshua Coops (Hanson) **Finish:** Joshua Coops (Hanson)
Location of Analysis: Base laboratory - Level 2 / 11 Khartoum Road, North Ryde NSW 2113
Licensed Asbestos Removal Contractor: N/A **Notification No:** N/A

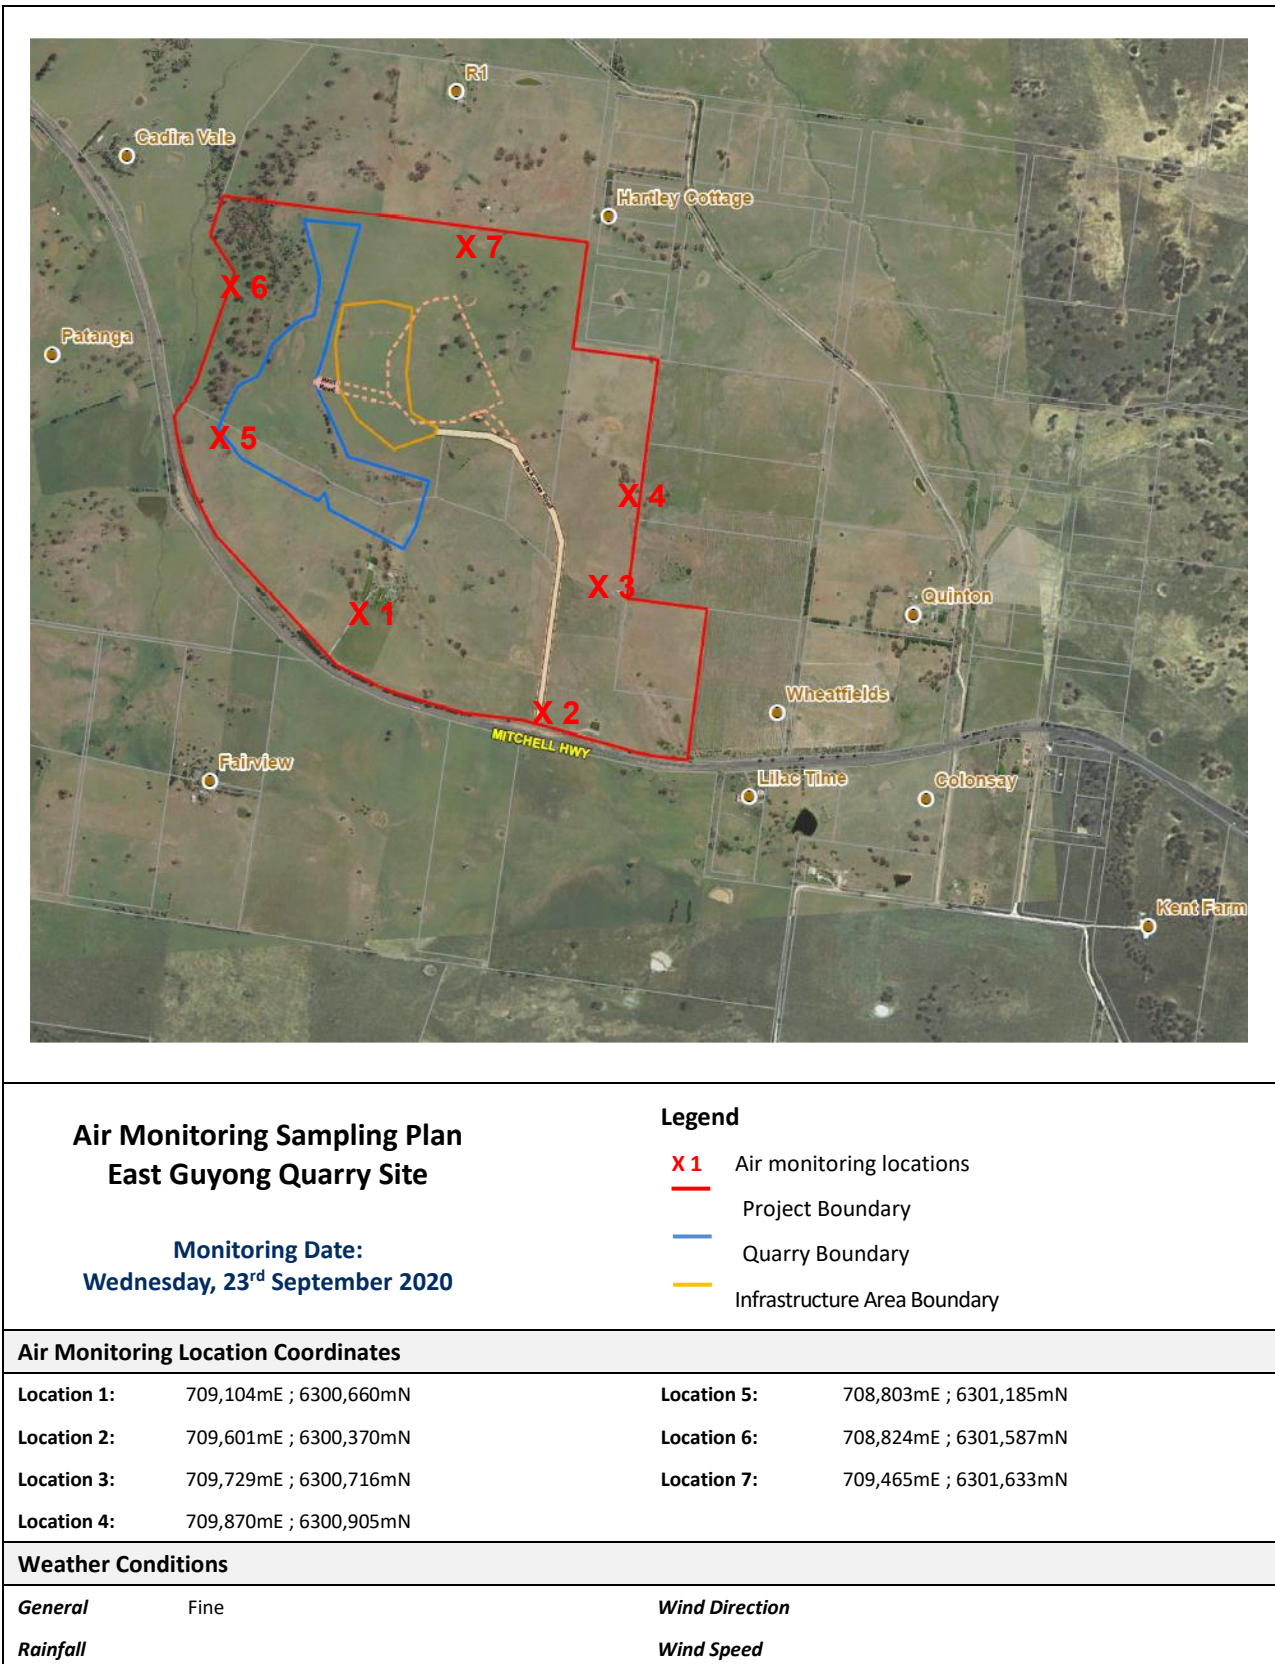
Figure 1 – Air Monitoring Location

Sample Filter No.	Test Type Sample Location	Sampling Period Start-Finish	Sampling Rate (avg) (L/min)	Fibres/ Fields	Result(s) Fibres/mL
00964	Field Blank (25 mm)	–	–	0.0/100	–
Background asbestos fibre air monitoring throughout various locations across the site.					
01002	Location 1 – Near Southern Boundary of Site, Access road to residence (No.3472) off Mitchell Highway, approximately 120 metres, North of South site boundary – On barbed wire fence	0900 – 1442	1.50	2.0/100	< 0.01
00868	Location 2 – Near Southern Boundary (SE Corner) of Site, Adjacent to new access road entry (No. 3410) off Mitchell Highway, approximately 30 metres from South site boundary – On barbed wire fence	0906 – 1446	1.50	1.0/100	< 0.01
00730	Location 3 – Near Eastern Boundary (near Southeast Corner) of site, approximately 70 metres West of shed, Access road – On barbed wire fence	0911 – 1449	1.50	1.0/100	< 0.01
00932	Location 4 – Near Eastern Boundary (near Centre) of site, approximately 50 metres West of East site boundary – On fencing post	0918 – 1453	1.50	1.0/100	< 0.01

76028	Location 5 – Western Boundary of proposed quarry pit (near Western Site Boundary) – On barbed wire fence	0931 – 1503	1.50	0.0/100	< 0.01
00933	Location 6 – Western Boundary (near Northwest Corner) of site – On barbed wire fence	0943 – 1512	1.50	2.0/100	< 0.01

Sample Filter No.	Test Type Sample Location	Sampling Period Start-Finish	Sampling Rate (avg) (L/min)	Fibres/ Fields	Result(s) Fibres/mL
00865	Location 7 – Near Northern Boundary of Site (near Northeast corner site) – On fencing post	0951 – 1527	1.50	3.00/100	< 0.01
