2021-2022 WAGGA WAGGA QUARRY ANNUAL REVIEW

Wagga Wagga Quarry

ANNUAL REVIEW

Name of operation	Wagga Wagga Quarry
Name of operator	Hanson Construction Materials Pty Ltd
Development consent / project approval #	MP 07_0069
Name of holder of development consent / project approval	Hanson Construction Materials Pty Ltd
Water licence #	40BL190719 and 40BL190720 for groundwater extraction of 360 ML/year; and WAL37001 (and the associated Water Supply Works Approvals) entitled the quarry to pump 100 ML/year from the Murrumbidgee River.
Name of holder of water licence	Hanson Construction Materials Pty Ltd
Annual Review start date	1 July 2021
Annual Review end date	30 June 2022

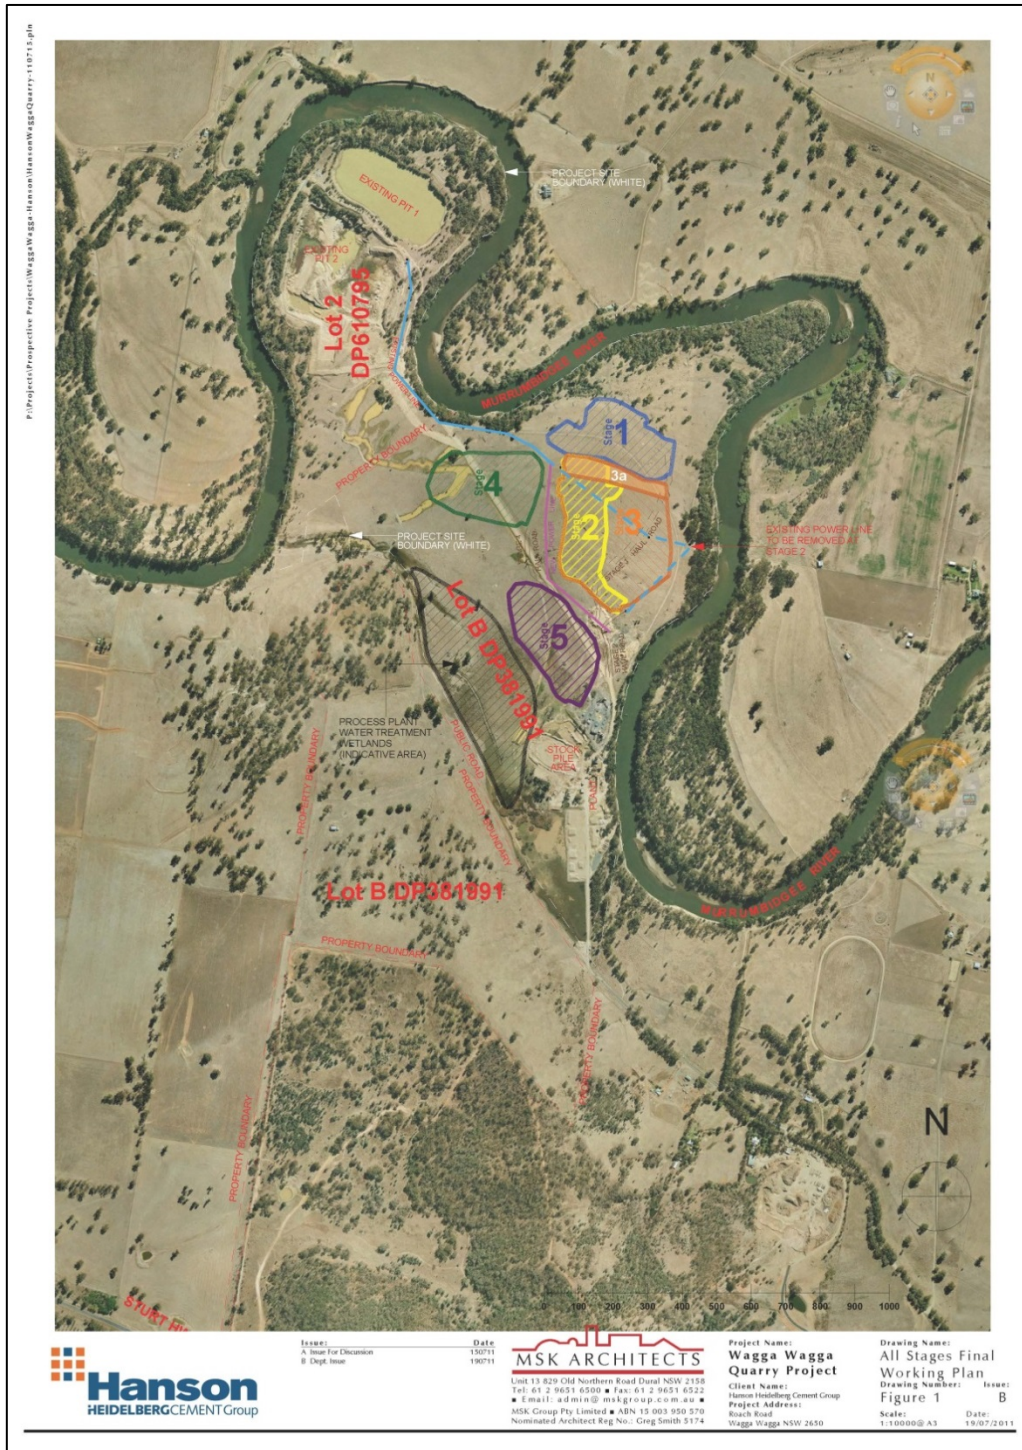
Figure 2: General Project Layout

Figure 2 presents an overview of the Quarry layout at the end of the current reporting period.

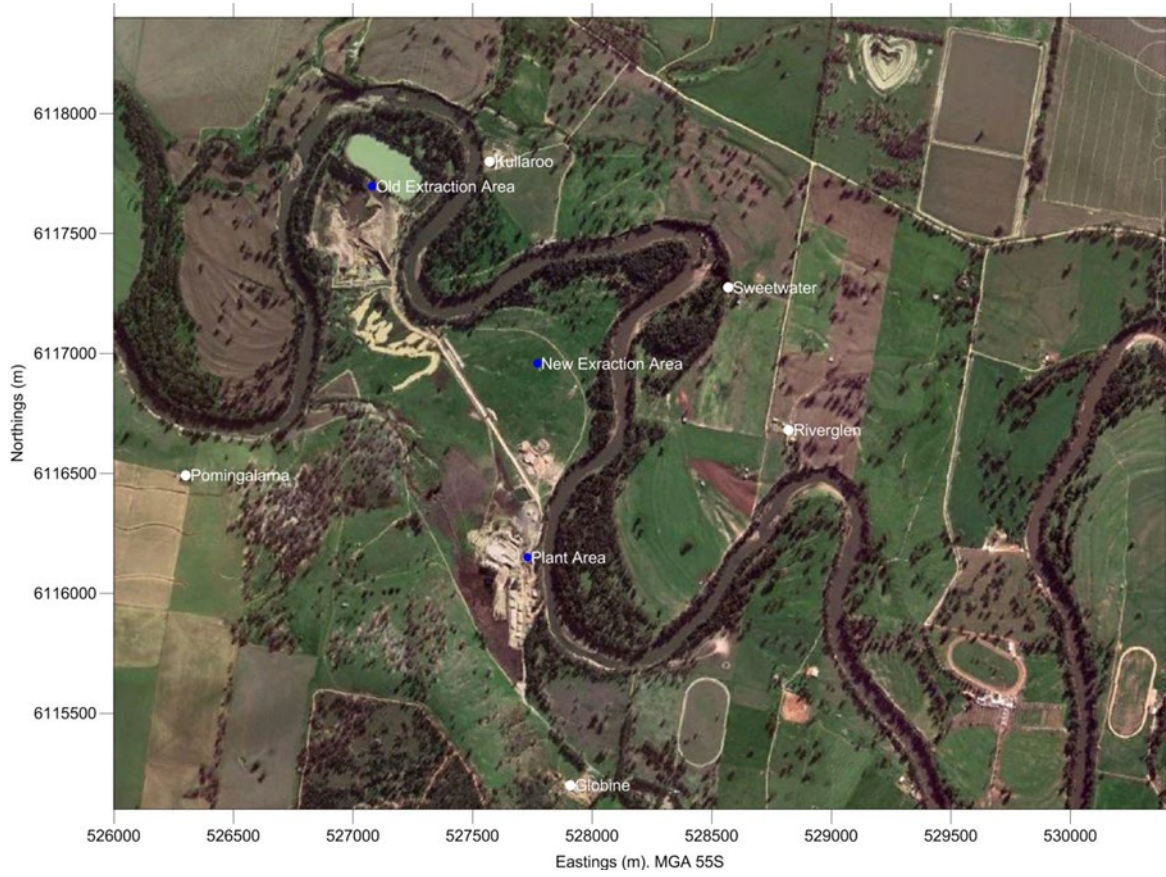
Figure 3: Site Map and Nearest Receivers

Figure 3 and **Figure 4** provide monitoring locations and residences referred to in this section.

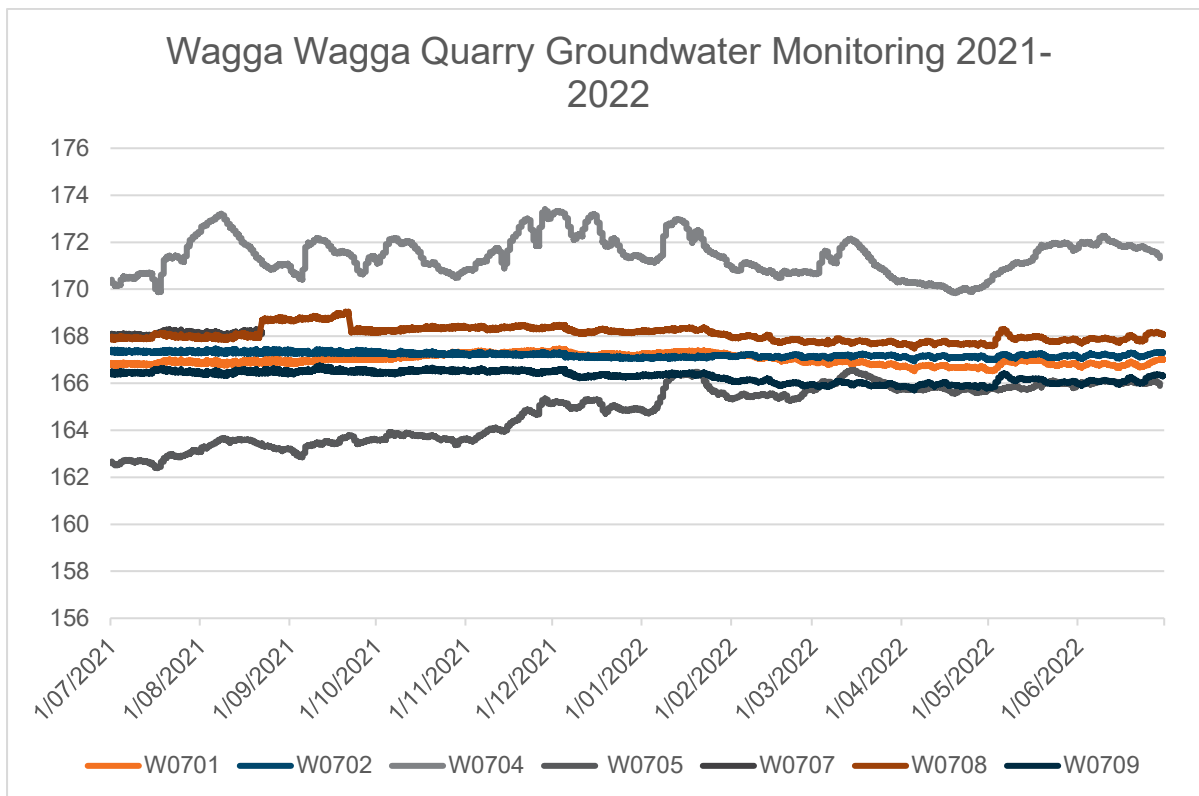
Figure 8: Groundwater Monitoring Bore Results

Groundwater data is recorded hourly using Dipper Logger Heron Software. This data is stored in the Dipper Logger and is collected periodically and uploaded digitally. The compensated water depth (MB GL) of groundwater from the seven monitoring bores is depicted in **Figure 8**.

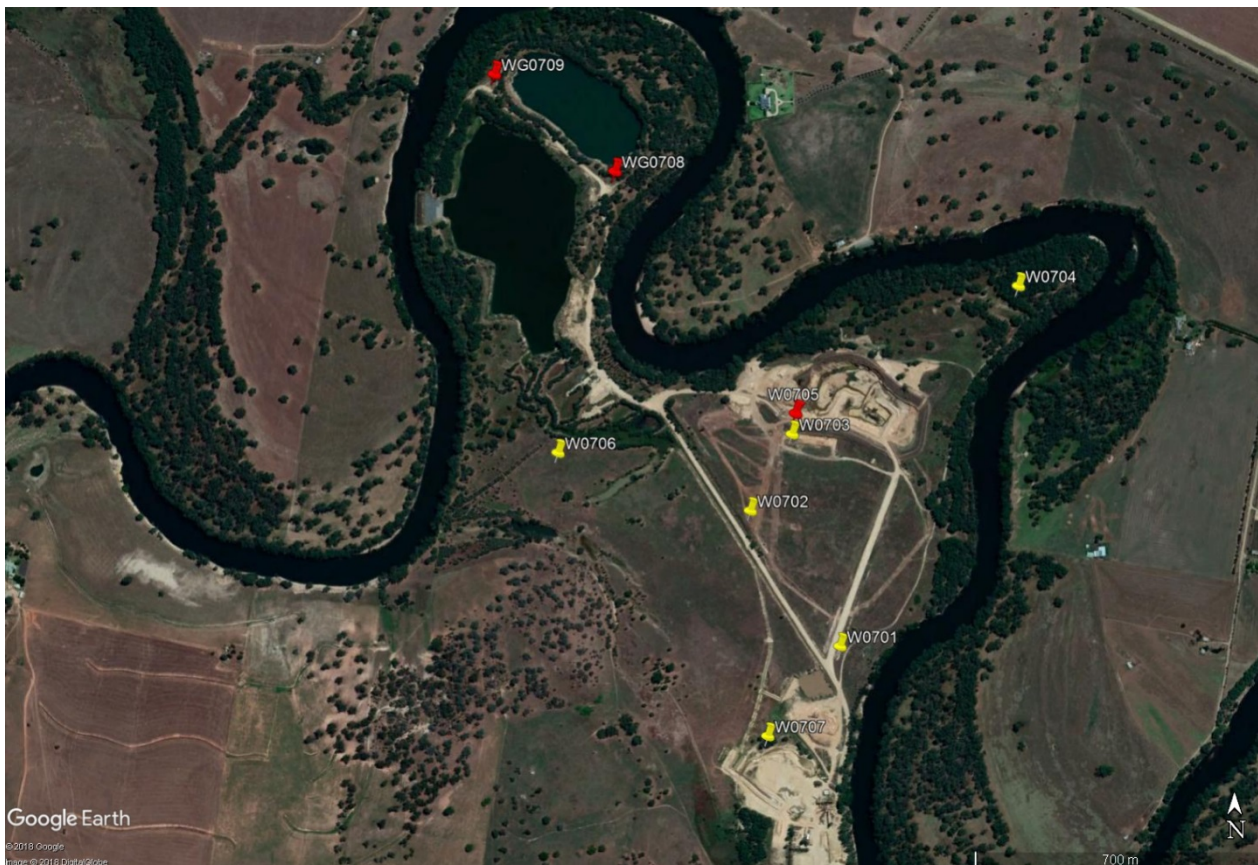
Figure 9: Location of Groundwater Monitoring Bores (no logger in 706)

Wagga Wagga Quarry has seven (7) active borehole water depth loggers located on site collecting and recording continuous water depth and temperature readings. The locations of these monitoring boreholes are depicted in **Figure 7**.
