2022-2023 WAGGA WAGGA QUARRY ANNUAL REVIEW

Wagga Wagga Quarry

ANNUAL REVIEW

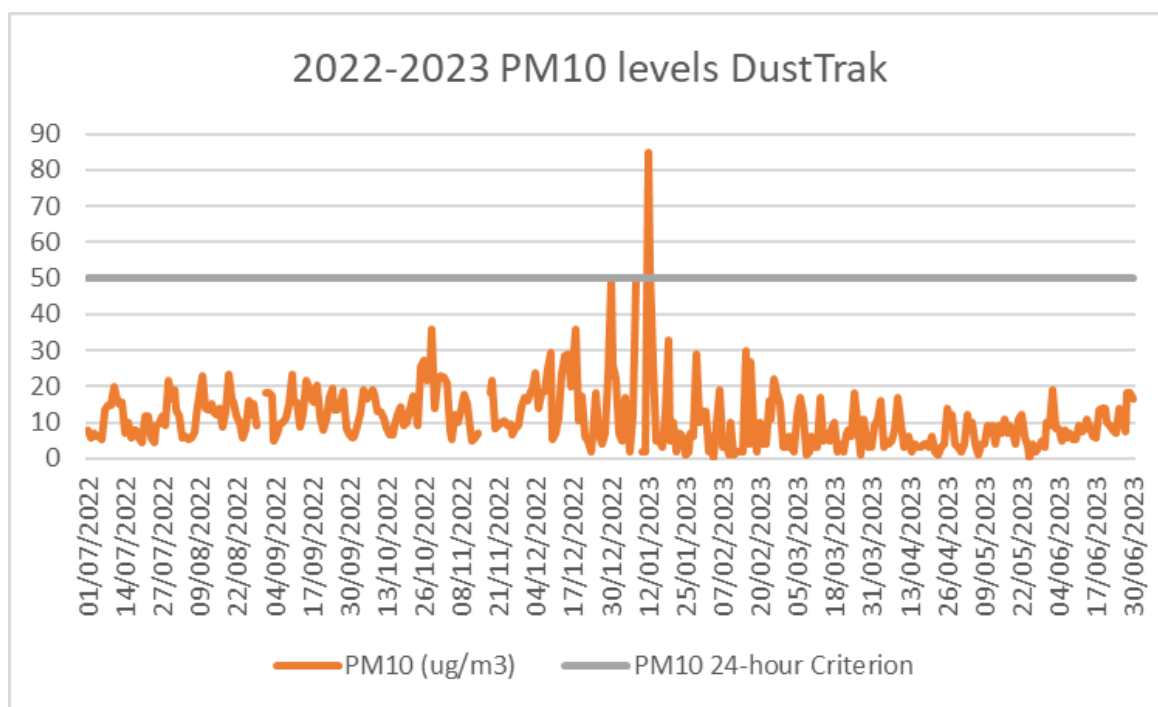
Figure 6: Site PM₁₀ monitoring over the 2022-2023 period.

24-hour averaging period for PM₁₀ readings generally fell below the applicable 50 µg/m³ criterion however there were multiple instances recorded PM₁₀ level for the 24-hour averaging period that were at or just below the criteria of 50 µg/m³. The majority of the instances had the high levels occur outside of site operational hours. This indicates that site air quality management and mitigation during manned hours at the Quarry was reasonable and effective.

Based on this review PM₁₀ emissions have been compliant with the limits established in MP07_0069 and EPL 2433.

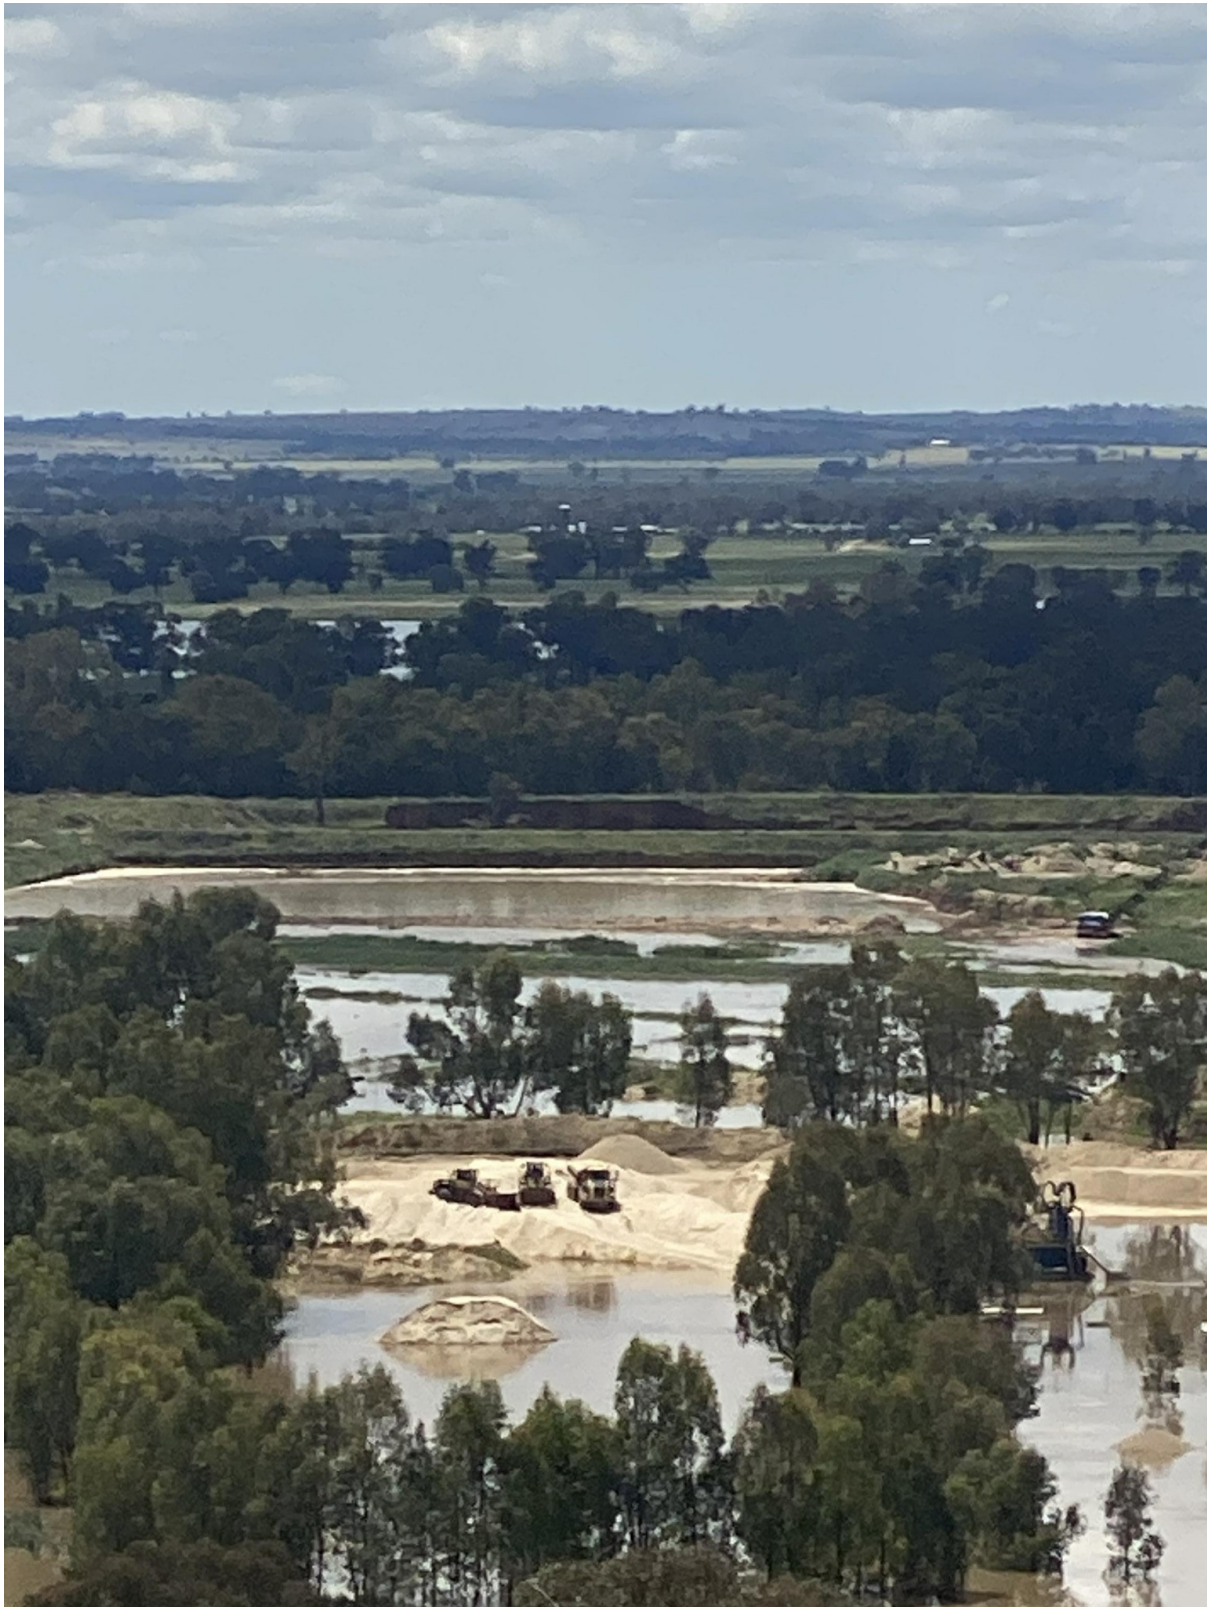
Figure 9: November 2022 Flooding, breach of wall between Cell 1 and Cell 2 (facing North towards active cells and River).

In the flooding event of 2022, the riverbank and fuse plug/spillway of Pit 2 performed as per its design. The wall between Cell 1 and Cell 2 collapsed due to incoming flooding waters. The collapsing wall resulted in loss access to bore 705. There was no breach between Cell 1 and the river, which occurred in 2016.
