## ASBESTOS FIBRE AIR MONITORING REPORT

Our Ref: C107605:J111804.077-20130515

Job Location: East Guyong Quarry, Mitchell Highway, East Guyong NSW

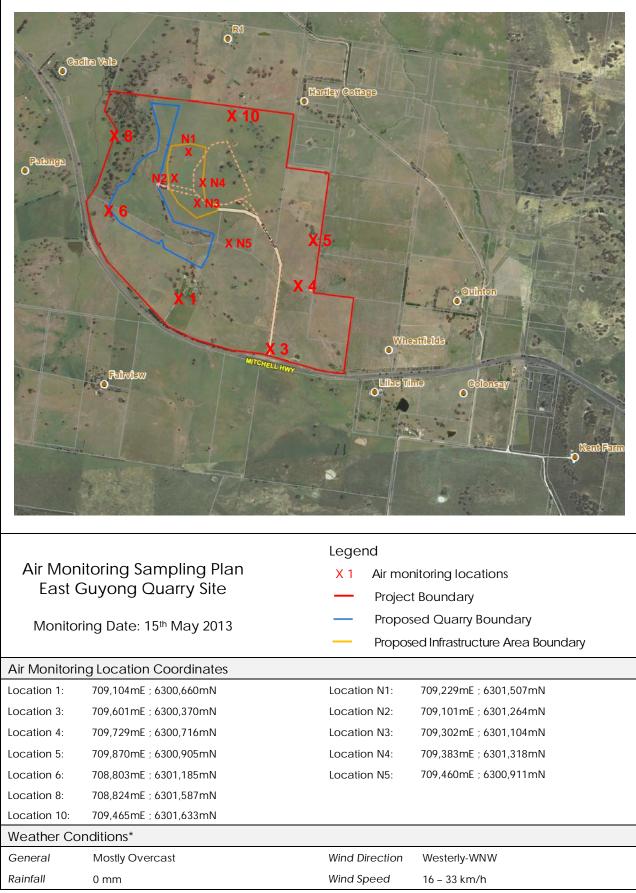
## Figure 1 – Air Monitoring Location

\* East Guyong Quarry Weather Station

Control static monitoring during the scraping of top soil in the Infras	structure Area on the East Guyong
Quarry Site
