## ASBESTOS FIBRE AIR MONITORING REPORT

Our Ref:	C107605:J111804.076-20130514			
Client:	Hanson Construction Materials Pty Lt	d		
Attention:	Martin Gear - Project Manager Aggr	egates		
Job Location:	East Guyong Quarry, Mitchell Highway, East Guyong NSW			
Report Date:	Tuesday 14 May 2013	Test Date:	Tuesday 14 May 2013	
Sampling Proc	edure: Control	Sampled By:	Pumps On: SB Pumps Off: SB

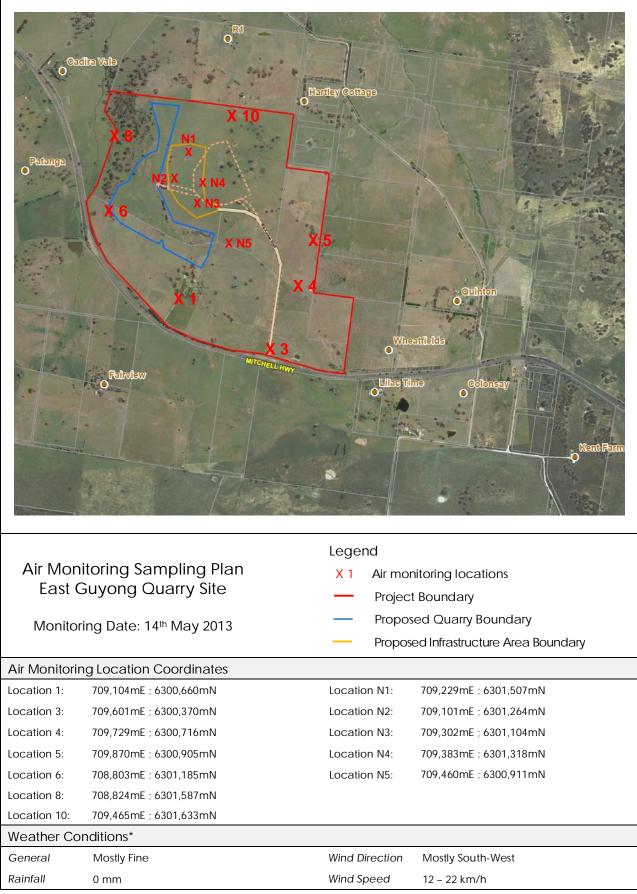
## Figure 1 – Air Monitoring Location

\* East Guyong Quarry Weather Station

3079	Field Blank	_	_	0.0/100	_
3014	Location 1 – Near Southern Boundary of Site, Access Road to Residence (No.3472) off Mitchell Highway, approx. 120 metres North of South Site Boundary – On barbed wire fence	0929 – 1630	1.20	1.0/100	< 0.01
3068	Location 3 – Near Southern Boundary (SE Corner) of Site, Adjacent to New Access Road Entry (No.3410) off Mitchell Highway, approx. 30 metres from South Site Boundary – On barbed wire fence	0934 – 1546	1.25	0.0/100	< 0.01
3012	Location 4 – Near Eastern Boundary (near SE Corner) of Site, approx. 70 metres West of Shed, Access Road – On barbed wire fence	0937 - 1550	1.20	0.0/100	< 0.01
3022	Location 5 – Near Eastern Boundary (near Centre) of Site, approx. 50 metres West of East Site Boundary – On fencing post	0941 - 1553	1.20	0.0/100	< 0.01
3058	Location 6 – Western Boundary of Proposed Quarry Pit (near Western Site Boundary) – On barbed wire fence	0953 - 1610	1.20	0.0/100	< 0.01
