ASBESTOS FIBRE AIR MONITORING REPORT

Our Ref:	C107605:J111804.087-20130603					
Client:	Hanson Construction Materials Pty Ltd					
Attention:	Martin Gear - Project Manager Aggregates					
Job Location:	D Location: East Guyong Quarry, Mitchell Highway, East Guyong NSW					
Report Date:	Wednesday 5 June 2013	Test Date:	Monday 3 June 2013			
Sampling Proc	cedure: Control	Sampled By:	Pumps On: Pere Riini (Hanson) Pumps Off: Pere Riini (Hanson)

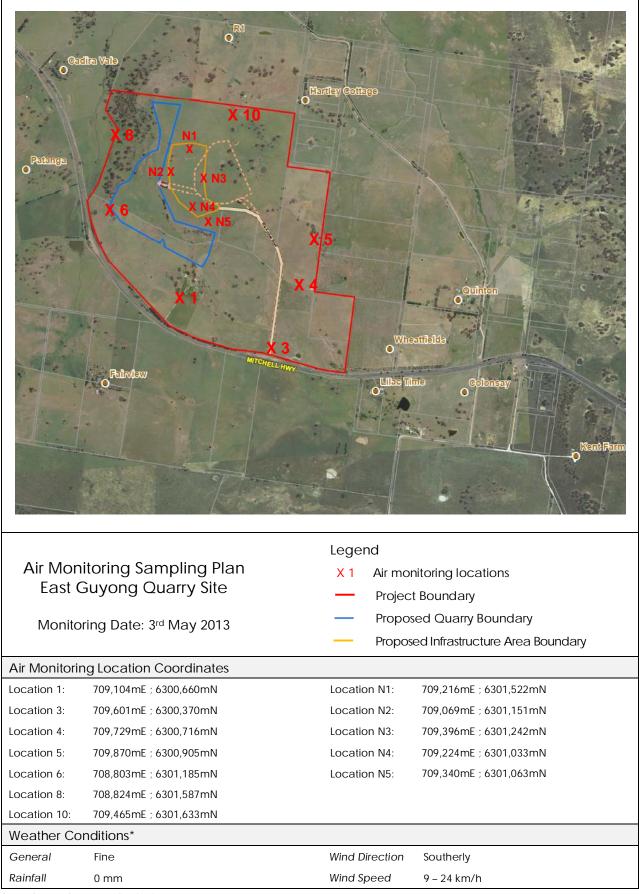
Figure 1 – Air Monitoring Location

* East Guyong Quarry Weather Station

Filter No.	Test Type Sample Location	Sample Period Start-Finish	Average Flow Rate (L/min)	Fibres/ Fields	Result(s) Fibres/mL		
Control static monitoring during the excavation of soil in the Infrastructure Area on the East Guyong Quarry Site							
647	Field Blank	-	-	0.0/100	-		
453	Location 1 – Near Southern Boundary of Site, Access Road to Residence (No.3472) off Mitchell Highway, approx. 120 metres North of South Site Boundary – On barbed wire fence	0752 – 1415	1.00	0.0/100	< 0.01		
3099	Location 3 – Near Southern Boundary (SE Corner) of Site, Adjacent to New Access Road Entry (No.3410) off Mitchell Highway, approx. 30 metres from South Site Boundary – On barbed wire fence	0755 – 1418	1.00	0.0/100	< 0.01		
2178	Location 4 – Near Eastern Boundary (near SE Corner) of Site, approx. 70 metres West of Shed, Access Road – On barbed wire fence	0758 - 1421	1.00	0.0/100	< 0.01		
2152A	Location 5 – Near Eastern Boundary (near Centre) of Site, approx. 50 metres West of East Site Boundary – On fencing post	0801 - 1425	1.00	0.0/100	< 0.01

1223	Location 6 – Western Boundary of Proposed Quarry Pit (near Western Site Boundary) – On barbed wire fence	0806 - 1431	1.00	0.0/100	< 0.01		
2115	Location 8 – Western Boundary (near NW Corner) of Site – On barbed wire fence	0809 – 1434	1.00	0.0/100	< 0.01		
3084	Location 10 – Near Northern Boundary of Site (near NE Corner Site) – On fencing post	0814 - 1440	1.00	0.0/100	< 0.01
