## ASBESTOS FIBRE AIR MONITORING REPORT

Our Ref:	C107605:J111804.090-20130606					
Client:	Hanson Construction Materials Pty Ltd					
Attention:	Martin Gear - Project Manager Aggr	egates				
Job Location:	n: East Guyong Quarry, Mitchell Highway, East Guyong NSW					
Report Date:	Friday 7 June 2013	Test Date:	Thursday 6 June 2013			
Sampling Procedure: Control		Sampled By:	Pumps On: Pere Riini (Hanson)

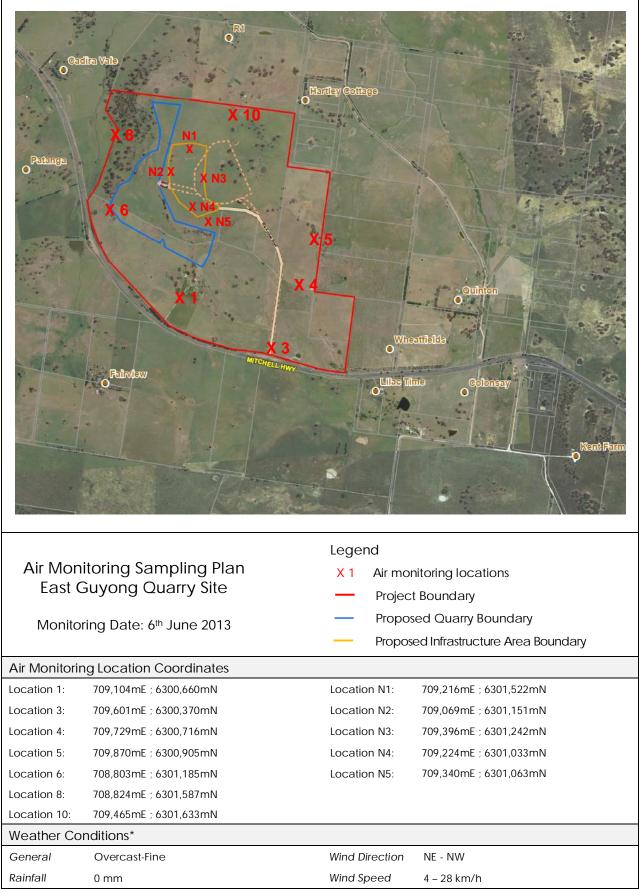
## Figure 1 – Air Monitoring Location

Filter No.	Test Type Sample Location	Sample Period Start-Finish	Average Flow Rate (L/min)	Fibres/ Fields	Result(s) Fibres/mL		
Control static monitoring during the excavation of soil in the Infrastructure Area on the East Guyong Quarry Site							
1310	Field Blank	-	-	0.0/100	-		
3064	Location 1 – Near Southern Boundary of Site, Access Road to Residence (No.3472) off Mitchell Highway, approx. 120 metres North of South Site Boundary – On barbed wire fence	0745 – 1345	1.00	0.0/100	< 0.01		
640	Location 3 – Near Southern Boundary (SE Corner) of Site, Adjacent to New Access Road Entry (No.3410) off Mitchell Highway, approx. 30 metres from South Site Boundary – On barbed wire fence	0748 – 1348	1.00	0.0/100	< 0.01		
2262	Location 4 – Near Eastern Boundary (near SE Corner) of Site, approx. 70 metres West of Shed, Access Road – On barbed wire fence	0752 - 1352	1.00	1.0/100	< 0.01		
2146A	Location 5 – Near Eastern Boundary (near Centre) of Site, approx. 50 metres West of East Site Boundary – On fencing post	0755 - 1355	1.00	0.0/100	< 0.01
