ASBESTOS FIBRE AIR MONITORING REPORT

Our Ref:	C107605:J111804.155-20131010				
Client:	Hanson Construction Materials Pty Lt	td			
Attention:	Martin Gear - Project Manager Aggregates				
Job Location: East Guyong Quarry, Mitchell Highway, East Guyong NSW					
Report Date:	Wednesday 16 October 2013	Test Date:	Thursday 10 October 2013		
Sampling Proc	cedure: Control	Sampled By:	Pumps On: Pere Riini (Hanson) Pumps Off: Pere Riini (Hanson)

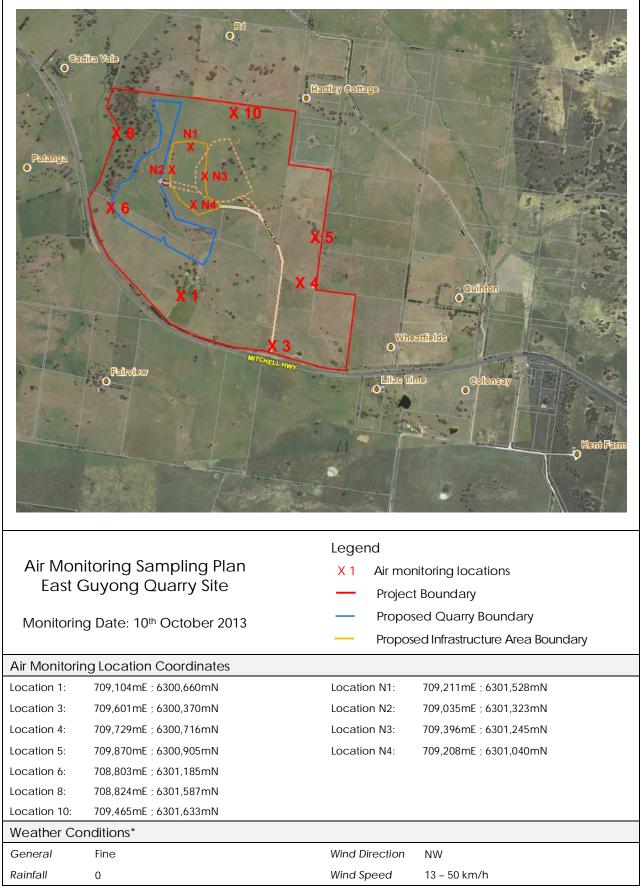
Figure 1 – Air Monitoring Location

Filter No.	Test Type Sample Location	Sample Period Start-Finish	Average Flow Rate (L/min)	Fibres/ Fields	Result(s) Fibres/mL		
Control/static monitoring during earthworks in the Infrastructure Area on the East Guyong Quarry Site							
169956	Field Blank	-	-	0.0/100	-		
167674	Location 1 – Near Southern Boundary of Site, Access Road to Residence (No.3472) off Mitchell Highway, approx. 120 metres North of South Site Boundary – On barbed wire fence	0703 – 1332	1.00	1.0/100	< 0.01		
167853	Location 3 – Near Southern Boundary (SE Corner) of Site, Adjacent to New Access Road Entry (No.3410) off Mitchell Highway, approx. 30 metres from South Site Boundary – On barbed wire fence	0706 – 1335	1.00	0.0/100	< 0.01		
167671	Location 4 – Near Eastern Boundary (near SE Corner) of Site, approx. 70 metres West of Shed, Access Road – On barbed wire fence	0709 – 1338	1.00	0.5/100	< 0.01		
167677	Location 5 – Near Eastern Boundary (near Centre) of Site, approx. 50 metres West of East Site Boundary – On fencing post	0712 – 1341	1.00	1.0/100	< 0.01

167675	Location 6 – Western Boundary of Proposed Quarry Pit (near Western Site Boundary) – On barbed wire fence	0717 – 1346	1.00	0.0/100	< 0.01		
167888	Location 8 – Western Boundary (near NW Corner) of Site – On barbed wire fence	0720 – 1349	1.00	0.5/100	< 0.01		
167672	Location 10 – Near Northern Boundary of Site (near NE Corner Site) – On fencing post	0722 – 1355	1.00	0.0/100	< 0.01
