ASBESTOS FIBRE AIR MONITORING REPORT

Our Ref:	C107605:J111804.162-20131021					
Client:	Hanson Construction Materials Pty Ltd					
Attention:	Martin Gear - Project Manager Aggregates					
Job Location:	: East Guyong Quarry, Mitchell Highway, East Guyong NSW					
Report Date:	Thursday 24 October 2013	Test Date:	Monday 21 October 2013			
Sampling Proc	cedure: Control	Sampled By:	Pumps On: Pere Riini (Hanson) Pumps Off: Pere Riini (Hanson)

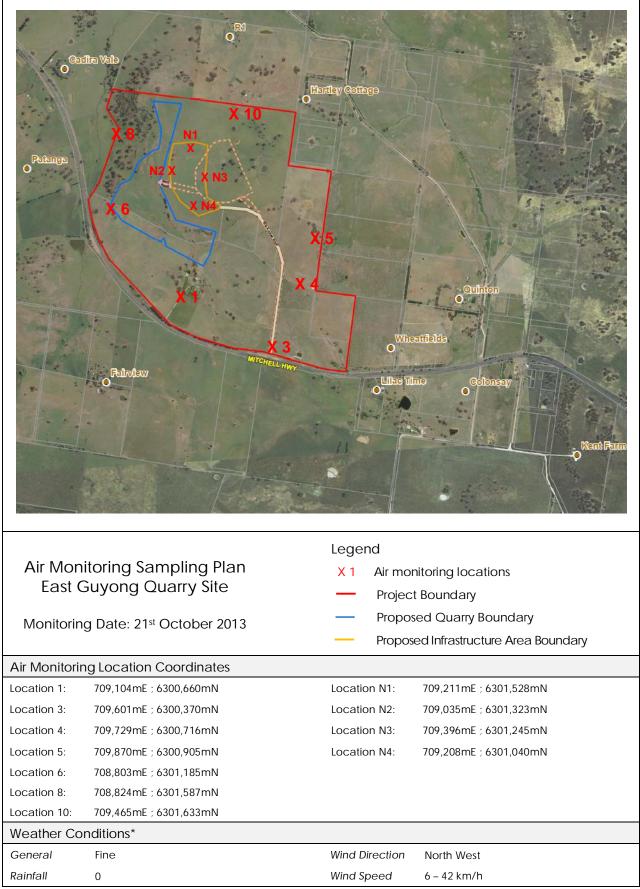
Figure 1 – Air Monitoring Location

* East Guyong Quarry Weather Station

Filter No.	Test Type Sample Location	Sample Period Start-Finish	Average Flow Rate (L/min)	Fibres/ Fields	Result(s) Fibres/mL		
Control/static monitoring during earthworks in the Infrastructure Area on the East Guyong Quarry Site							
167052	Field Blank	-	-	0.0/100	-		
167604	Location 1 – Near Southern Boundary of Site, Access Road to Residence (No.3472) off Mitchell Highway, approx. 120 metres North of South Site Boundary – On barbed wire fence	0723 – 1421	1.00	1.0/100	< 0.01		
167491	Location 3 – Near Southern Boundary (SE Corner) of Site, Adjacent to New Access Road Entry (No.3410) off Mitchell Highway, approx. 30 metres from South Site Boundary – On barbed wire fence	0726 – 1424	1.00	0.0/100	< 0.01		
167347	Location 4 – Near Eastern Boundary (near SE Corner) of Site, approx. 70 metres West of Shed, Access Road – On barbed wire fence	0729 – 1427	1.00	0.0/100	< 0.01		
167667	Location 5 – Near Eastern Boundary (near Centre) of Site, approx. 50 metres West of East Site Boundary – On fencing post	0732 – 1430	1.00	0.0/100	< 0.01

167595	Location 6 – Western Boundary of Proposed Quarry Pit (near Western Site Boundary) – On barbed wire fence	0737 – 1433	1.00	0.0/100	< 0.01		
166991	Location 8 – Western Boundary (near NW Corner) of Site – On barbed wire fence	0740 – 1436	1.00	0.0/100	< 0.01		
167224	Location 10 – Near Northern Boundary of Site (near NE Corner Site) – On fencing post	0746 – 1447	1.00	1.0/100	< 0.01
