## ASBESTOS FIBRE AIR MONITORING REPORT

Our Ref:	C107605:J111804.164-20131023					
Client:	Hanson Construction Materials Pty Lt	d				
Attention:	Martin Gear - Project Manager Aggregates					
Job Location:	Job Location: East Guyong Quarry, Mitchell Highway, East Guyong NSW					
Report Date:	Monday 28 October 2013	Test Date:	Wednesday 23 October 2013			
Sampling Proc	cedure: Control	Sampled By:	Pumps On: Pere Riini (Hanson) Pumps Off: Pere Riini (Hanson)

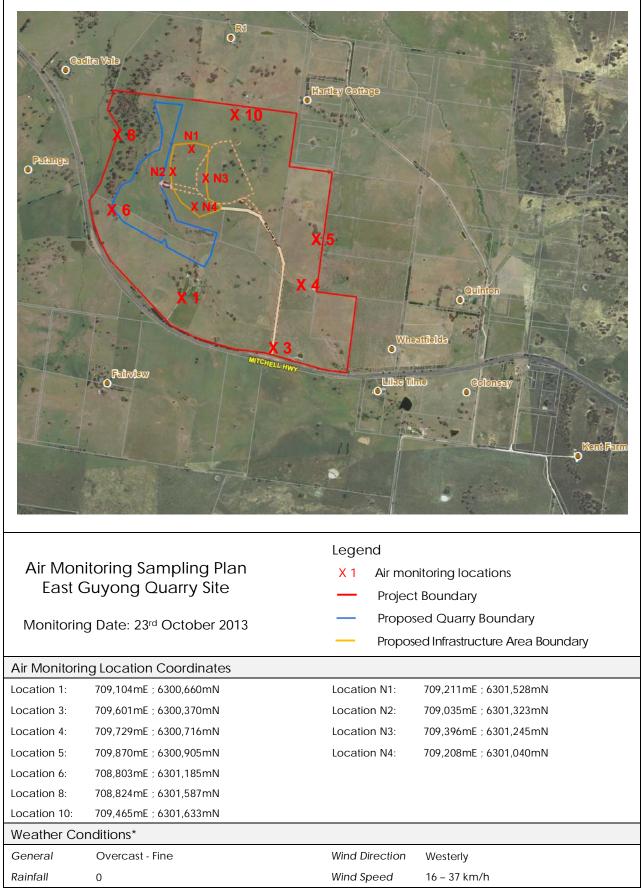
## Figure 1 – Air Monitoring Location

\* East Guyong Quarry Weather Station

Filter No.	Test Type Sample Location	Sample Period Start-Finish	Average Flow Rate (L/min)	Fibres/ Fields	Result(s) Fibres/mL		
Control/static monitoring during earthworks in the Infrastructure Area on the East Guyong Quarry Site							
210112	Field Blank	-	-	0.0/100	-		
215924	Location 1 – Near Southern Boundary of Site, Access Road to Residence (No.3472) off Mitchell Highway, approx. 120 metres North of South Site Boundary – On barbed wire fence	0712 – 1401	1.00	0.0/100	< 0.01		
215933	Location 3 – Near Southern Boundary (SE Corner) of Site, Adjacent to New Access Road Entry (No.3410) off Mitchell Highway, approx. 30 metres from South Site Boundary – On barbed wire fence	0715 – 1404	1.00	0.0/100	< 0.01		
210328	Location 4 – Near Eastern Boundary (near SE Corner) of Site, approx. 70 metres West of Shed, Access Road – On barbed wire fence	0718 – 1407	1.00	0.0/100	< 0.01		
210249	Location 5 – Near Eastern Boundary (near Centre) of Site, approx. 50 metres West of East Site Boundary – On fencing post	0721 – 1410	1.00	0.0/100	< 0.01
