ASBESTOS FIBRE AIR MONITORING REPORT

Our Ref:	C107605:J111804.178-20131112				
Client:	Hanson Construction Materials Pty Lt	td			
Attention:	Martin Gear - Project Manager Aggregates				
Job Location: East Guyong Quarry, Mitchell Highway, East Guyong NSW					
Report Date:	Friday 15 November 2013	Test Date:	Tuesday 12 November 2013		
Sampling Proc	cedure: Control	Sampled By:	Pumps On: Pere Riini (Hanson) Pumps Off: Pere Riini (Hanson)

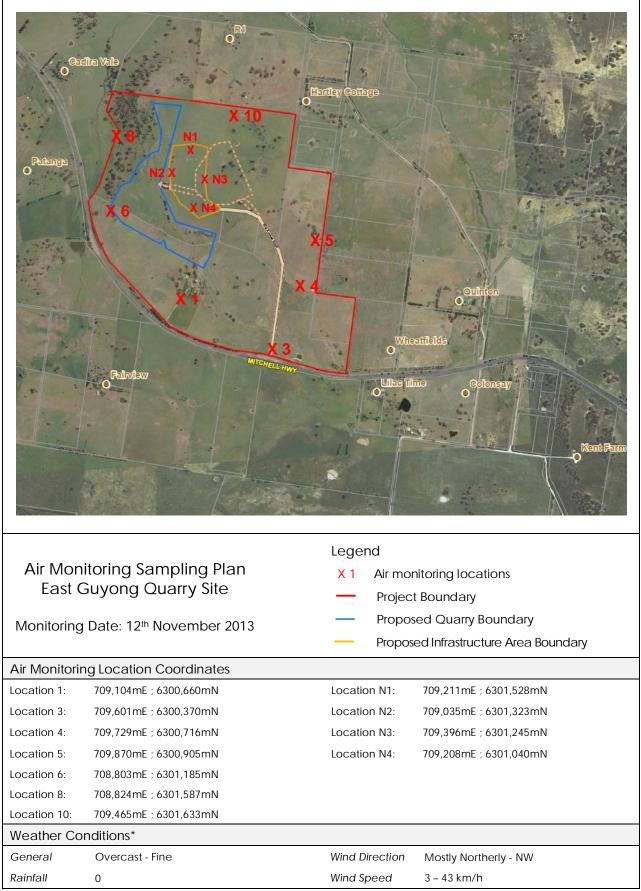
Figure 1 – Air Monitoring Location

* East Guyong Quarry Weather Station

Filter No.	Test Type Sample Location	Sample Period Start-Finish	Average Flow Rate (L/min)	Fibres/ Fields	Result(s) Fibres/mL		
Control/static monitoring during earthworks in the Infrastructure Area on the East Guyong Quarry Site							
166953	Field Blank	-	-	0.0/100	-		
167651	Location 1 – Near Southern Boundary of Site, Access Road to Residence (No.3472) off Mitchell Highway, approx. 120 metres North of South Site Boundary – On barbed wire fence	0702 – 1331	1.00	0.0/100	< 0.01		
166936	Location 3 – Near Southern Boundary (SE Corner) of Site, Adjacent to New Access Road Entry (No.3410) off Mitchell Highway, approx. 30 metres from South Site Boundary – On barbed wire fence	0705 – 1334	1.00	0.0/100	< 0.01		
167564	Location 4 – Near Eastern Boundary (near SE Corner) of Site, approx. 70 metres West of Shed, Access Road – On barbed wire fence	0708 – 1337	1.00	1.0/100	< 0.01		
166930	Location 5 – Near Eastern Boundary (near Centre) of Site, approx. 50 metres West of East Site Boundary – On fencing post	0711 – 1340	1.00	0.0/100	< 0.01

166932	Location 6 – Western Boundary of Proposed Quarry Pit (near Western Site Boundary) – On barbed wire fence	0716 – 1343	1.00	0.0/100	< 0.01		
166915	Location 8 – Western Boundary (near NW Corner) of Site – On barbed wire fence	0719 – 1346	1.00	4.0/100	< 0.01		
166980	Location 10 – Near Northern Boundary of Site (near NE Corner Site) – On fencing post	0725 – 1352	1.00	0.0/100	< 0.01
