Asbestos Fibre Air Monitoring Report

Our Ref: C107605:J111804.198-20141118
Client: Hanson Construction Materials Pty Ltd

Job Location: East Guyong Quarry, Mitchell Highway, East Guyong NSW

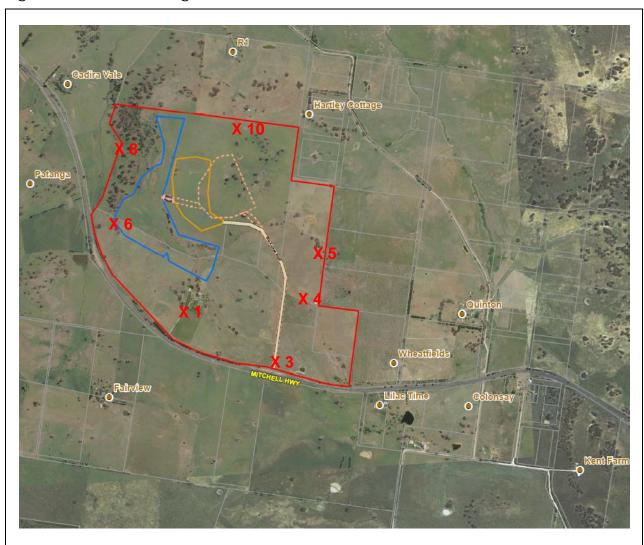
Air Monitoring Sampling Plan East Guyong Quarry Site

Monitoring Date: 18th November 2014

CK194798	Location 6 – Western Boundary of Proposed Quarry Pit (near Western Site Boundary) – On barbed wire fence	0748 – 1436	1.00	1.0/100	< 0.01
