Asbestos Fibre Air Monitoring Report

Our Ref: C107605:SO2001810.002-20160601
 Client: Hanson Construction Materials Pty Ltd
 Client Address: Locked Bag 5260
 Parramatta NSW 2124
 Attention: Pere Riini - Quarry Manager
 Job Location: East Guyong Quarry, Mitchell Highway, East Guyong NSW
 Report Date: Thursday 9th June 2016
 Test Date: Wednesday 1st June 2016
 Sampling Type: Control
 Sampled By: Pumps On: Pere Riini (Hanson)
 Pumps Off: Pere Riini (Hanson)

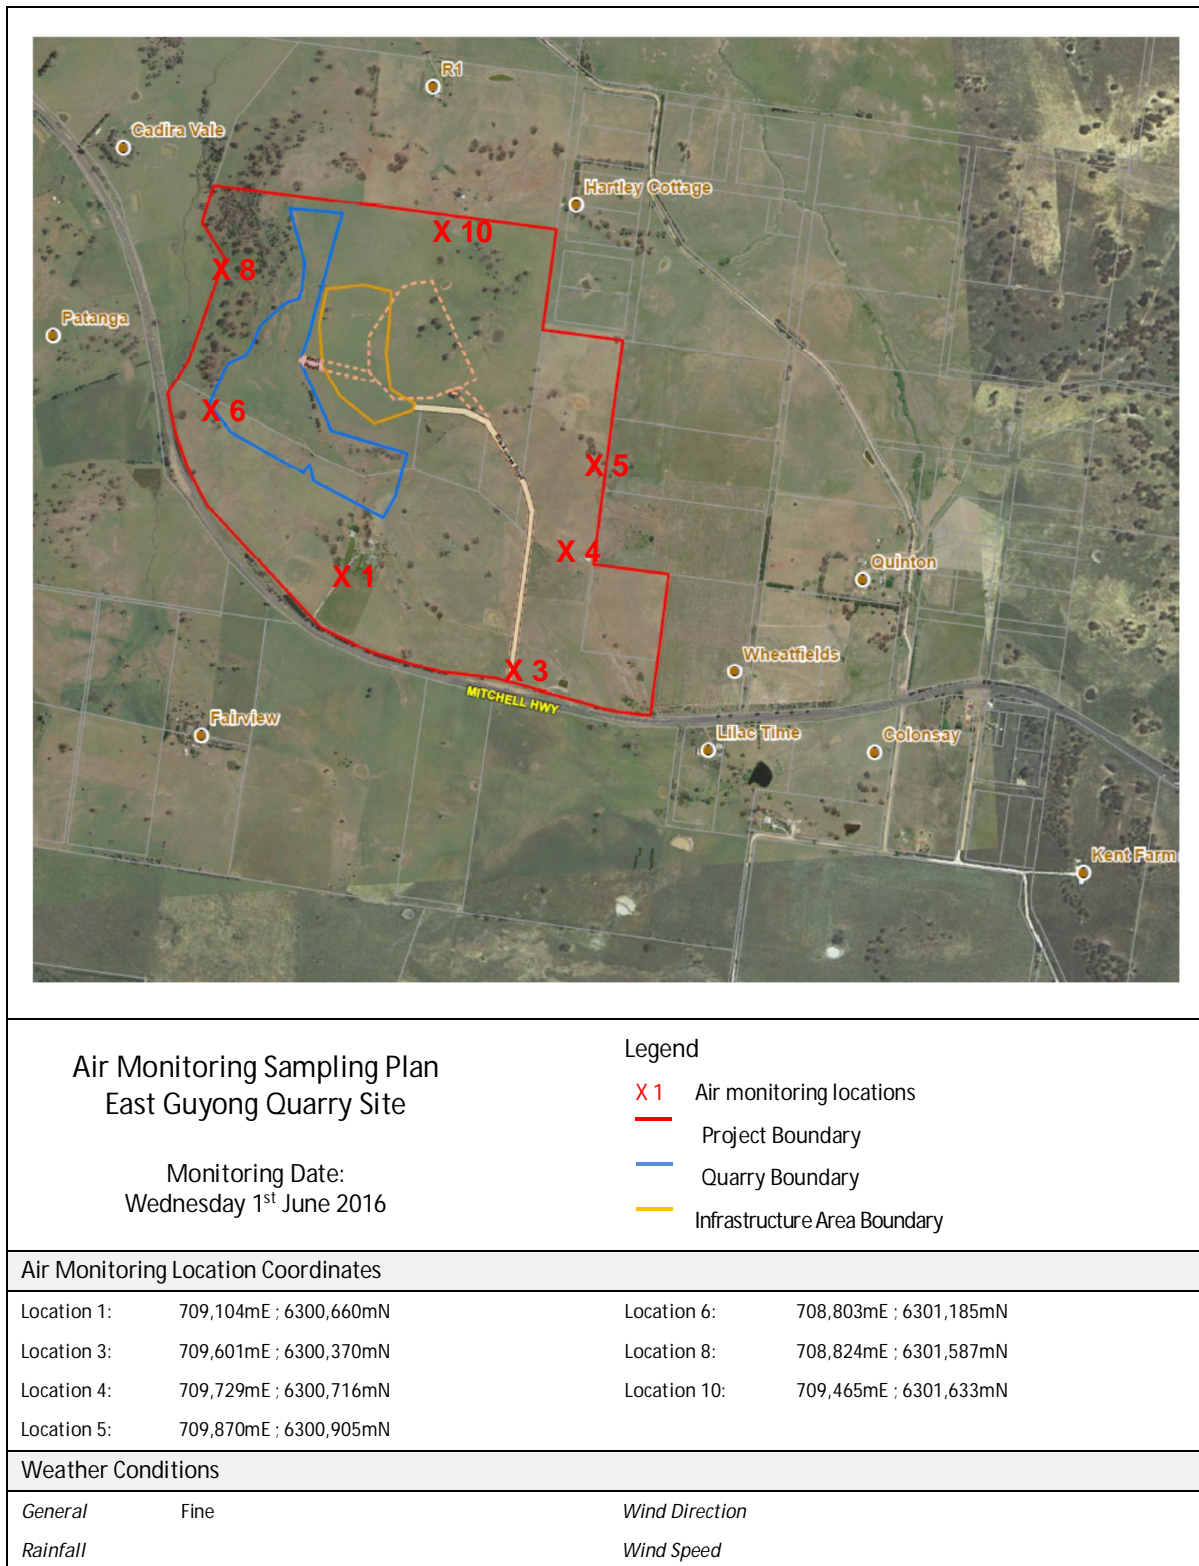
Figure 1 – Air Monitoring Location

Filter No.	Test Type Sample Location	Sample Period Start-Finish	Average Flow Rate (L/min)	Fibres/ Fields	Result(s) Fibres/mL
Background asbestos air monitoring throughout various locations across the site					
19612575	Field Blank	–	–	0.0/100	–
19612614	Location 1 – Near Southern Boundary of Site, Access Road to Residence (No.3472) off Mitchell Highway, approx. 120 metres North of South Site Boundary – On barbed wire fence	0634 – 1433	1.00	0.0/100	< 0.01
19612586	Location 3 – Near Southern Boundary (SE Corner) of Site, Adjacent to New Access Road Entry (No. 3410) off Mitchell Highway, approx. 30 metres from South Site Boundary – On barbed wire fence	0639 – 1439	1.00	0.0/100	< 0.01
19612582	Location 4 – Near Eastern Boundary (near SE Corner) of Site, approx. 70 metres West of Shed, Access Road – On barbed wire fence	0646 – 1444	1.00	0.0/100	< 0.01
19612594	Location 5 – Near Eastern Boundary (near Centre) of Site, approx. 50 metres West of East Site Boundary – On fencing post	0652 – 1451	1.00	0.0/100	< 0.01

Filter No.	Test Type Sample Location	Sample Period Start-Finish	Average Flow Rate (L/min)	Fibres/ Fields	Result(s) Fibres/mL
19612603	Location 6 – Western Boundary of Proposed Quarry Pit (near Western Site Boundary) – On barbed wire fence	0658 – 1456	1.00	0.0/100	< 0.01
19612590	Location 8 – Western Boundary (near NW Corner) of Site – On barbed wire fence	0710 – 1502	1.00	0.0/100	< 0.01
19612593	Location 10 – Near Northern Boundary of Site (near NE Corner Site) – On fencing post	0715 – 1508	1.00	0.0/100	< 0.01
