Asbestos Fibre Air Monitoring Report

Our Ref: C107605:SO2003945.002-20161201
Client: Hanson Construction Materials Pty Ltd
Client Address: Locked Bag 5260, Parramatta NSW 2124

Job Location: East Guyong Quarry, Mitchell Highway, East Guyong NSW

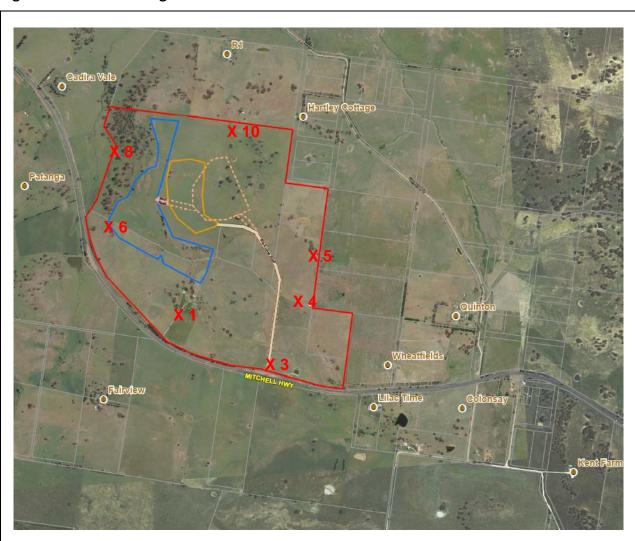
Figure 1 – Air Monitoring Location

Legend **Air Monitoring Sampling Plan** Air monitoring locations **East Guyong Quarry Site Project Boundary Monitoring Date: Quarry Boundary** Thursday 1st December 2016 Infrastructure Area Boundary **Air Monitoring Location Coordinates** Location 1: 709,104mE; 6300,660mN Location 6: 708,803mE; 6301,185mN Location 3: 709,601mE; 6300,370mN Location 8: 708,824mE; 6301,587mN Location 4: 709,729mE; 6300,716mN Location 10: 709,465mE; 6301,633mN Location 5: 709,870mE; 6300,905mN **Weather Conditions** General Fine **Wind Direction** Rainfall Wind Speed
