Asbestos Fibre Air Monitoring Report

Our Ref: C107605:SO2004975.002-20170602
Client: Hanson Construction Materials Pty Ltd
Client Address: Locked Bag 5260, Parramatta NSW 2124

Job Location: East Guyong Quarry, Mitchell Highway, East Guyong NSW

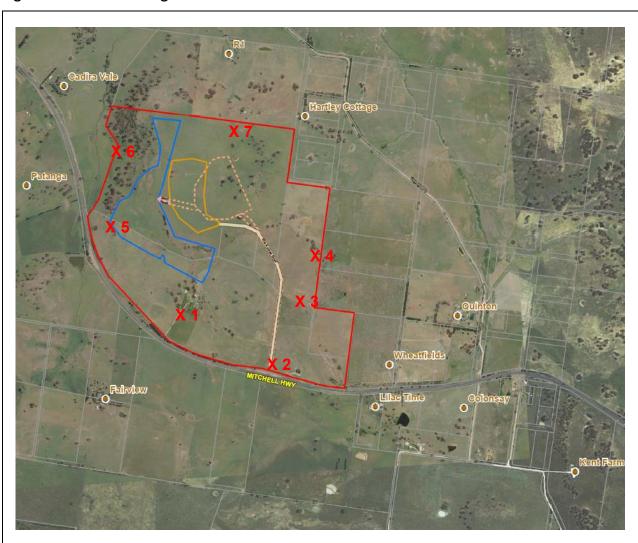
Figure 1 – Air Monitoring Location

Legend **Air Monitoring Sampling Plan** Air monitoring locations **East Guyong Quarry Site Project Boundary Monitoring Date: Quarry Boundary** Friday 2nd June 2017 Infrastructure Area Boundary **Air Monitoring Location Coordinates** Location 1: 709,104mE; 6300,660mN Location 5: 708,803mE; 6301,185mN 709,601mE; 6300,370mN Location 2: Location 6: 708,824mE; 6301,587mN Location 3: Location 7: 709,729mE; 6300,716mN 709,465mE; 6301,633mN Location 4: 709,870mE; 6300,905mN **Weather Conditions** General Fine Wind Direction Rainfall Wind Speed

Filter No.	Test Type Sample Location	Sample Period Start-Finish	Average Flow Rate (L/min)	Fibres/ Fields	Result(s) Fibres/mL
C0019 74032	Field Blank	-	_	0.0/100	_
Asbestos background - Background asbestos air monitoring throughout various locations across the site					
C0019 73940	Location 1 – Near Southern Boundary of Site, Access Road to Residence (No.3472) off Mitchell Highway, approx. 120 metres North of South site boundary – On barbed wire fence	0711 – 1436	1.00	0.0/100	< 0.01
C0009 22329	Location 2 – Near Southern Boundary (SE corner) of Site, Adjacent to New Access Road Entry (No.3410) off Mitchell Highway, approx. 30 metres from South site boundary – On barbed wire fence	0718 – 1441	1.00	0.0/100	< 0.01
C0019 73855	Location 3 – Near Eastern Boundary (near SE corner) of Site, approx. 70 metres West of Shed, Access Road – On barbed wire fence	0725 – 1447	1.00	1.0/100	< 0.01
C0019 73956	Location 4 – Near Eastern Boundary (near Centre) of Site, approx. 50 metres West of East Site Boundary – On fencing post	0734 – 1452	1.00	0.5/100	< 0.01
