ASBESTOS FIBRE AIR MONITORING REPORT

Our Ref: C107605:J111804 020-20120829
Client: Hanson Construction Materials Pty Ltd
Attention: Martin Gear - Project Manager Aggregates
Job Location: East Guyong Quarry, Mitchell Highway, East Guyong NSW
Report Date: Wednesday 29 August 2012 **Test Date:** Wednesday 29 August 2012
Sampling Procedure: Control **Sampled By:** Pumps On: SB
Pumps Off: SB

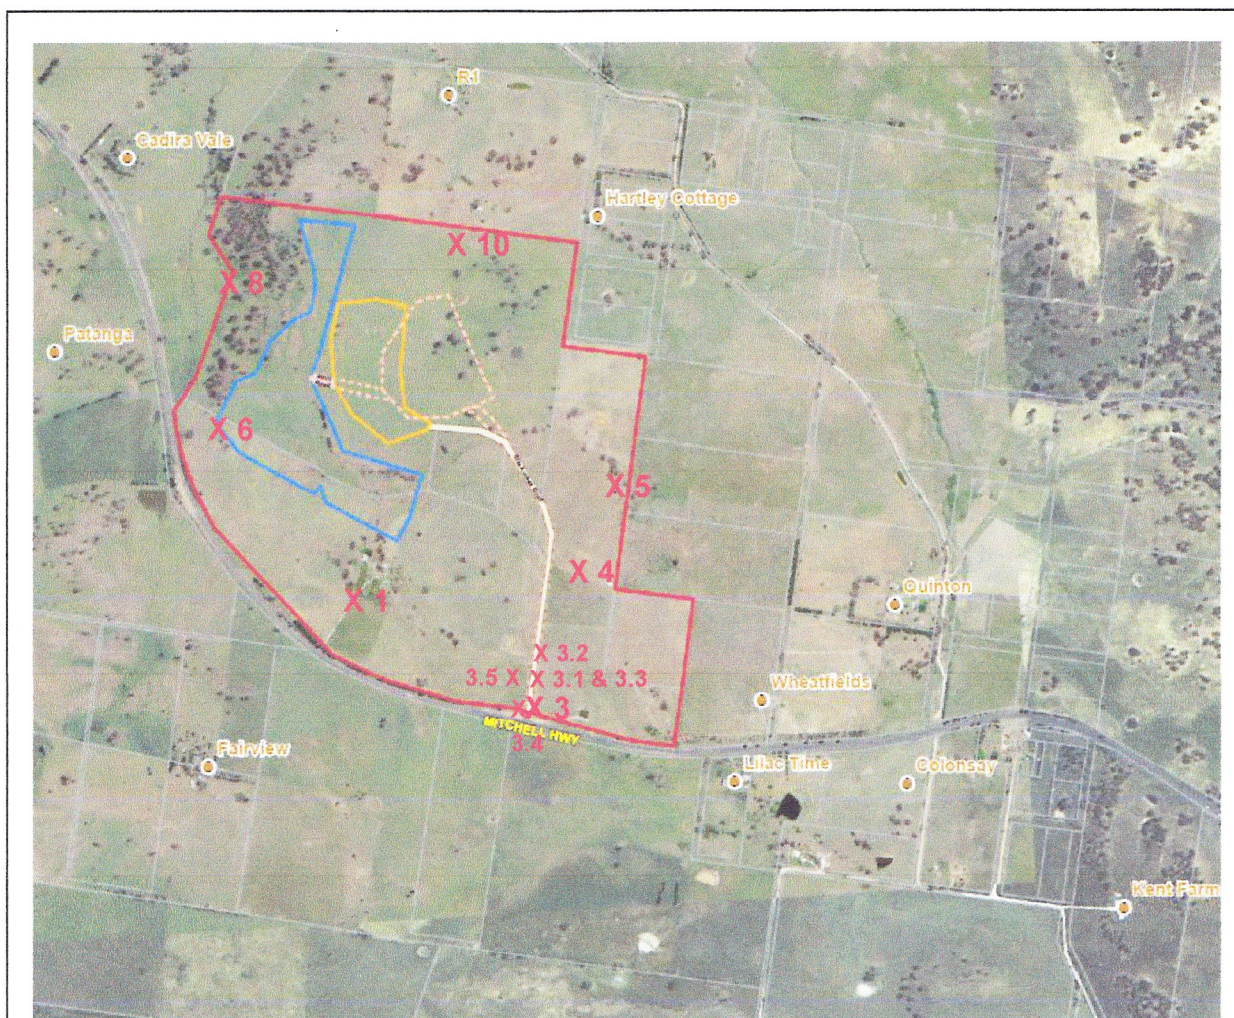
Figure 1 – Air Monitoring Locations

**Air Monitoring Sampling Plan
East Guyong Quarry Site**

Monitoring Date: 29th August 2012

Location 1:	709,104mE ; 6300,660mN	Location 10:	709,465mE ; 6301,633mN
Location 3:	709,600mE ; 6300,372mN	Location 3.1:	709,623mE ; 6300,426mN
Location 4:	709,729mE ; 6300,716mN	Location 3.2:	709,622mE ; 6300,487mN
Location 5:	709,870mE ; 6300,905mN	Location 3.3:	709,583mE ; 6300,405mN
Location 6:	708,803mE ; 6301,185mN	Location 3.4:	709,554mE ; 6300,344mN
Location 8:	708,824mE ; 6301,587mN	Location 3.5:	709,526mE ; 6300,440mN
