ASBESTOS FIBRE AIR MONITORING REPORT

Our Ref: C107605:J111804 M012-20121211
Client: Hanson Construction Materials Pty Ltd
Attention: Martin Gear - Project Manager Aggregates
Job Location: East Guyong Quarry, Mitchell Highway Intersection Upgrade, East Guyong NSW
Report Date: Tuesday 11 December 2012 **Test Date:** Tuesday 11 December 2012
Sampling Procedure: Control **Sampled By:** Pumps On: SB
Pumps Off: SB

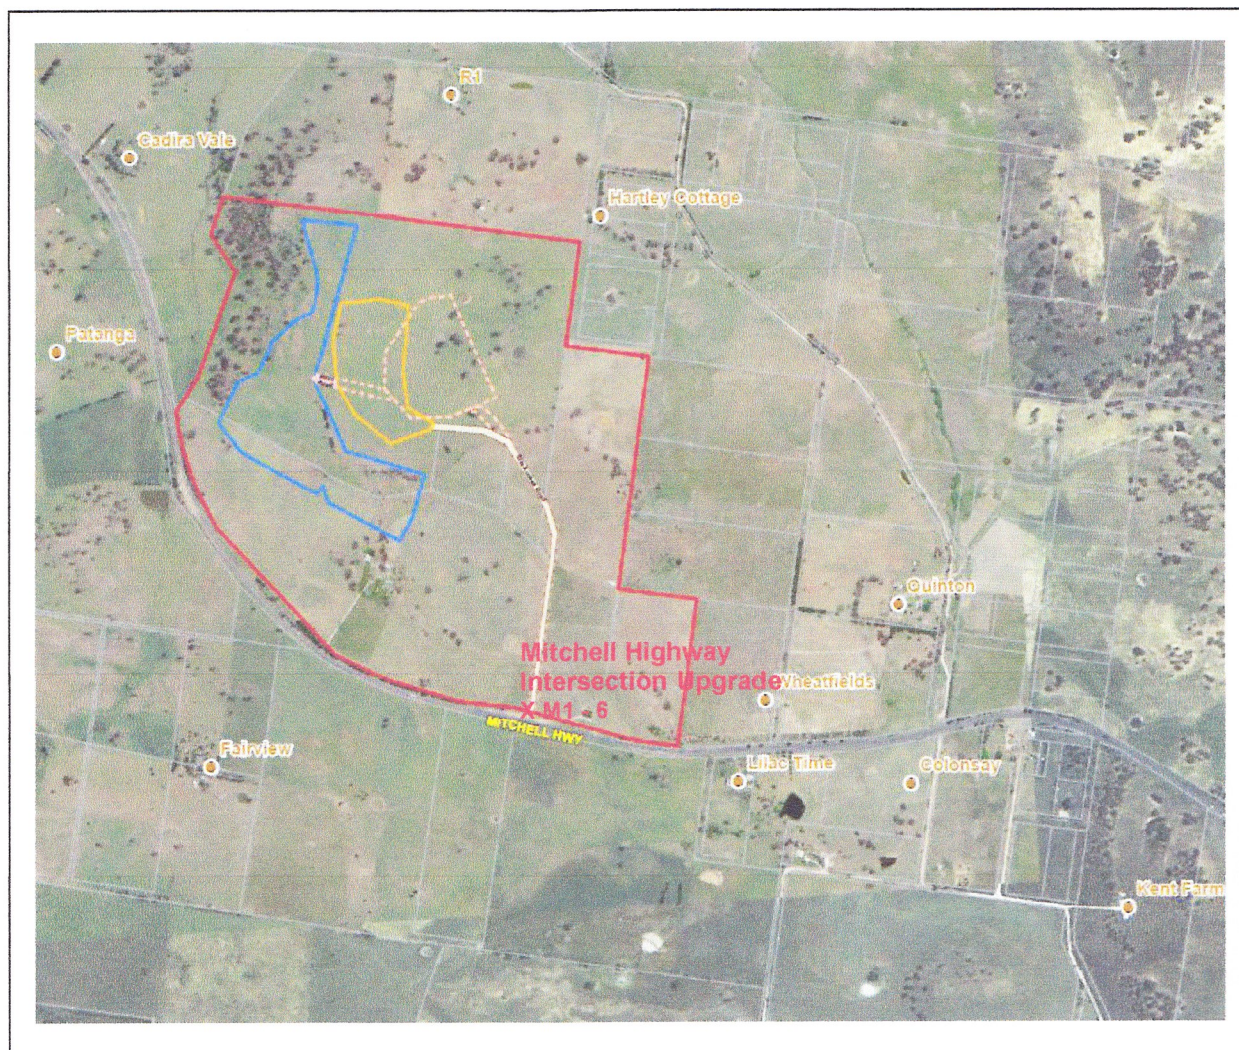
Figure 1 – Air Monitoring Locations

**Air Monitoring Sampling Plan
East Guyong Quarry
Mitchell Highway Intersection
Upgrade Site**

Location M1:	709,560mE ; 6300,347mN	Location M2:	709,475mE ; 6300,351mN
Location M3:	709,590mE ; 6300,325mN	Location M4:	709,534mE ; 6300,310mN
Location M5:	709,577mE ; 6300,332mN	Location M6:	709,532mE ; 6300,460mN
