## ASBESTOS FIBRE AIR MONITORING REPORT

Our Ref: C107605:J111804.157-20131014

Client: Hanson Construction Materials Pty Ltd

Job Location: East Guyong Quarry, Mitchell Highway, East Guyong NSW

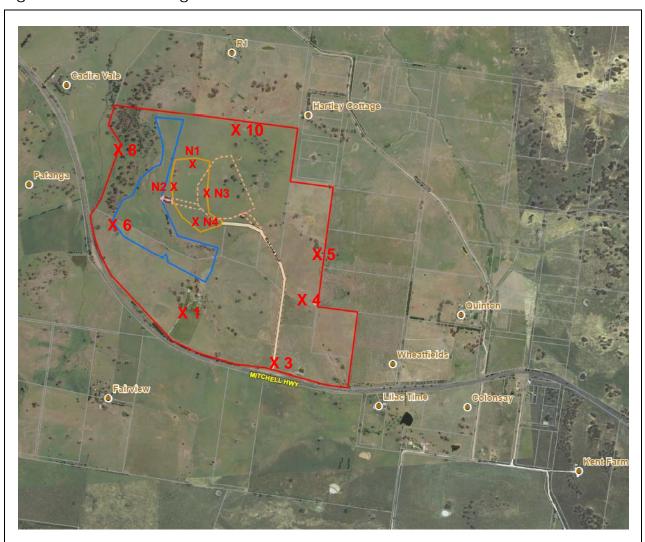
Figure 1 – Air Monitoring Location

## Air Monitoring Sampling Plan East Guyong Quarry Site

Monitoring Date: 14th October 2013

Location 1:	709,104mE; 6300,660mN	Location N1:	709,211mE ; 6301,528mN
Location 3:	709,601mE; 6300,370mN	Location N2:	709,035mE; 6301,323mN
Location 4:	709,729mE; 6300,716mN	Location N3:	709,396mE; 6301,245mN
Location 5:	709,870mE; 6300,905mN	Location N4:	709,208mE ; 6301,040mN
Location 6:	708,803mE; 6301,185mN
