ASBESTOS FIBRE AIR MONITORING REPORT

Client: Hanson Construction Materials Pty Ltd

Job Location: East Guyong Quarry, Mitchell Highway, East Guyong NSW

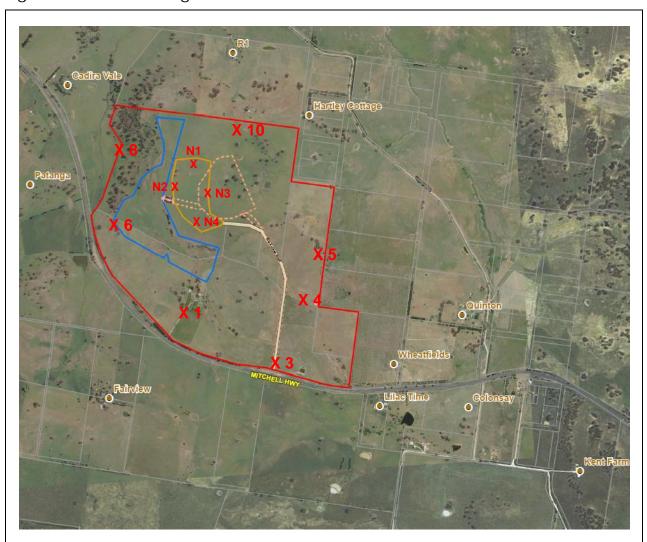
Figure 1 – Air Monitoring Location

Air Monitoring Sampling Plan East Guyong Quarry Site

Monitoring Date: 22nd October 2013

Location 1: 709,104mE; 6300,660mN Location N1: 709,211mE; 6301,528mN Location 3: 709,601mE; 6300,370mN Location N2: 709,035mE; 6301,323mN Location 4: 709,729mE; 6300,716mN Location N3: 709,396mE; 6301,245mN Location 5: 709,870mE; 6300,905mN Location N4: 709,208mE; 6301,040mN 708,803mE; 6301,185mN Location 6:
