ASBESTOS FIBRE AIR MONITORING REPORT

Job Location: East Guyong Quarry, Mitchell Highway, East Guyong NSW

Report Date: Thursday 21 November 2013 Test Date: Thursday 14 November 2013

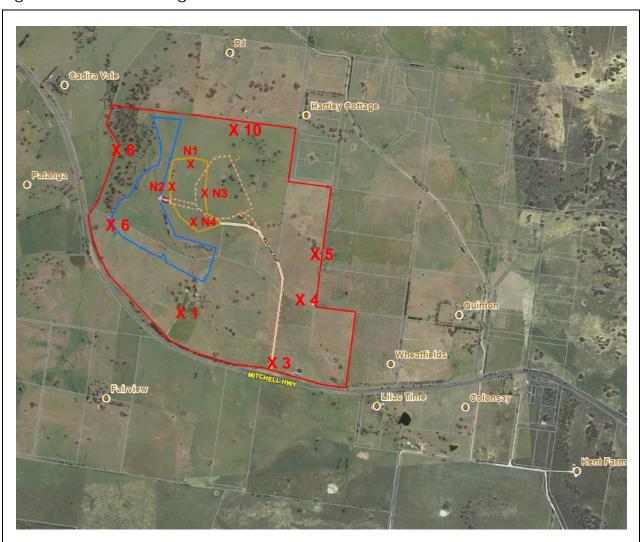
Figure 1 – Air Monitoring Location

Air Monitoring Sampling Plan East Guyong Quarry Site

Monitoring Date: 14th November 2013

Location N1: 709,211mE; 6301,528mN Location 1: 709,104mE; 6300,660mN Location 3: 709,601mE; 6300,370mN Location N2: 709,035mE; 6301,323mN Location 4: 709,729mE; 6300,716mN Location N3: 709,396mE; 6301,245mN Location 5: 709,870mE; 6300,905mN Location N4: 709,208mE; 6301,040mN 708,803mE; 6301,185mN Location 6:
