Asbestos Fibre Air Monitoring Report

Our Ref: C107605:J111804.196-20141017
 Client: Hanson Construction Materials Pty Ltd
 Client Address: Locked Bag 5260
 Parramatta NSW 2124
 Attention: Martin Gear - Project Manager Aggregates
 Copy to: Other relevant party if required
 Job Location: East Guyong Quarry, Mitchell Highway, East Guyong NSW
 Report Date: Wednesday 22nd October 2014
 Test Date: Friday 17th October 2014
 Sampling Type: Control
 Sampled By: Pumps On: Pere Riini (Hanson)
 Pumps Off: Pere Riini (Hanson)

**Air Monitoring Sampling Plan
East Guyong Quarry Site**

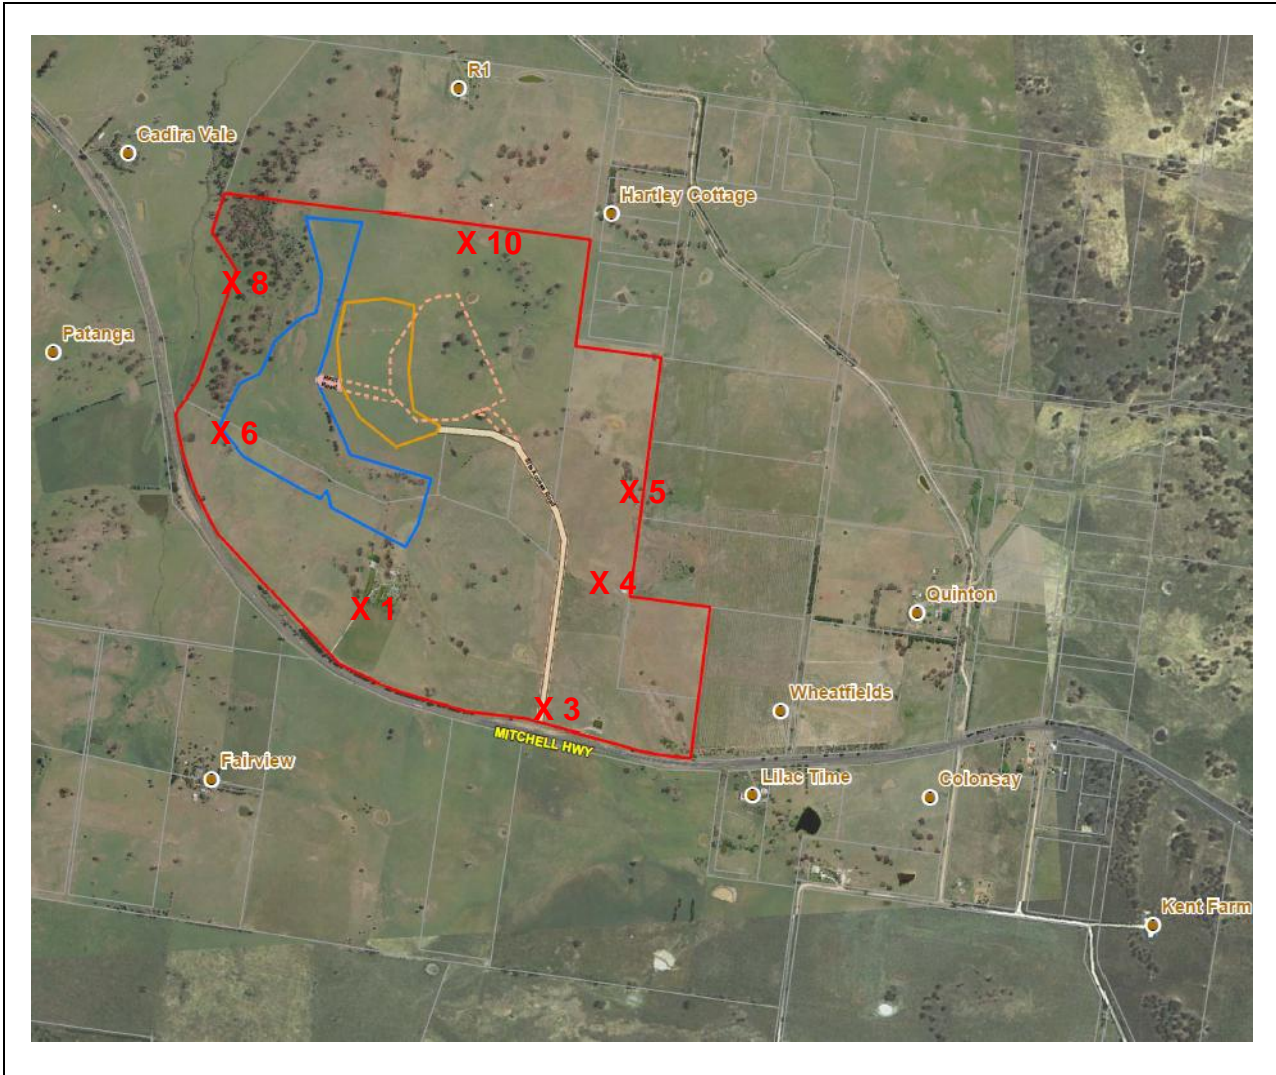
Figure 1 – Air Monitoring Location

Air Monitoring Location Coordinates

Location 1:	709,104mE ; 6300,660mN	Location 6:	708,803mE ; 6301,185mN
Location 3:	709,601mE ; 6300,370mN	Location 8:	708,824mE ; 6301,587mN
Location 4:	709,729mE ; 6300,716mN	Location 10:	709,465mE ; 6301,633mN
Location 5:	709,870mE ; 6300,905mN
