Asbestos Fibre Air Monitoring Report

Our Ref: C107605:J111804.200-20150428
Client: Hanson Construction Materials Pty Ltd

Job Location: East Guyong Quarry, Mitchell Highway, East Guyong NSW

Report Date: Monday 4th May 2015
Test Date: Tuesday 28th April 2015

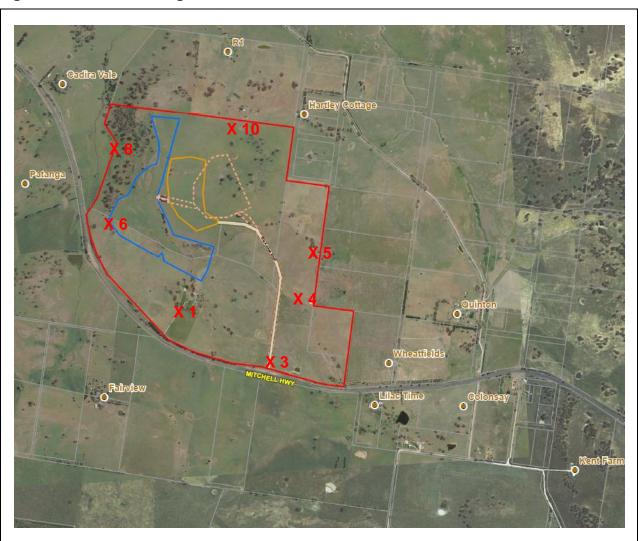
Figure 1 – Air Monitoring Location

Air Monitoring Sampling Plan East Guyong Quarry Site

Monitoring Date: Tuesday 28th April 2015

Air Monitoring Location Coordinates

Location 1:
 709,104mE; 6300,660mN
 Location 6:
 708,803mE; 6301,185mN

Location 3:
 709,601mE; 6300,370mN
 Location 8:
 708,824mE; 6301,587mN

Location 4:
 709,729mE; 6300,716mN
 Location 10:
 709,465mE; 6301,633mN

Location 5:
 709,870mE; 6300,905mN
