## Asbestos Fibre Air Monitoring Report

Our Ref: C107605:SO2001810.001-20160531  
 Client: Hanson Construction Materials Pty Ltd  
 Client Address: Locked Bag 5260  
 Parramatta NSW 2124  
 Attention: Pere Riini - Quarry Manager  
 Job Location: East Guyong Quarry, Mitchell Highway, East Guyong NSW  
 Report Date: Thursday 9th June 2016  
 Test Date: Tuesday 31st May 2016  
 Sampling Type: Control  
 Sampled By: Pumps On: Pere Riini (Hanson)  
 Pumps Off: Pere Riini (Hanson)

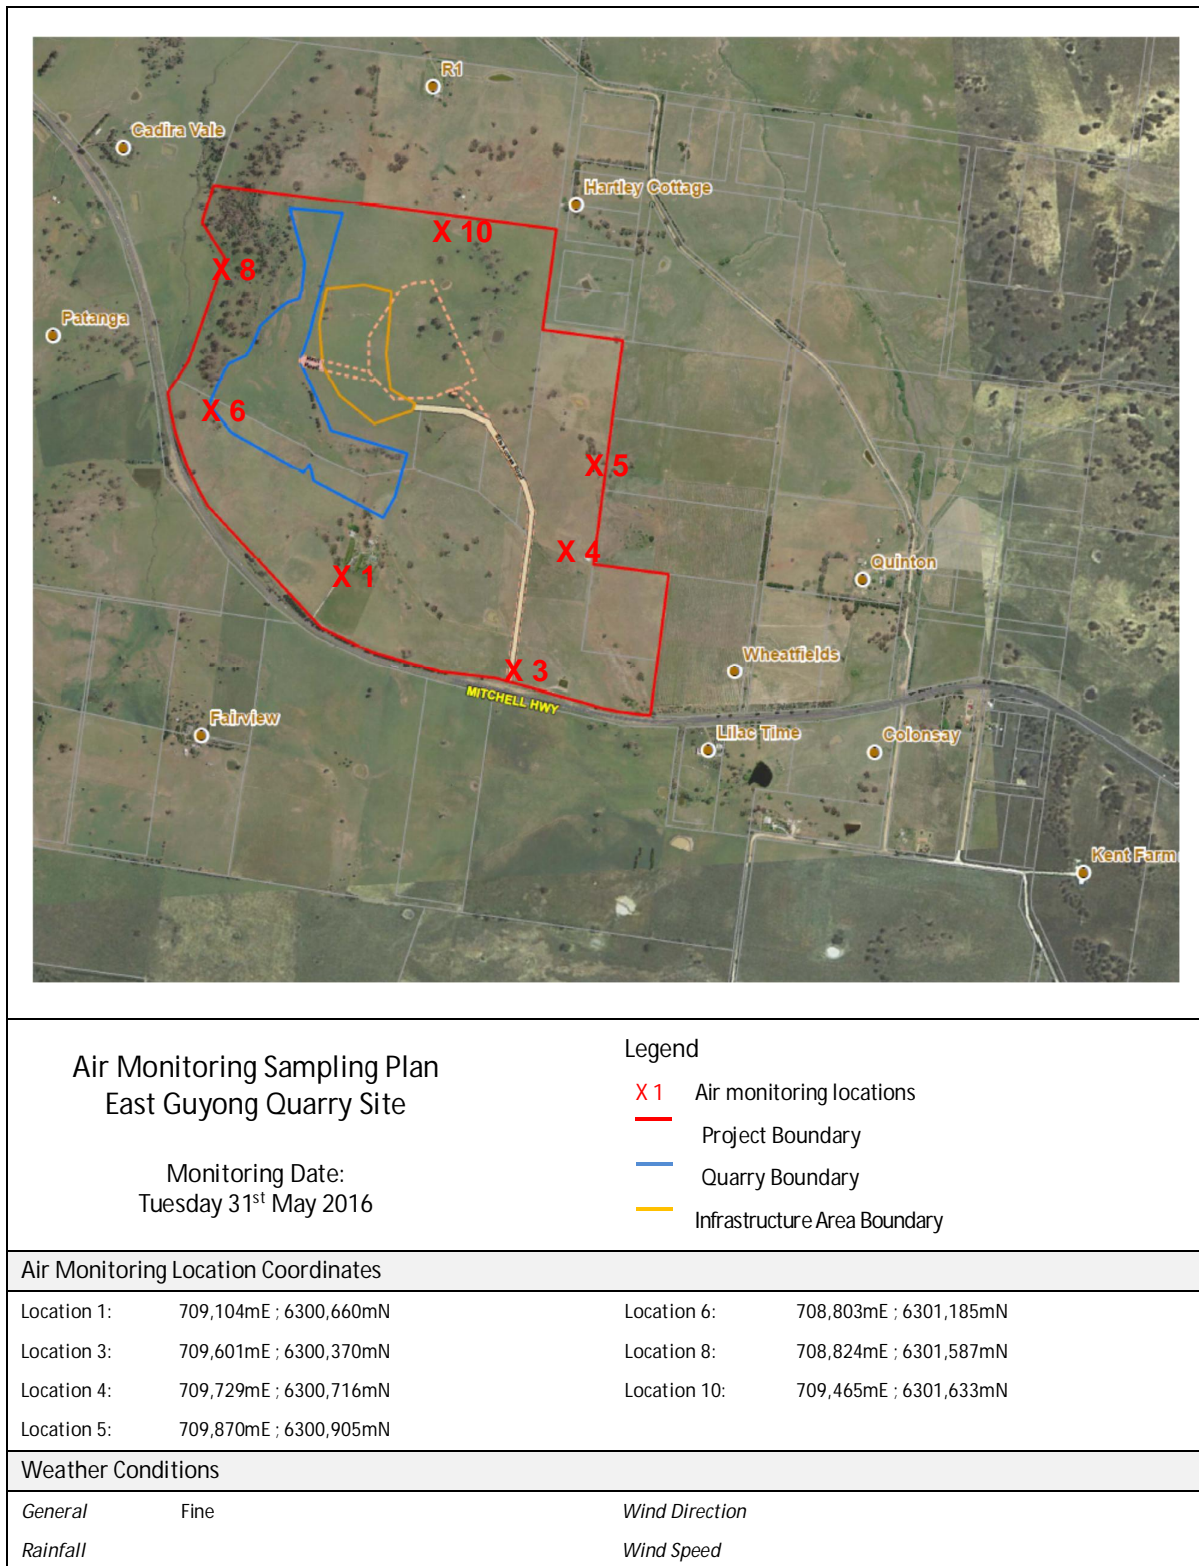
Figure 1 – Air Monitoring Location

Filter No.	Test Type Sample Location	Sample Period Start-Finish	Average Flow Rate (L/min)	Fibres/ Fields	Result(s) Fibres/mL
Background asbestos air monitoring throughout various locations across the site					
19612568	Field Blank	–	–	0.0/100	–
19612591	Location 1 – Near Southern Boundary of Site, Access Road to Residence (No.3472) off Mitchell Highway, approx. 120 metres North of South Site Boundary – On barbed wire fence	0732 – 1444	1.00	0.0/100	< 0.01
19612585	Location 3 – Near Southern Boundary (SE Corner) of Site, Adjacent to New Access Road Entry (No. 3410) off Mitchell Highway, approx. 30 metres from South Site Boundary – On barbed wire fence	0739 – 1451	1.00	0.0/100	< 0.01
19612478	Location 4 – Near Eastern Boundary (near SE Corner) of Site, approx. 70 metres West of Shed, Access Road – On barbed wire fence	0744 – 1459	1.00	0.0/100	< 0.01
19612616	Location 5 – Near Eastern Boundary (near Centre) of Site, approx. 50 metres West of East Site Boundary – On fencing post	0752 – 1506	1.00	0.0/100	< 0.01

Filter No.	Test Type Sample Location	Sample Period Start-Finish	Average Flow Rate (L/min)	Fibres/ Fields	Result(s) Fibres/mL
19612595	Location 6 – Western Boundary of Proposed Quarry Pit (near Western Site Boundary) – On barbed wire fence	0759 – 1514	1.00	0.0/100	< 0.01
19612611	Location 8 – Western Boundary (near NW Corner) of Site – On barbed wire fence	0806 – 1519	1.00	0.0/100	< 0.01
19612592	Location 10 – Near Northern Boundary of Site (near NE Corner Site) – On fencing post	0817 – 1526	1.00	0.0/100	< 0.01
