## Asbestos Fibre Air Sampling & Analysis Report

**Our Ref:** C107605:SO2009256.002 2018-12-03  
**Client:** Hanson Construction Materials Pty Ltd  
**Client Address:** Locked Bag 5260, Parramatta NSW 2124  
**Attention:** Pere Riini - Quarry Manager  
**Job Location:** East Guyong Quarry, 3410 Mitchell Highway, East Guyong NSW 2798  
**Report Date:** Tuesday, 11 December 2018  
**Analysis Date:** Monday, 10 December 2018  
**Sampling Date:** Monday, 3 December 2018  
**Sampling Type:** Control  
**Sampled By:** **Start:** Pere Riini (Hanson) **Finish:** Pere Riini (Hanson)  
**Location of Analysis:** Base laboratory - Level 2, 11 Khartoum Road, North Ryde NSW 2113  
**Licensed Asbestos Removal Contractor:** N/A **Notification No:** N/A

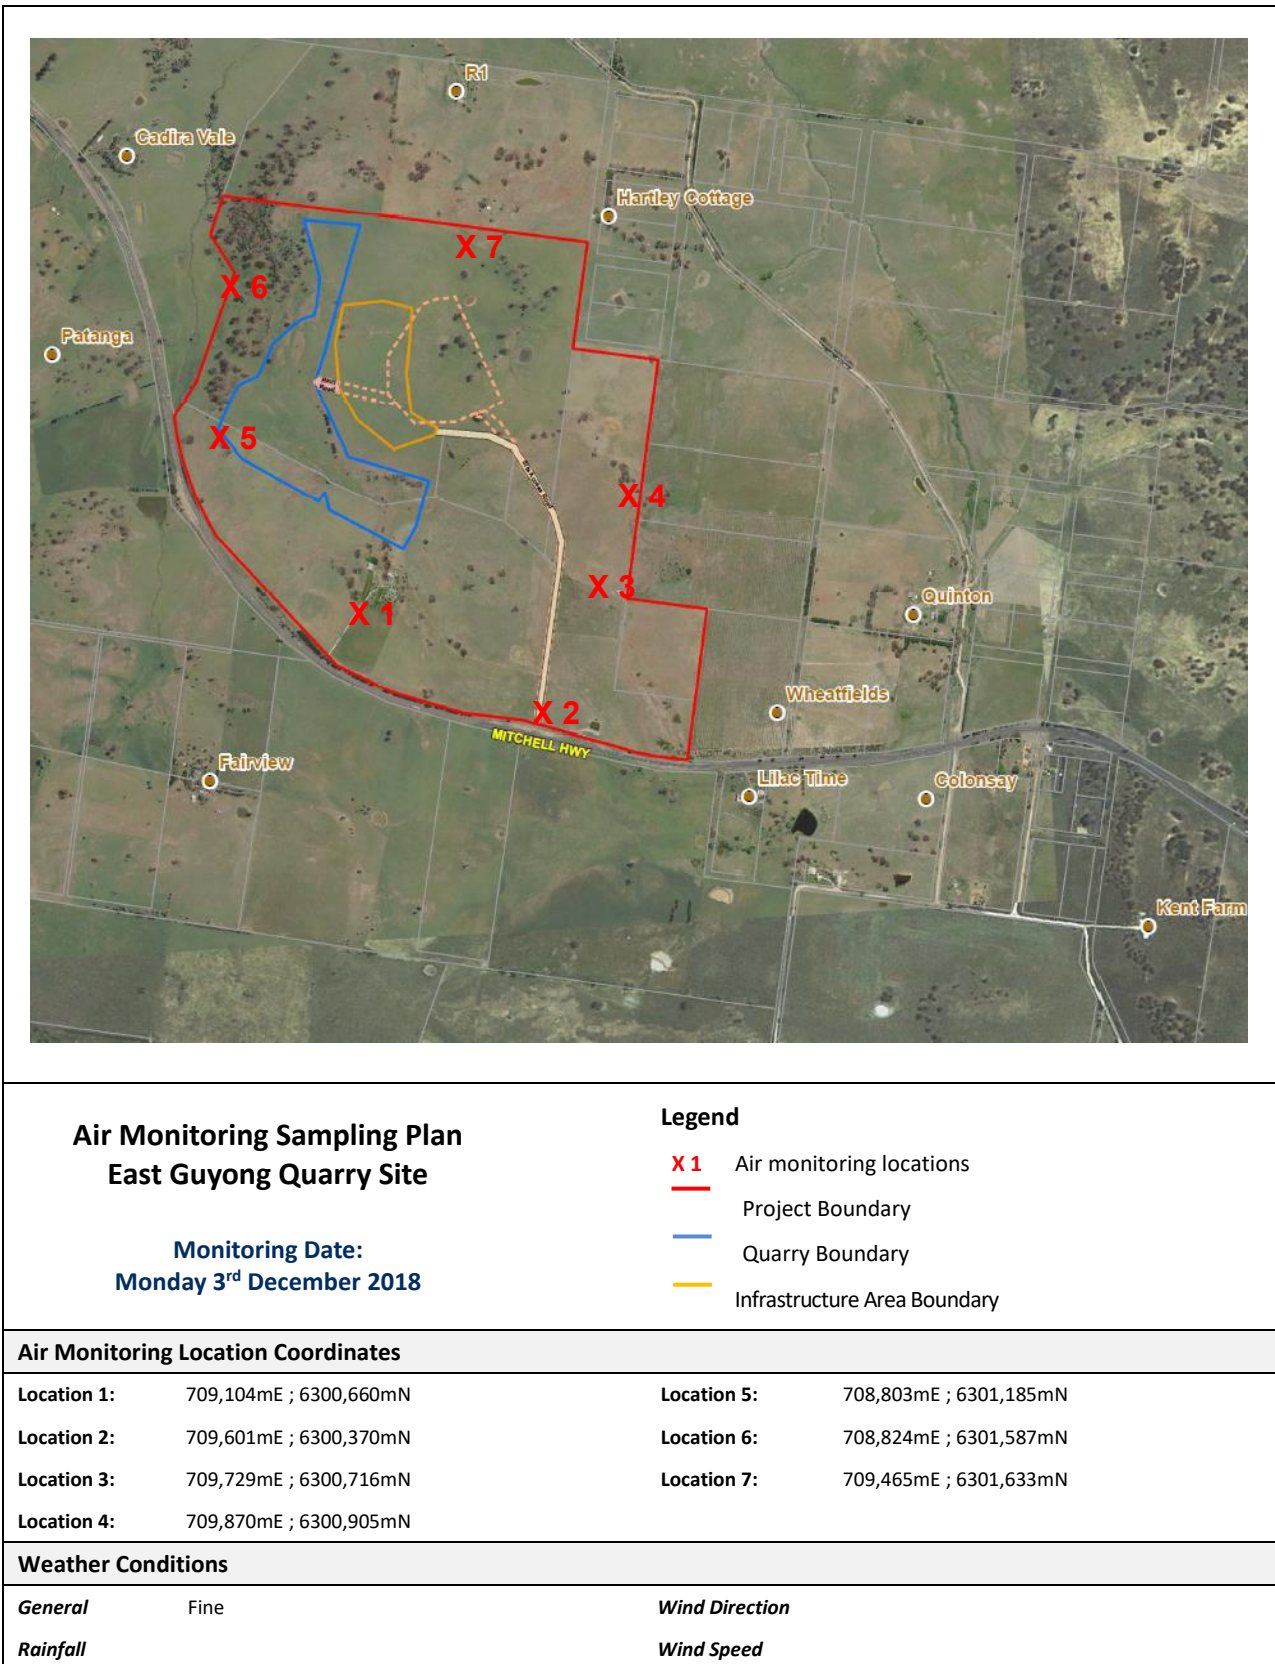
**Figure 1 – Air Monitoring Location**

Sample Filter No.	Test Type Sample Location	Sample Time Start-Finish	Sampling Rate (avg) (L/min)	Fibres/ Fields	Result(s) Fibres/mL
C005079009	Field Blank	–	–	0.0/100	–
Asbestos background - air monitoring throughout various locations across the site					
C005079020	Location 1 – Near Southern Boundary of Site, Access Road to Residence (No.3472) off Mitchell Highway, approx. 120 metres North of South Site Boundary – On barbed wire fence	0631 – 1449	1.00	0.0/100	< 0.01
C005079070	Location 2 – Near Southern Boundary (SE Corner) of Site, Adjacent to New Access Road Entry (No. 3410) off Mitchell Highway, approx. 30 metres from South Site Boundary – On barbed wire fence	0642 – 1438	1.00	0.0/100	< 0.01
C005078966	Location 3 – Near Eastern Boundary (near SE Corner) of Site, approx. 70 metres West of Shed, Access Road – On barbed wire fence	0649 – 1503	1.00	1.0/100	< 0.01
C005079293	Location 4 – Near Eastern Boundary (near Centre) of Site, approx. 50 metres West of East Site Boundary – On fencing post	0658 – 1512	1.00	1.0/100	< 0.01

C005079021	Location 5 – Western Boundary of Proposed Quarry Pit (near Western Site Boundary) – On barbed wire fence	0711 – 1520	1.00	0.0/100	< 0.01

Sample Filter No.	Test Type Sample Location	Sample Time Start-Finish	Sampling Rate (avg) (L/min)	Fibres/ Fields	Result(s) Fibres/mL
C006124012	Location 6 – Western Boundary (near NW Corner) of Site – On barbed wire fence	0718 – 1530	1.00	0.0/100	< 0.01
C005078970	Location 7 – Near Northern Boundary of Site (near NE Corner Site) – On fencing post	0729 – 1538	1.00	0.0/100	< 0.01
C005079245	Personal Monitor – PC450 Excavator – R. Chapman	0738 – 1546	1.00	0.0/100	< 0.01
