Asbestos Fibre Air Sampling & Analysis Report

Our Ref: C107605:J177344.002_AFM_East_Guyong_Quarry_20220623
Client: Hanson Construction Materials Pty Ltd
Client Address: Locked Bag 5260, Parramatta NSW 2124
Attention: Chris Cooke – Quarry Manager
Job Location: East Guyong Quarry, 3410 Mitchell Highway, East Guyong NSW 2798
Report Date: Thursday, 23 June 2022
Analysis Date: Thursday, 23 June 2022
Sampling Date: Thursday, 23 June 2022
Sampling Type: Control (Static)
Sampled By: **Start:** Simon Day **Finish:** Simon Day
Location of Analysis: Field laboratory - East Guyong Quarry, 3410 Mitchell Highway, East Guyong NSW 2798
 (Site Office, Training Room)

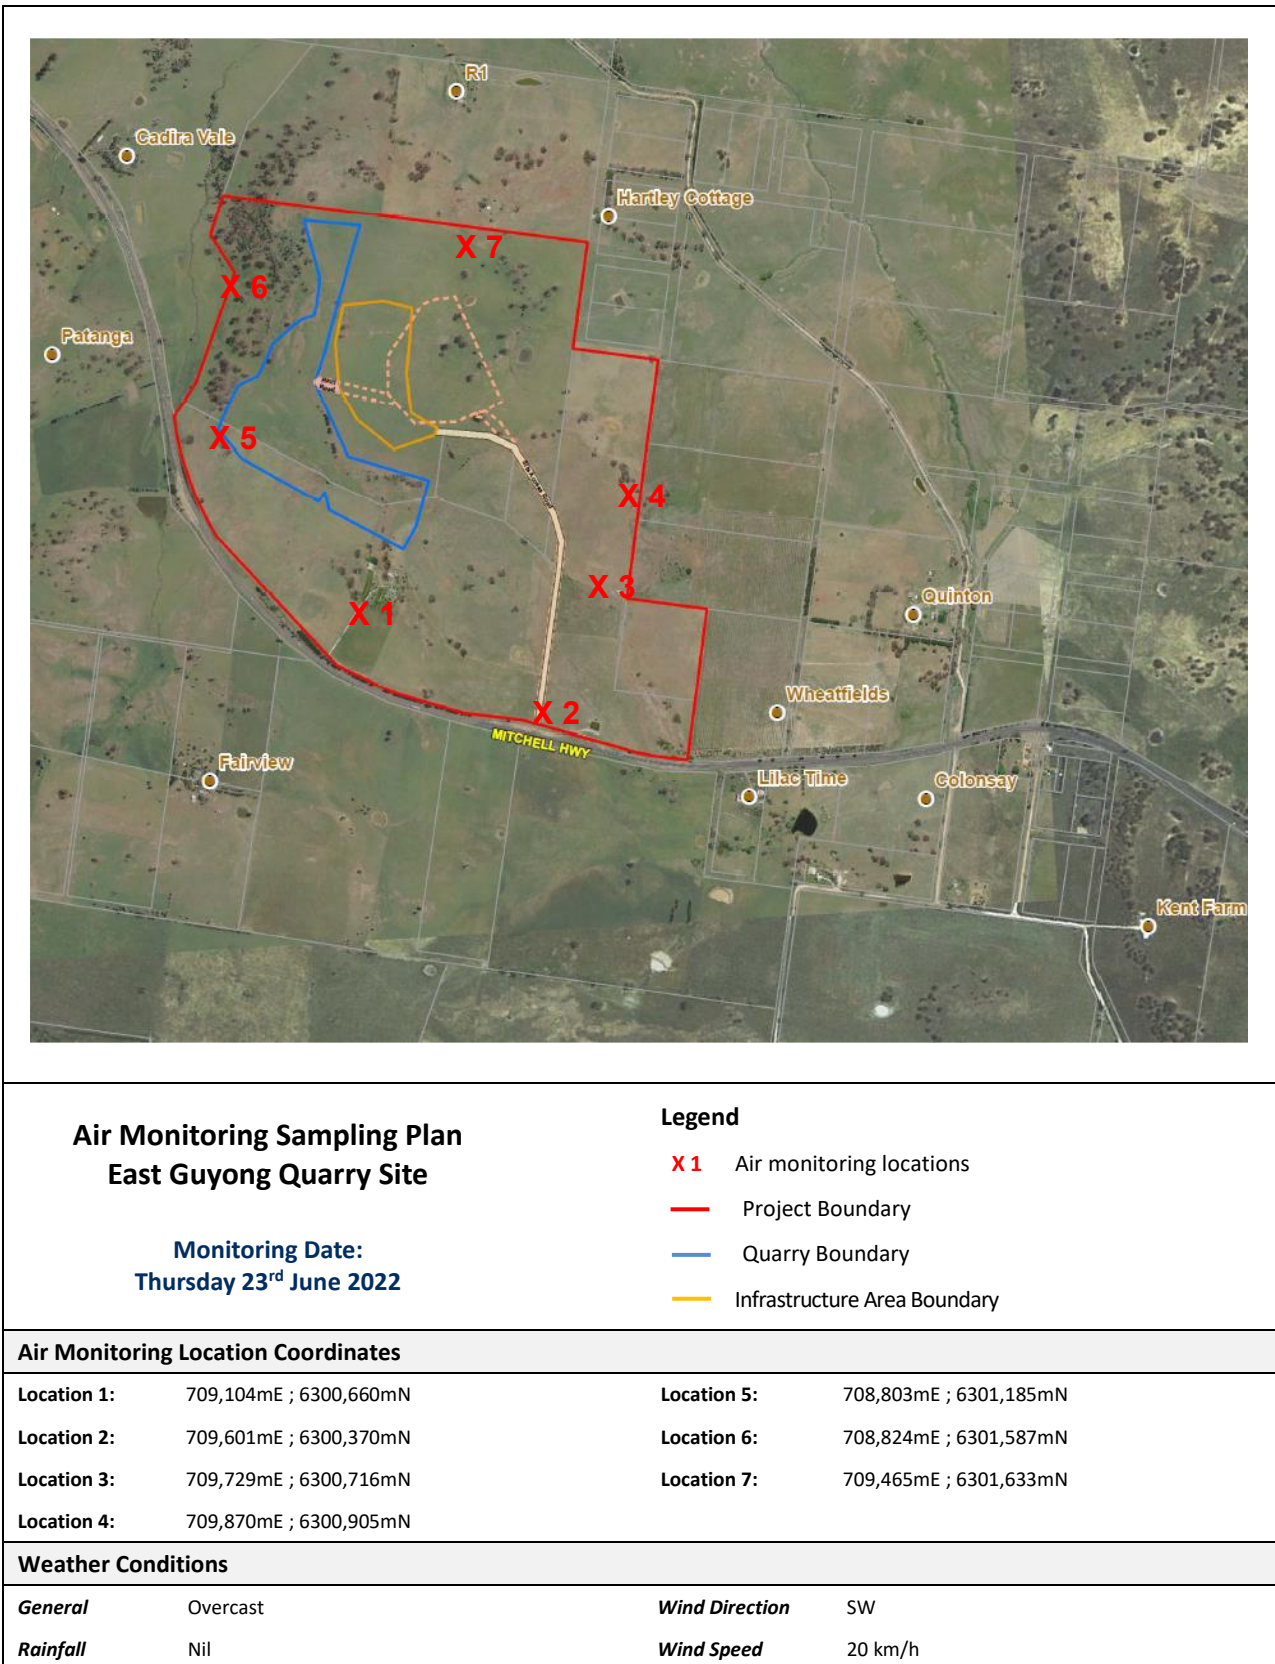
Figure 1 – Air Monitoring Locations

Sample Filter No.	Test Type Sample Location	Sampling Period Start-Finish	Sampling Rate (avg) (L/min)	Fibres/Fields	Result(s) Fibres/mL
73532	Field Blank (25 mm)	–	–	0.0/100	–
73558	Field Lab - Site Office, Training Room, On desk – North end	0837 – 1348	1.50	4.5/100	< 0.01
Background asbestos fibre air monitoring throughout various locations across the site.					
73537	Location 1 – Near Southern Boundary of Site, Access road to residence (No.3472) off Mitchell Hwy, approx. 120m North of South site boundary – On barbed wire fence	0748 – 1313	1.50	0.0/100	< 0.01
73668	Location 2 – Near Southern Boundary (South-east Corner) of site, Adj new access road entry (No. 3410) off Mitchell Hwy, approx. 30m of South site boundary – On barbed wire fence	0745 – 1307	1.50	0.0/100	< 0.01
73579	Location 3 – Near Eastern Boundary (near South-east Corner) of site, approx. 70 m West of shed, Access road – On barbed wire fence	0752 – 1318	1.50	1.0/100	< 0.01

73527	Location 4 – Near Eastern Boundary (near Centre) of site, approx. 50 m West of East site boundary – On fencing post	0755 – 1320	1.50	1.0/100	< 0.01
73550	Location 5 – Western Boundary of quarry pit (near Western site boundary) – On barbed wire fence	0802 – 1328	1.50	0.0/100	< 0.01
73535	Location 6 – Western Boundary (near Northwest Corner) of site – On barbed wire fence	0808 – 1332	1.50	0.0/100	< 0.01
73526	Location 7 – Near Northern Boundary of Site (near North-east corner site) – On fencing post	0819 – 1341	1.50	1.5/100	< 0.01
