Certificate of Analysis

LOCATION: 3410 Mitchell Highway, Guyong NSW 2798 **CERTIFICATE NO:** WOL-PS206308-0001-164990 CLIENT: Hanson Construction Materials Pty Ltd DATE\S SAMPLED: 18/07/2023 **CLIENT ADDRESS:** 55 Galway Avenue, Marleston SA 5033 DATE RECEIVED: 20/07/2023 0409907043 TELEPHONE: DATE ANALYSED: 20/07/2023 ORDER NUMBER: PS203608 EMAIL: chris.cooke@hanson.com.au Hamish Cowan CONTACT: Chris Cooke SAMPLED BY:

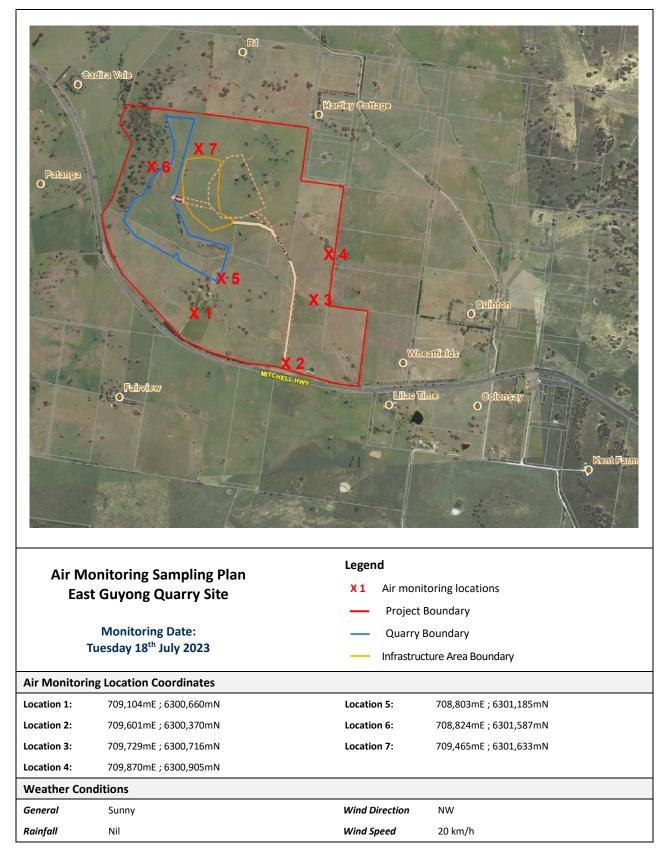
Figure 1 – Air Monitoring Locations

| Lab No | Sample ID | Location | <u>Results</u> (Fibres/Field) | Concentration (Fibres/mL) |
|---|---|---|---|---|
| 001 | 8869 | Location 1 - Near Southern Boundary of Site, Access road to residence (No.3472) off Mitchell Hwy, approx. 120m North of South site boundary - On barbed wire fence | 0.0 / 100 | <0.01 |
| 002 | 8868 | Location 2 – Near Southern Boundary (South-east Corner) of site, Adj new access road entry (No. 3410) off Mitchell Hwy, approx. 30m of South site boundary – On barbed wire fence | 0.0 / 100 | <0.01 |
| 003 | 8889 | Location 3 – Near Eastern Boundary (near South-east Corner) of site, approx. 70 m West of shed, Access road – On barbed wire fence | 0.0 / 100 | <0.01 |
| 004 | 8888 | Location 4 – Near Eastern Boundary (near Centre) of site, approx. 50 m West of East site boundary – On fencing post | 0.0 / 100 | <0.01 |
| 005 | 8899 | Location 5 – South-eastern Boundary of quarry pit (near residence boundary) – On barbed wire fence | 0.0 / 100 | <0.01 |
| 006 | 8878 | Location 6 – Western Boundary of quarry pit (near Northwest Corner) of site – On sign | 0.0 / 100 | <0.01 |
| 007 | 8879 | Location 7 – Near Northern Boundary of Site (near North-east corner site) – On gate | 0.0 / 100 | <0.01 |
